Date: February 1, 2013
To: Bill Cole, DOT&PF (NR)
From: Mel Langdon
Project: Noatak Airport
Subject: Noatak Riverbank Erosion Assessment

W.O.#: 879301
cc: Raymond Plummer
Sara Lindberg

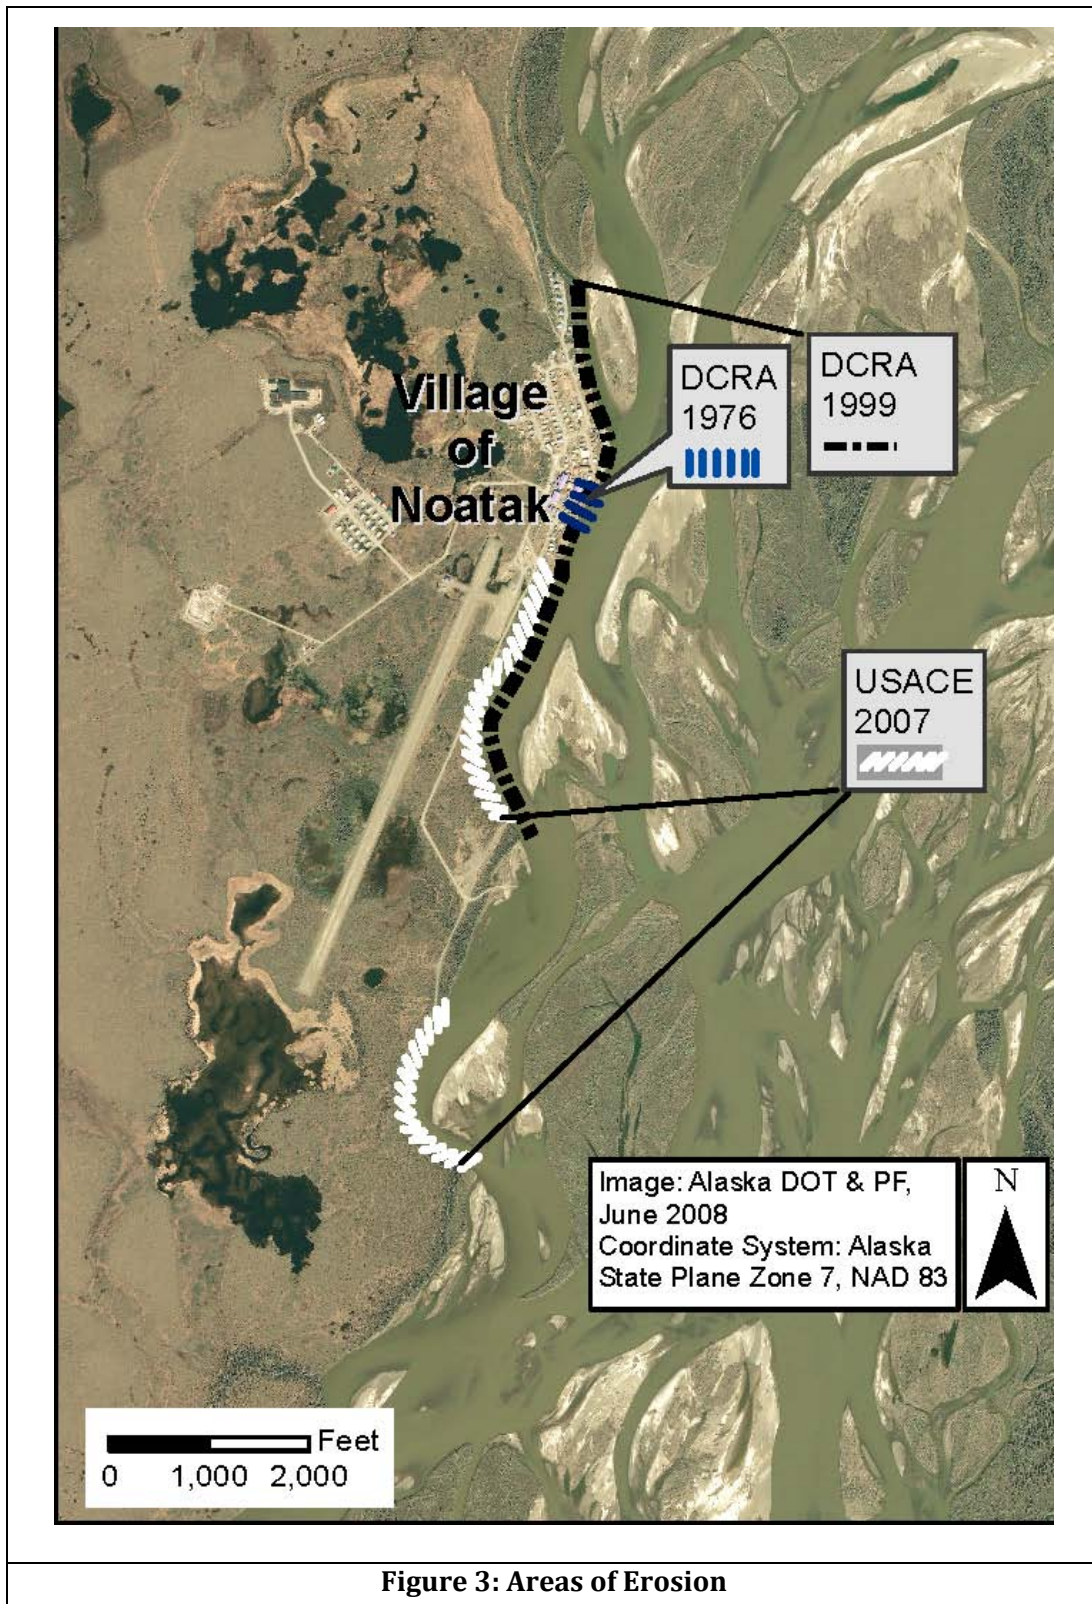
5. Current Areas Subject to Erosion. Areas depicted on maps prepared by two agencies (DCRA, 1999 and USACE, 2007) in the past 13 years are shown on Figure 3. Erosion is more apparent in areas of high, steep banks, than along the area adjacent to the airport apron. The *Alaska Baseline Erosion Assessment* (USACE, 2009) rated Noatak as a “Monitor Conditions Community,” having significant impacts related to erosion, in which taking action to prevent a problem from becoming worse would be prudent.

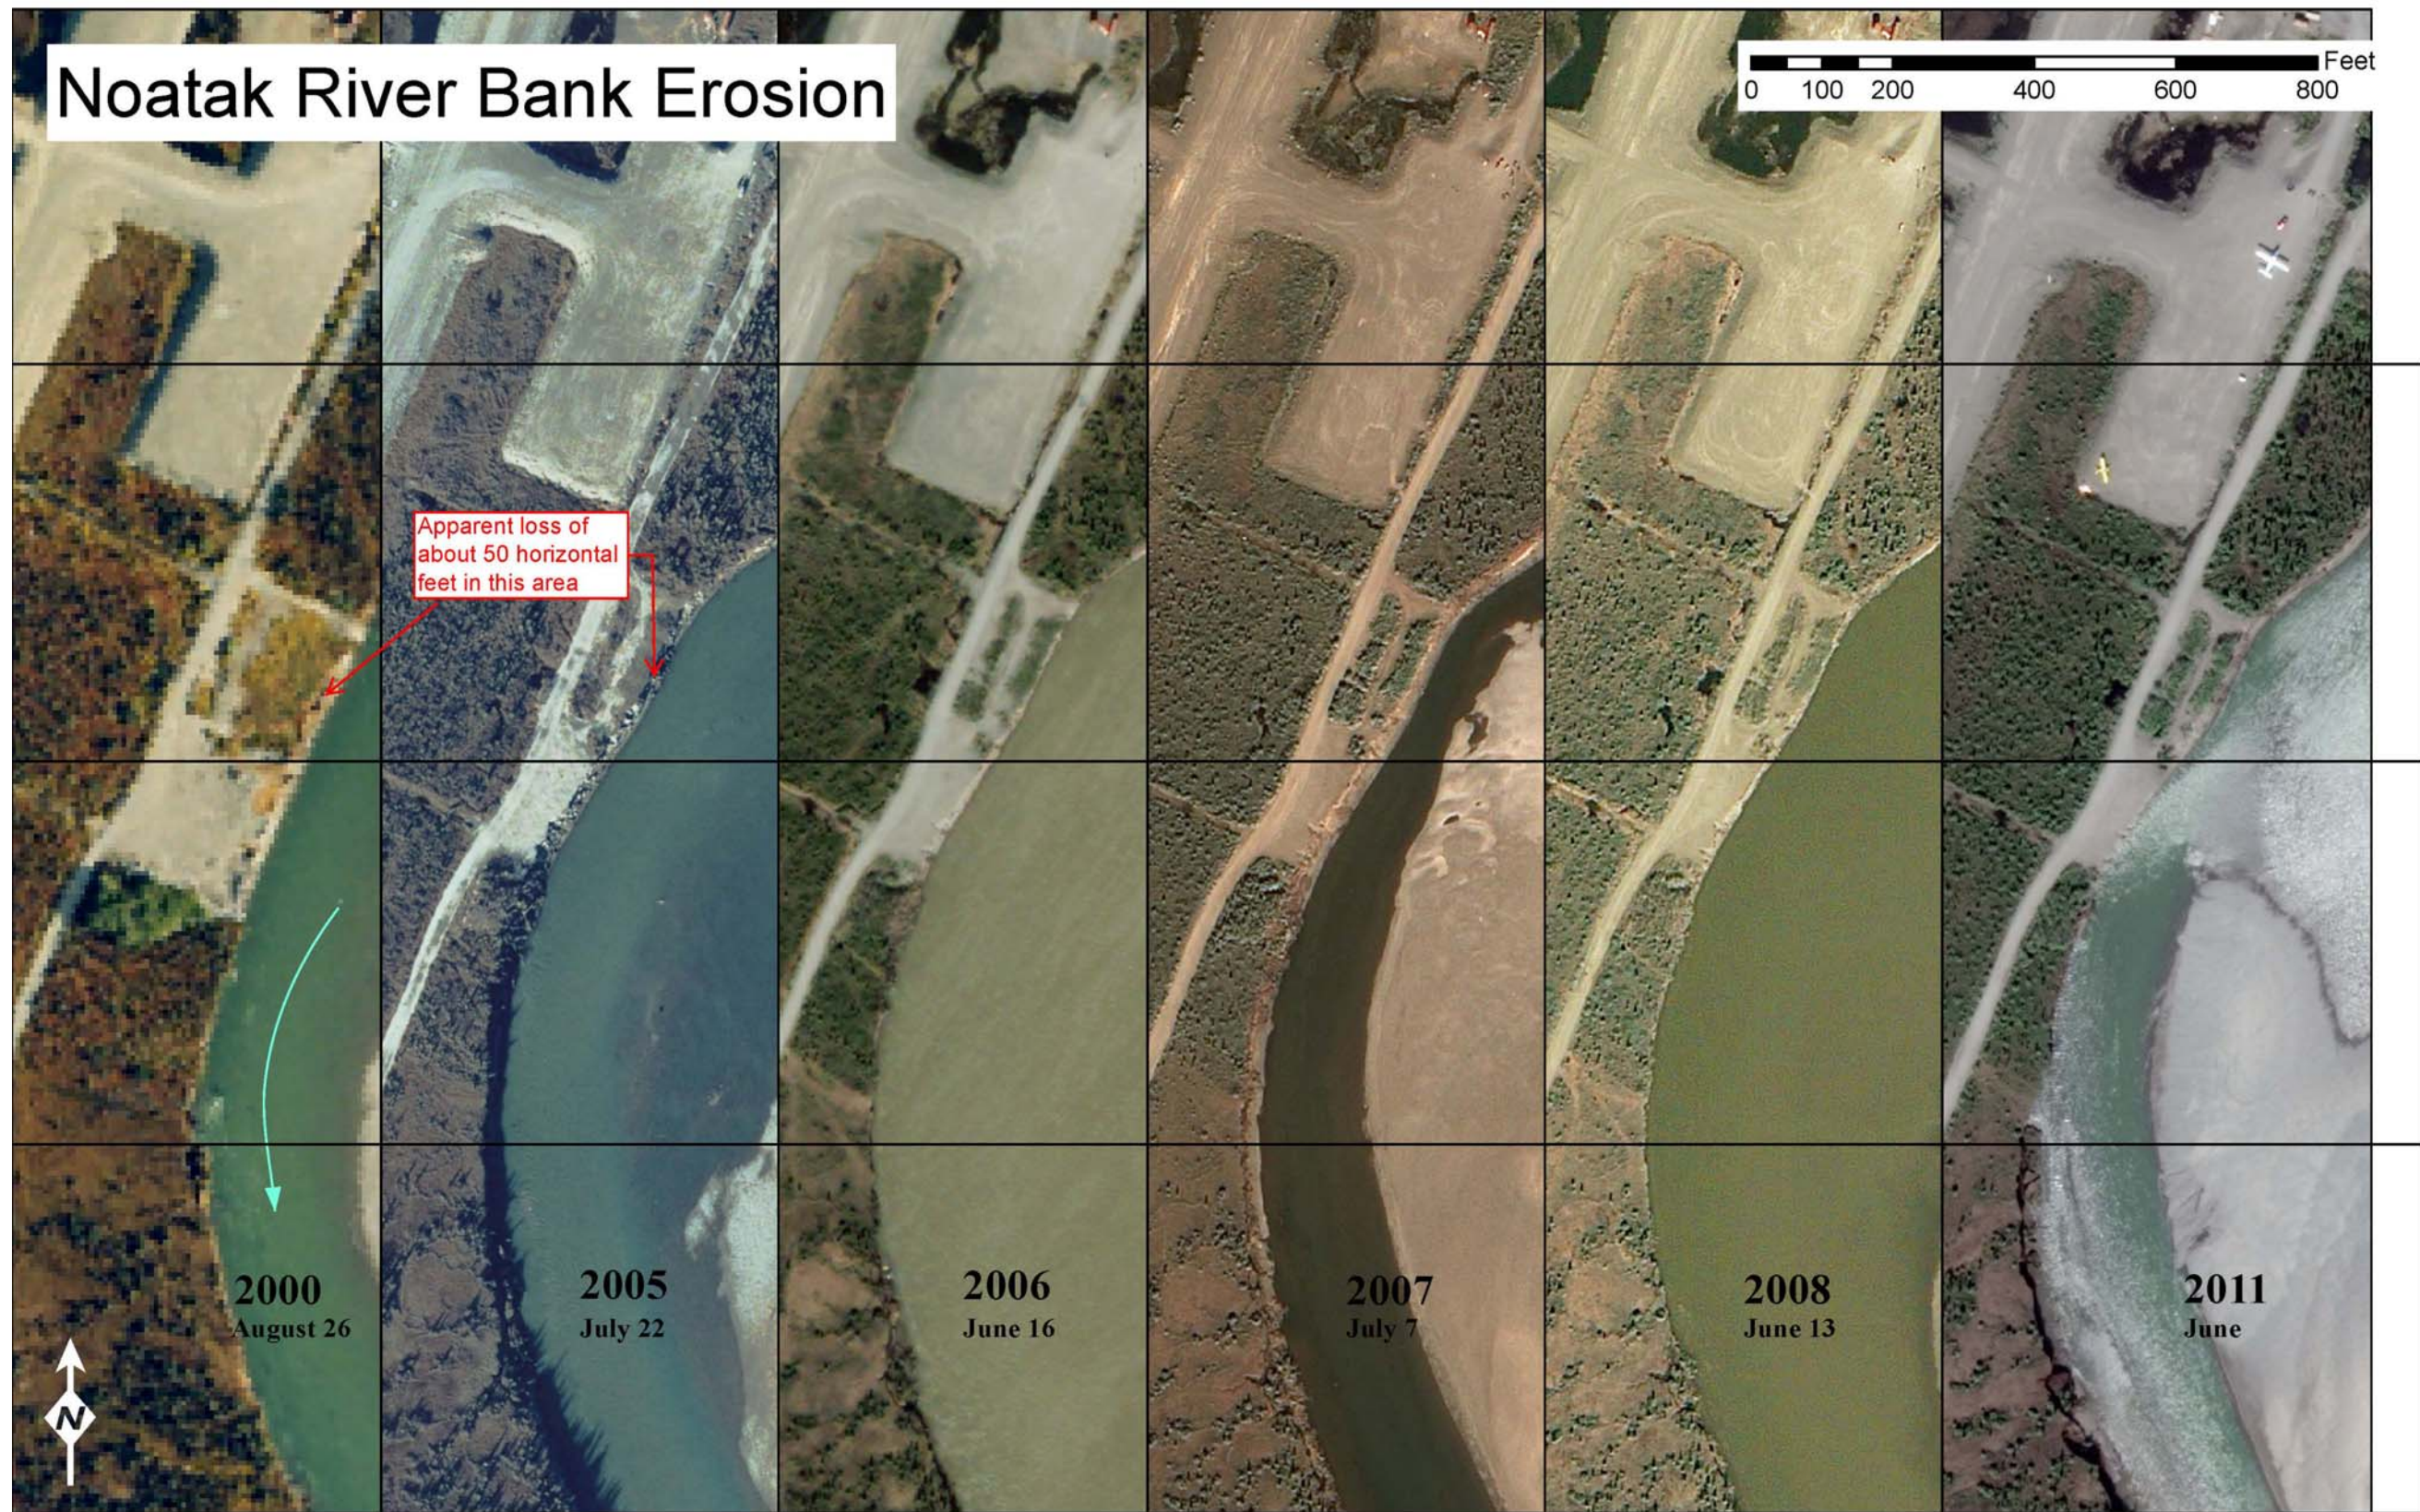
Figure 4: Aerial Photography 2000 to 2011

1. Aerial photographs were obtained by DOT&PF for 2000, 2005, 2006, 2007, 2008, and 2011 and are shown in Figure 4. Because of varying water levels at the time of the photos, the absolute extent of erosion is not measurable at the level of detail in the aerial photos. However, between 2000 and 2005, it appears that about 80 horizontal feet have been lost, corresponding with erosion observed in May-June, 2004.

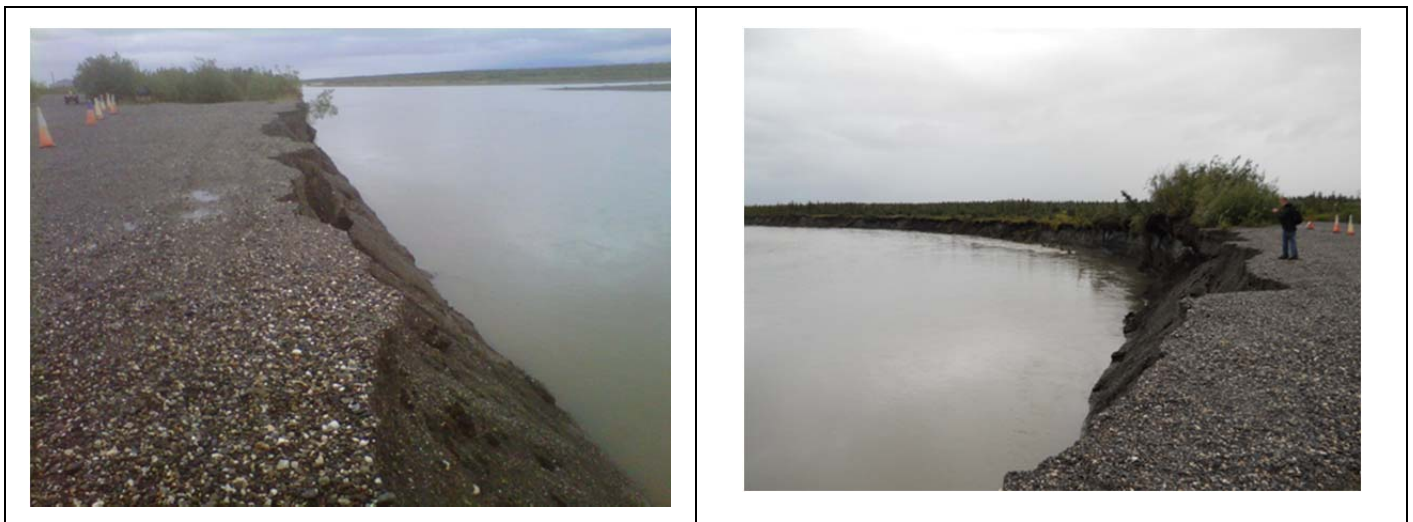
4. August 2012. Significant erosion occurred southeast of the airport apron during a very rainy late summer period.
- A DOT&PF sketch based on GPS coordinates collected on August 1, 2012, site visit and aerial imagery (Figure 6), indicates the distance from the southeast corner of the apron to the riverbank is now about 125 feet. Photos from that site visit (Figure 5) illustrate the bank height and the extent of erosion along the bank. DOT&PF personnel note that active erosion was occurring at Point C shown in Figure 6 and that erosion had occurred both up and downriver from Point C, as illustrated by the red line (“2012 anticipated shoreline”) in Figure 6. The actual location of Point C may be somewhat closer to the river than shown on this figure, due to cloud cover interfering with the GPS satellite signal (Dianoski, 2013). Assuming Point C is only half the distance from the river edge than shown on Figure 3 and comparing this with the 2006 edge of bank, it appears that 20 to 30 horizontal feet had been lost.

- DOT&PF’s contract airport maintenance staff in Noatak described the erosion as occurring over several weeks, losing about a foot a day (Kirk, 2013). He described high water all summer and an eddy effect against the bank during the active erosion. The maintenance staff also observed sinkholes next to Pit Road, between the road and the runway. During the summer rain, runoff from the road entered the sinkholes but didn’t fill them, apparently because water was seeping out. Seepage from the riverbank face on the other side of the Pit Road from the sinkholes was observed. This may indicate that there is direct seepage from the subsurface to the face of the riverbank.

Figure 5: Bank Erosion August 2012 Orange cones set along east side of Pit Road. (Left) looking upriver from Point C (Right) looking downriver from Point B
