APPENDIX HW
Hazardous Waste

**USACE Haines-Fairbanks Pipeline No Department of Defense Action
Indicated (NDAI) Final Determination (2014)**

Hazardous, Toxic, or Radioactive Waste
Project # F10AK1016-01
Haines-Fairbanks Pipeline
Various Locations, Alaska

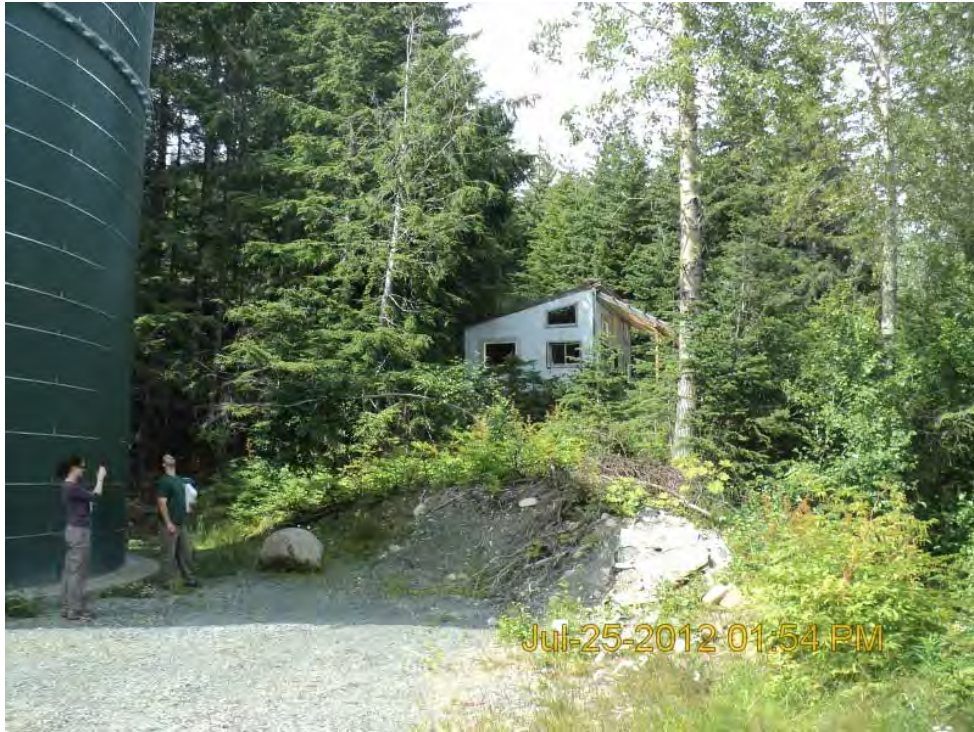
PMP 1.9 (Young Road Site) –Water Tank and Adjacent Soil Berm with Remaining Soil Contamination

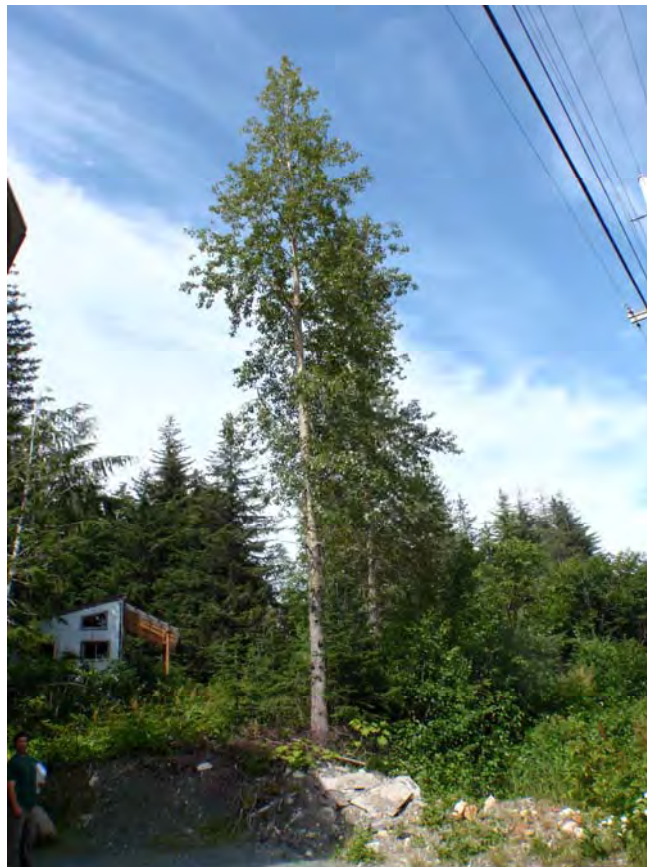
PMP 1.9 (Young Road Site) –Tree that May Need to be Removed Prior to Excavation

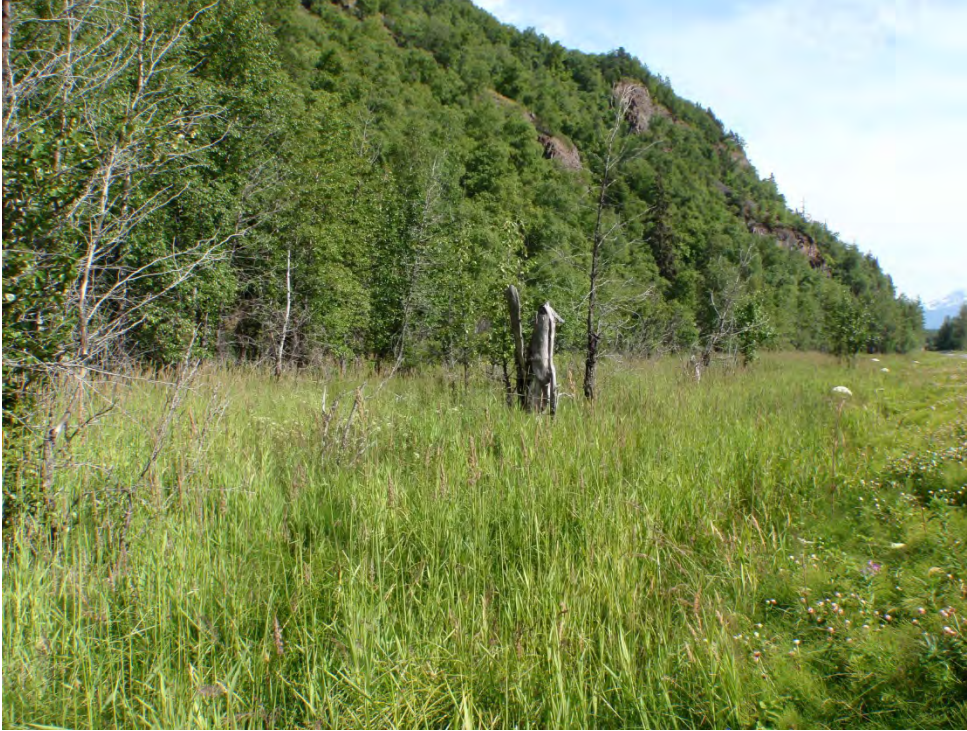
**PMP 17.7 – Tree Kill in Wetland on East Side of Highway
(Photo taken from Haines Highway - Looking Southeast)**

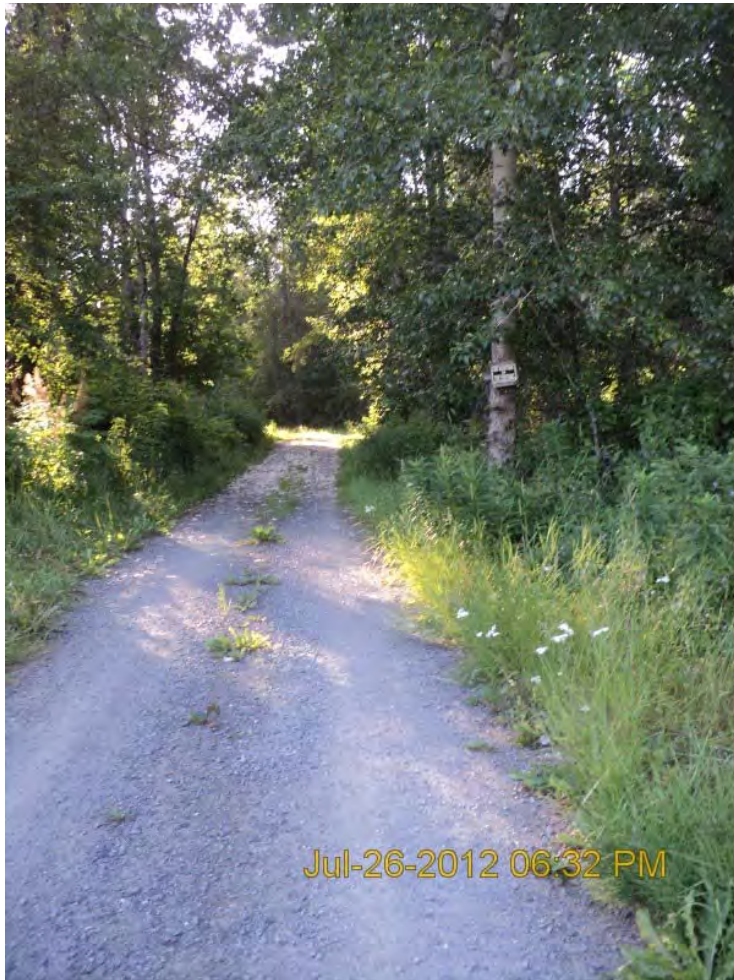
PMP 19.5 – Private Road that HFP Intersects and where Release is Believed to have Occurred (Photo Looking Northwest)

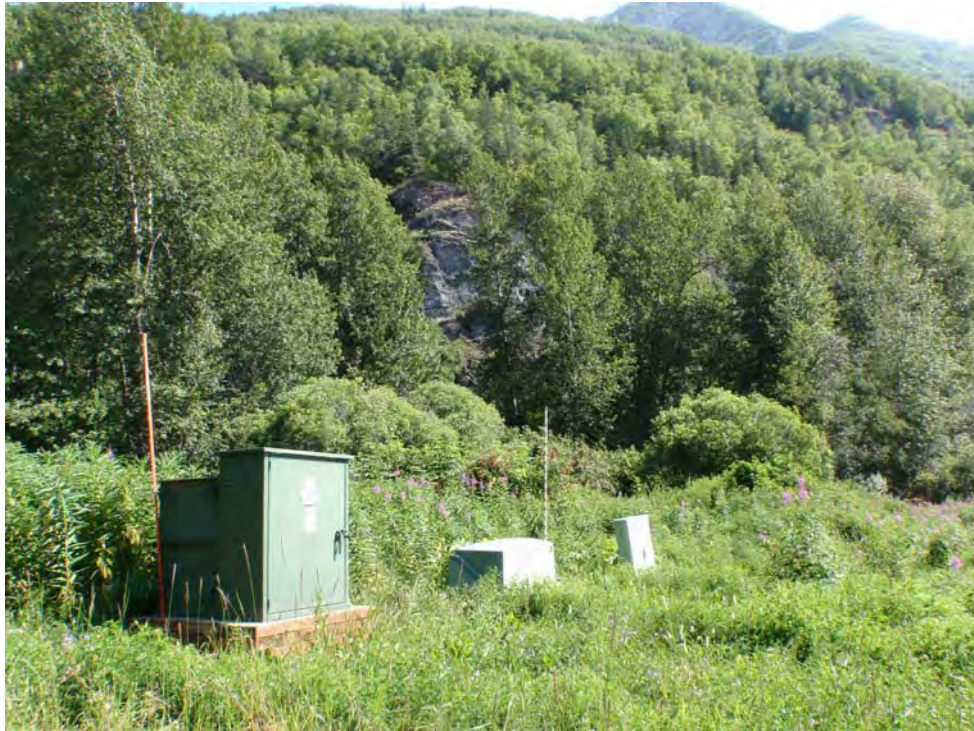
**PMP 19.5– Utility Boxes Near Where Fuel Odors were Reportedly Identified
(Photo Taken from along Haines Highway – Looking Northeast)**

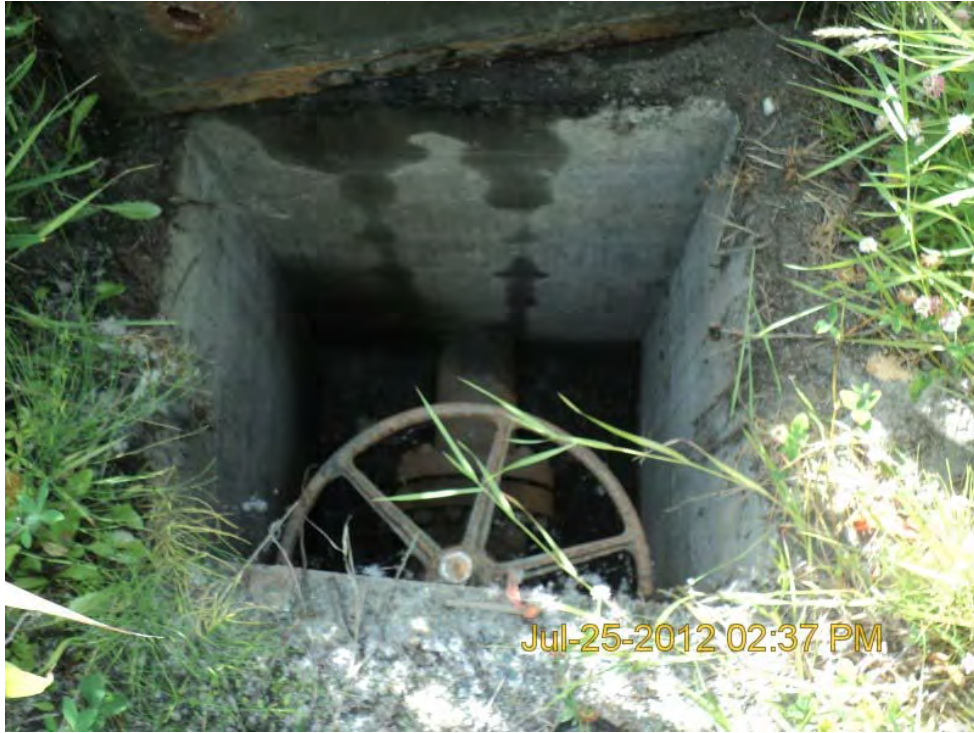
PMP 25.5 – View Inside Gate Valve 4

PMP 25.5 (GV 4) – The proximity of an underground power line and the Haines Highway represent limitations to drilling at this site. However, a sampling approach can be developed that will enable a safe and adequate investigation of the GV4 area. Since highway construction activities in this area are planned for 2014, this site should receive priority.

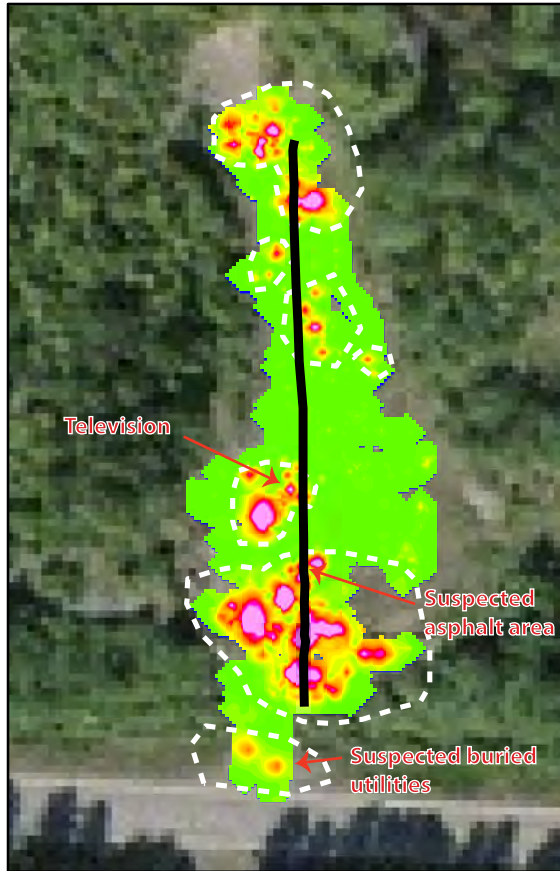
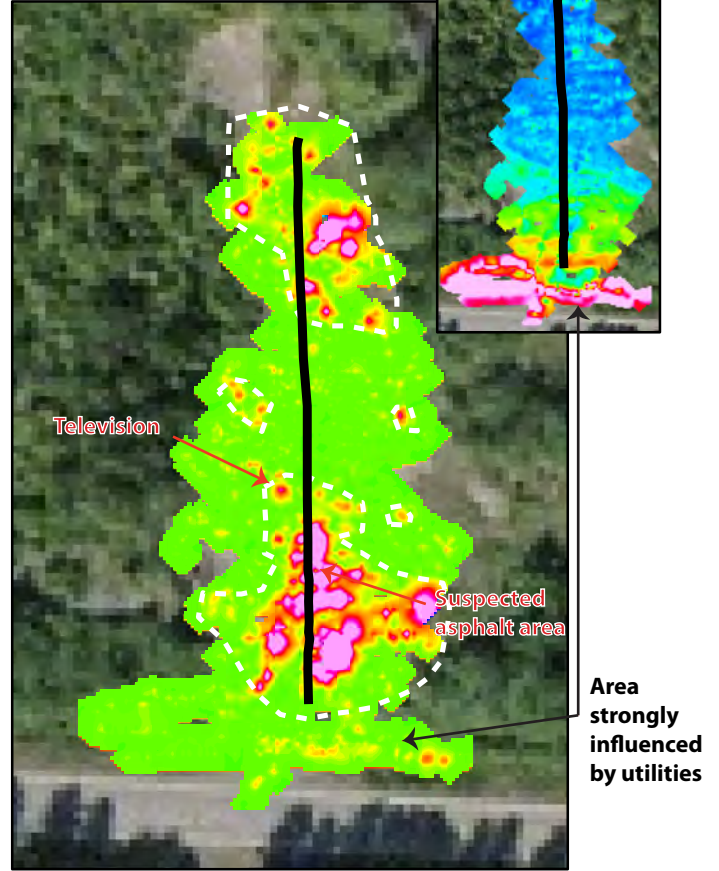
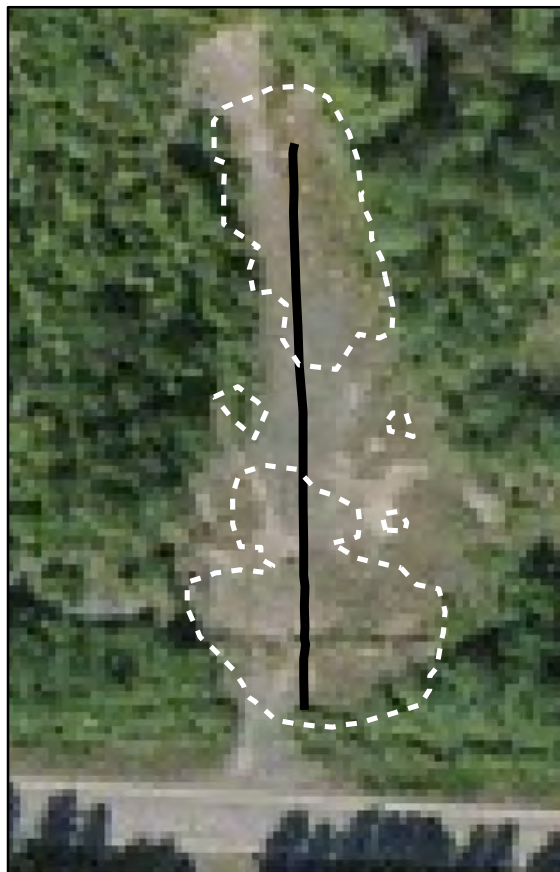
Figure 1. Results from surface geophysical surveys at the Haines 7-Mile Dump near Haines, Alaska. Maps show anomalies identified in the (a) magnetic vertical gradient and (b) electromagnetic in-phase response at 23 kHz with associated powerline monitoring data. Areas suspected to contain buried debris (white dashed lines) are summarized in (c).

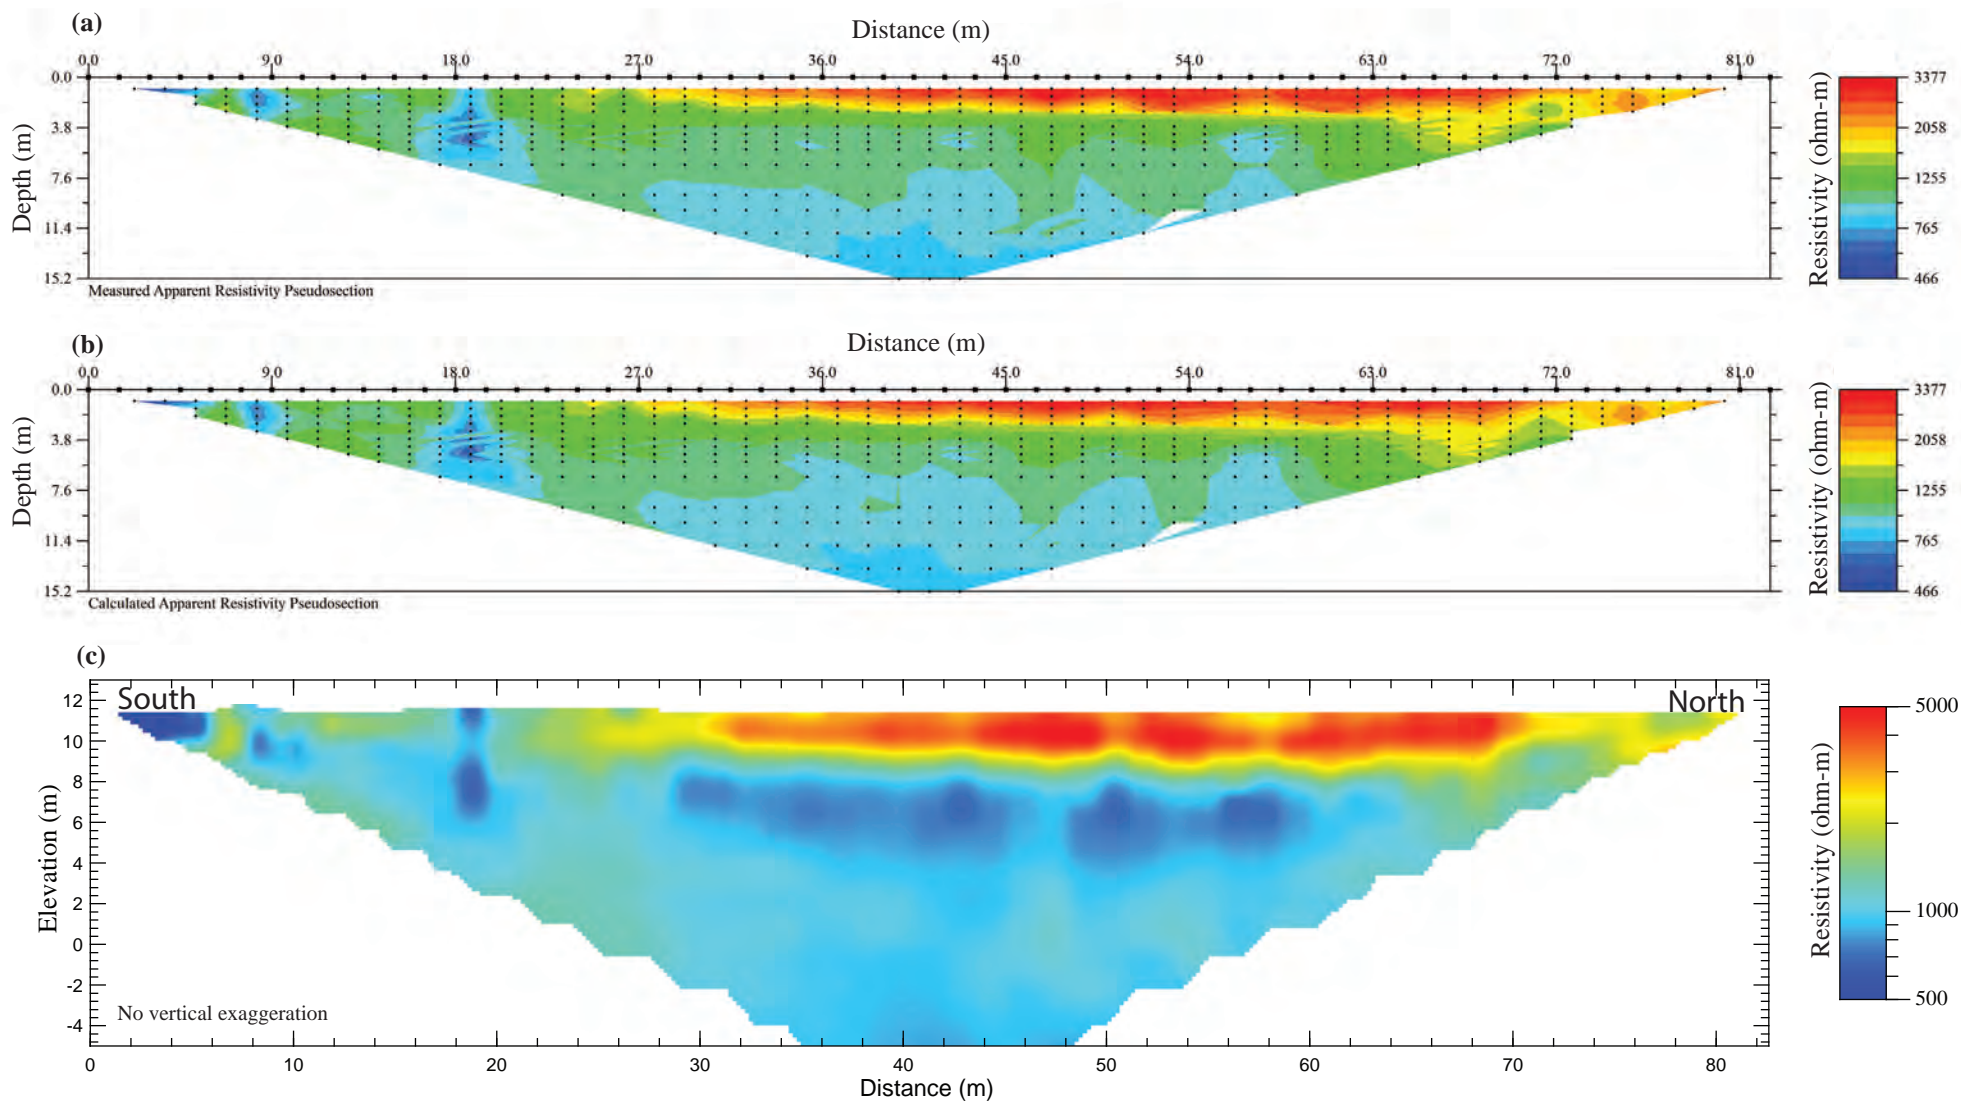
Figure 2. Results from direct-current resistivity surveys at the Haines 7-Mile Dump near Haines, Alaska. Sections show the (a) measured apparent resistivity, (b) calculated apparent resistivity resulting from the inverted model, and (c) the inverted model (root mean square error = 3.90%). The typical thickness of the high-resistivity layer at the surface is 2.0 to 2.5 m.

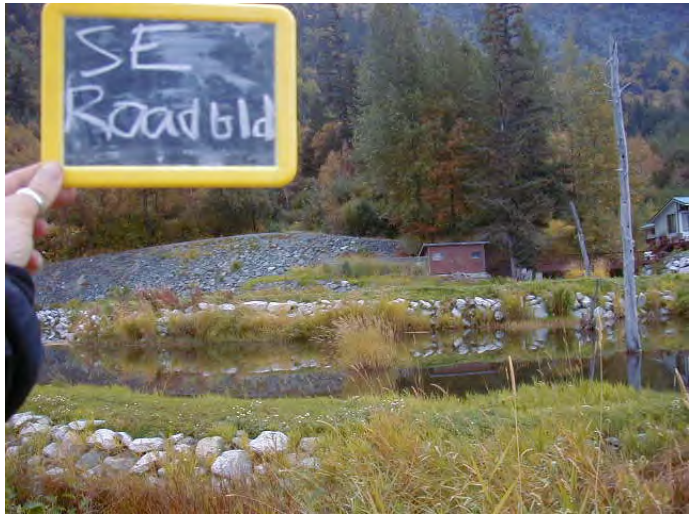
<p>Photograph No. 7</p> <p>Location: Site 3</p> <p>Direction: Facing west</p> <p>Comments: Squatters cabin</p>
