TITLE
GEOLOGIC HAZARD SUMMARY
ARRANGED BY 2012 SEIS STATIONING
 LYNN CANAL HIGHWAY PHASE 2
 2012 SEIS ALIGNMENT HAZARD REVISIONS

HDR / 2012 SEIS JUNEAU ACCESS / AK

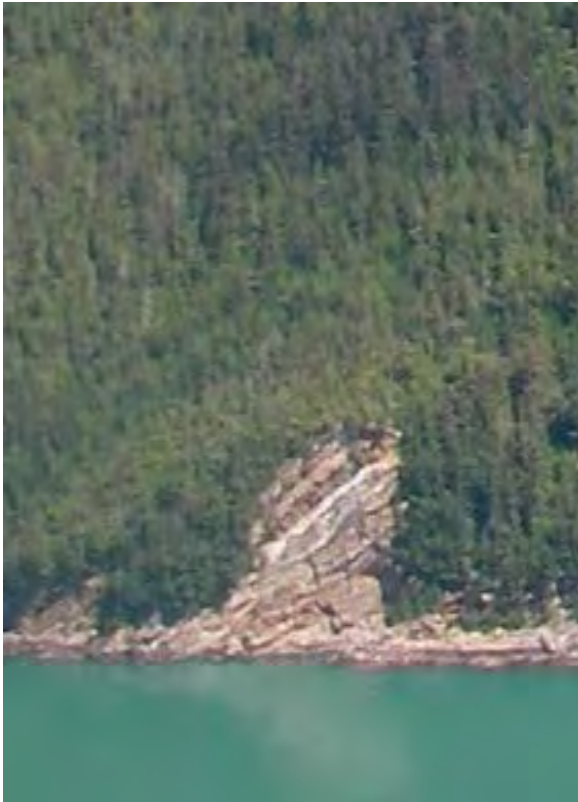
RF08. View east/upslope at rockfall hazard.

Hazard ID #:	RF08
Hazard Type:	rockfall
HIN:	183
Rating:	A
2012 SEIS Alignment Location:	1763
Frequency (yrs):	5-25
Predictability:	unpredictable
Material Volume (CY):	<10
Clast Size (ft):	4+
Source Elev. (ft):	100-500
Centerline Slope:	open_soil_slope
Alignment Location:	deposition_zone
Impact Alignment:	yes
Alignment Exposure (ft):	500+
Vegetation:	disturbed
Deciduous Trees:	no
2012 SEIS Alignment South Margin:	1760+10
2012 SEIS Alignment North Margin:	1767+60
Photo #:	5039, 5040, 5041, 5157, 6209

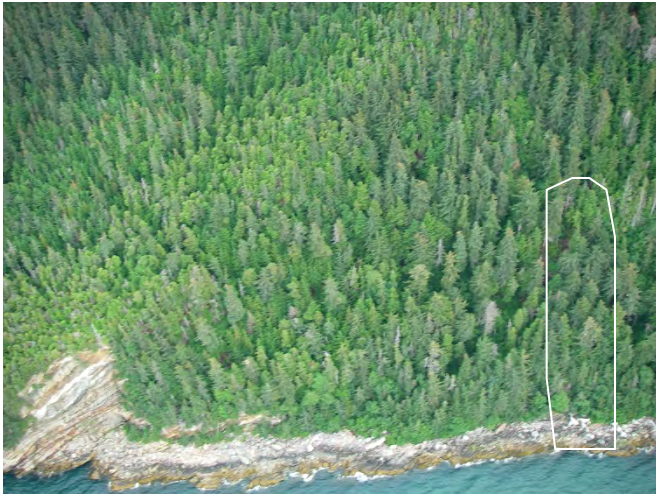
RF09. View east/upslope at area of greater frequency rockfall within rockfall area RF08.

Hazard ID #:	RF09
Hazard Type:	rockfall
HIN:	129
Rating:	A
2012 SEIS Alignment Location:	1764
Frequency (yrs):	1-5
Predictability:	unpredictable
Material Volume (CY):	<10
Clast Size (ft):	2-3
Source Elev. (ft):	100-500
Centerline Slope:	open_soil_slope
Alignment Location:	deposition_zone
Impact Alignment:	yes
Alignment Exposure (ft):	50-200
Vegetation:	disturbed
Deciduous Trees:	yes
2012 SEIS Alignment South Margin:	1764+10
2012 SEIS Alignment North Margin:	1764+70
Photo #:	3878

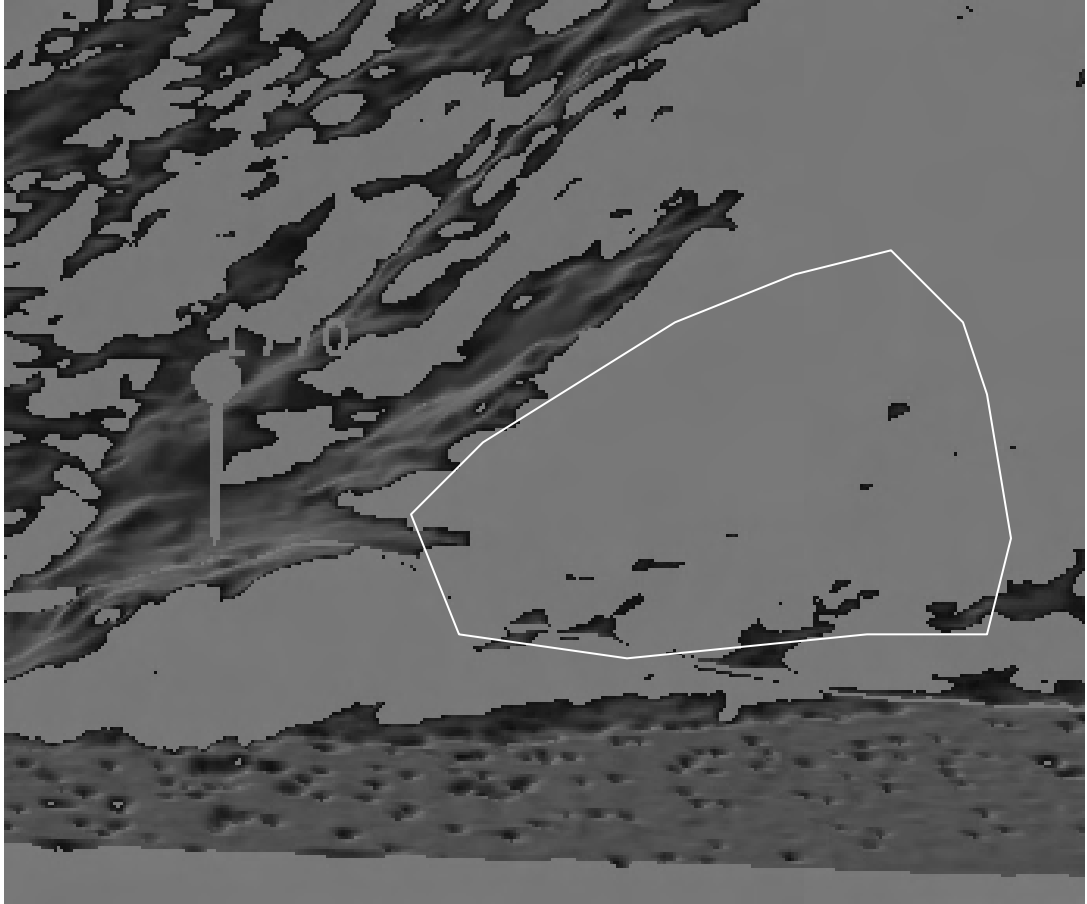
RF09. Bare earth LIDAR image of rockfall hazard. Station label represents previous IRP 2006 alignment.

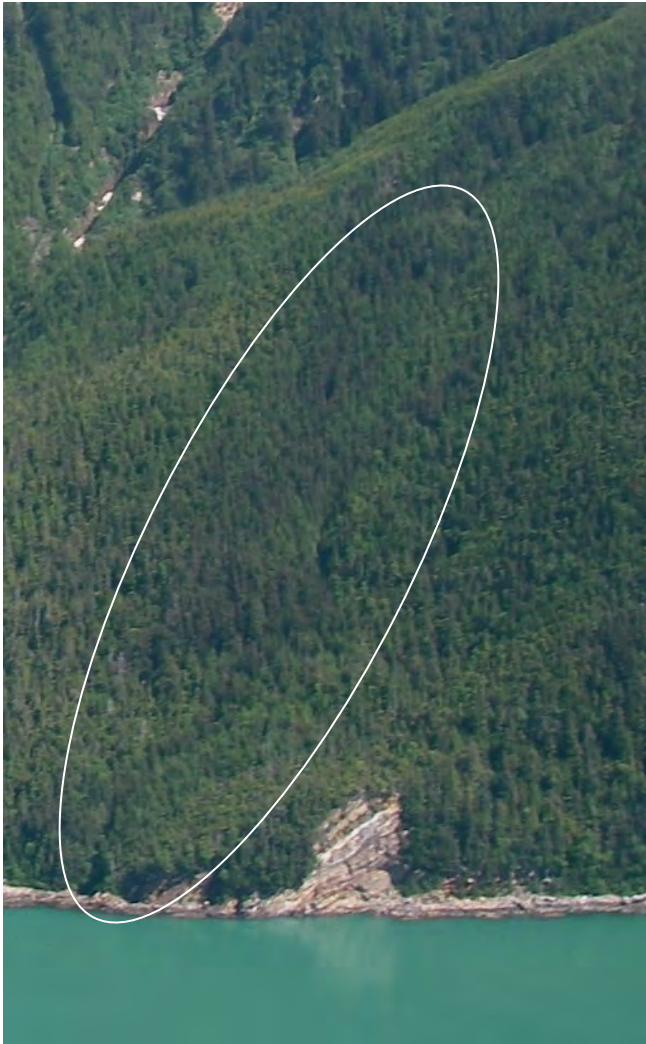
DF14. View east/upslope at debris flow channel.

Hazard ID #:	DF14
Hazard Type:	debris_flow
HIN:	111
Rating:	A
2012 SEIS Alignment Location:	1773
Frequency (yrs):	25+
Predictability:	moderate
Material Volume (CY):	10-100
Clast Size (ft):	2-3
Source Elev. (ft):	>1000
Centerline Slope:	single_channel
Alignment Location:	path
Impact Alignment:	yes
Alignment Exposure (ft):	50-200
Vegetation:	disturbed
Deciduous Trees:	no
2012 SEIS Alignment South Margin:	1772+40
2012 SEIS Alignment North Margin:	1773+20
Photo #:	2093, 4714

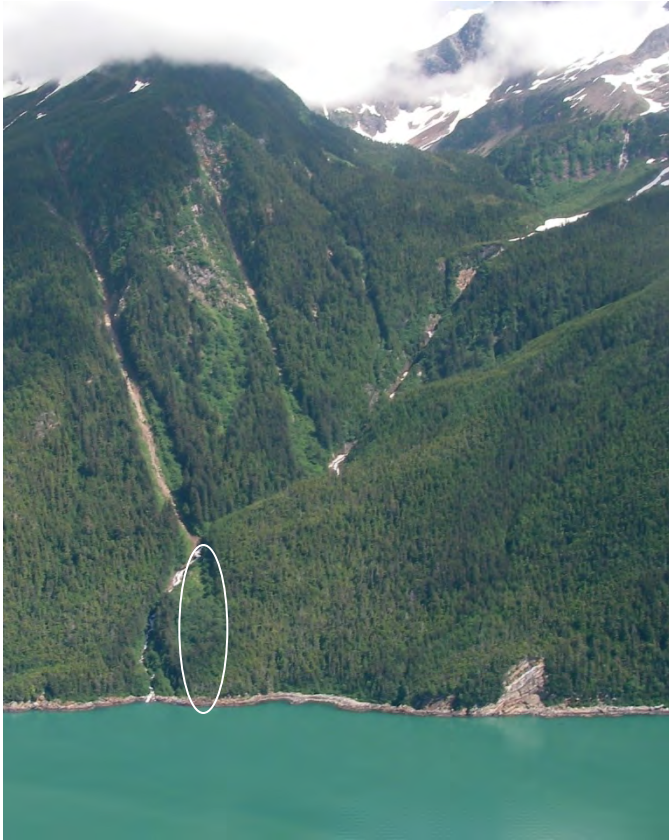
DF15. View east/upslope at debris flow channel and avalanche path.

Hazard ID #:	DF15
Hazard Type:	debris_flow
HIN:	189
Rating:	B
2012 SEIS Alignment Location:	1784
Frequency (yrs):	5-25
Predictability:	moderate
Material Volume (CY):	1000+
Clast Size (ft):	2-3
Source Elev. (ft):	>1000
Centerline Slope:	multi_channel
Alignment Location:	path
Impact Alignment:	yes
Alignment Exposure (ft):	50-200
Vegetation:	disturbed
Deciduous Trees:	yes
2012 SEIS Alignment South Margin:	1783+80
2012 SEIS Alignment North Margin:	1784+50
Photo #:	3912

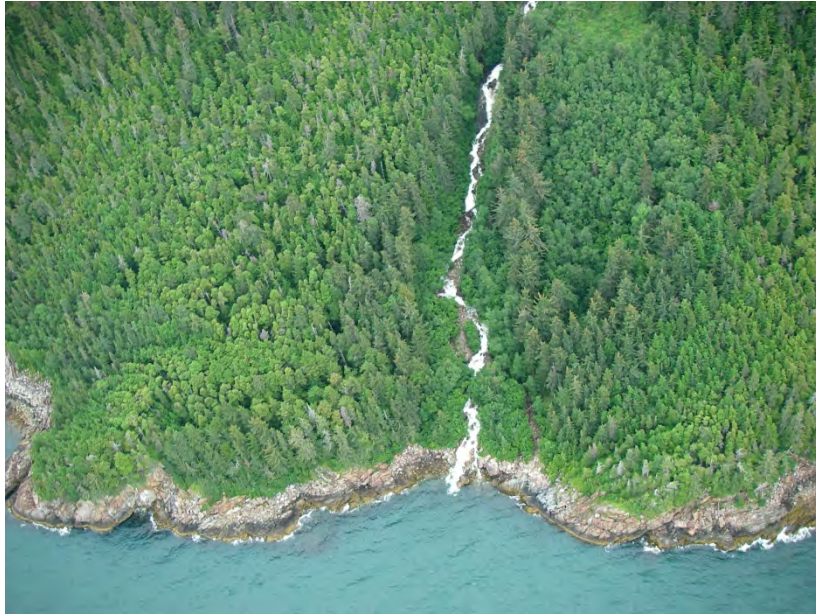
DF15. View east/upslope at debris flow channel.

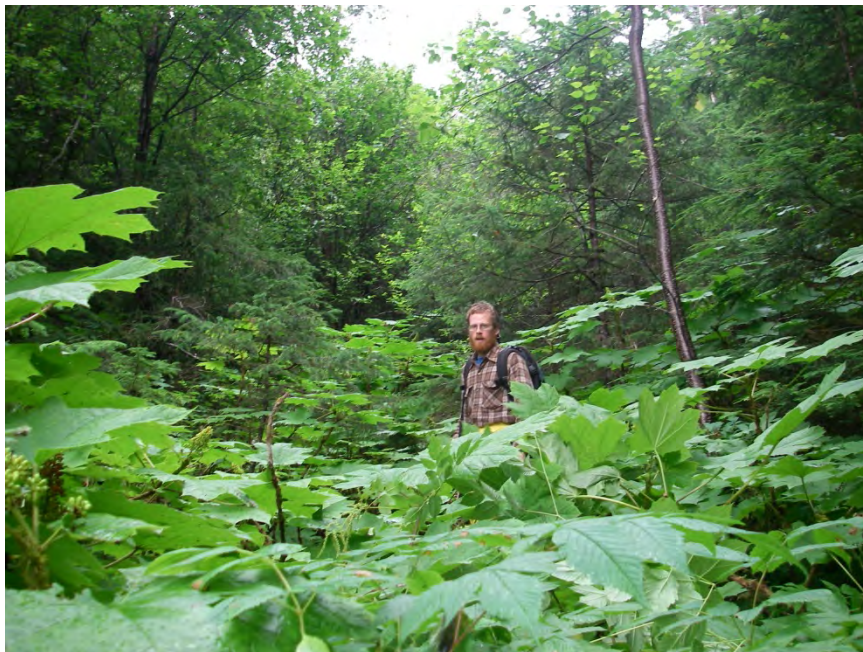
DF15. View east/upslope at abandoned/infrequently occupied debris flow path. During large events, this is believed to be an overflow channel from the adjacent, active debris flow channel to the north.

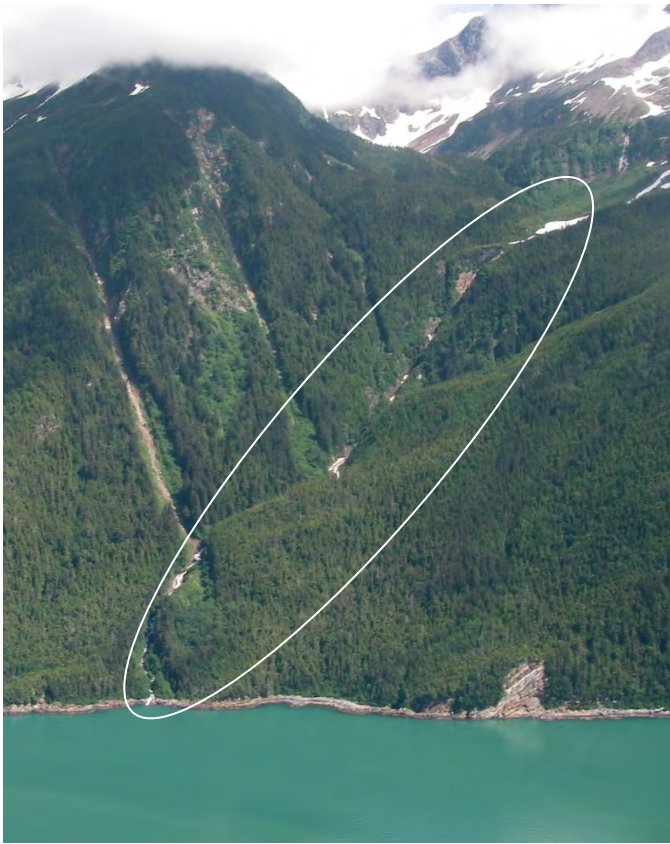
DF16. View east/upslope at debris flow channel and avalanche path.

Hazard ID #:	DF16
Hazard Type:	debris_flow
HIN:	207
Rating:	A
2012 SEIS Alignment Location:	1786
Frequency (yrs):	1-5
Predictability:	moderate
Material Volume (CY):	1000+
Clast Size (ft):	2-3
Source Elev. (ft):	>1000
Centerline Slope:	multi_channel
Alignment Location:	path
Impact Alignment:	yes
Alignment Exposure (ft):	50-200
Vegetation:	disturbed
Deciduous Trees:	yes
2012 SEIS Alignment South Margin:	1785+00
2012 SEIS Alignment North Margin:	1786+30
Photo #:	1141, 2091, 5158

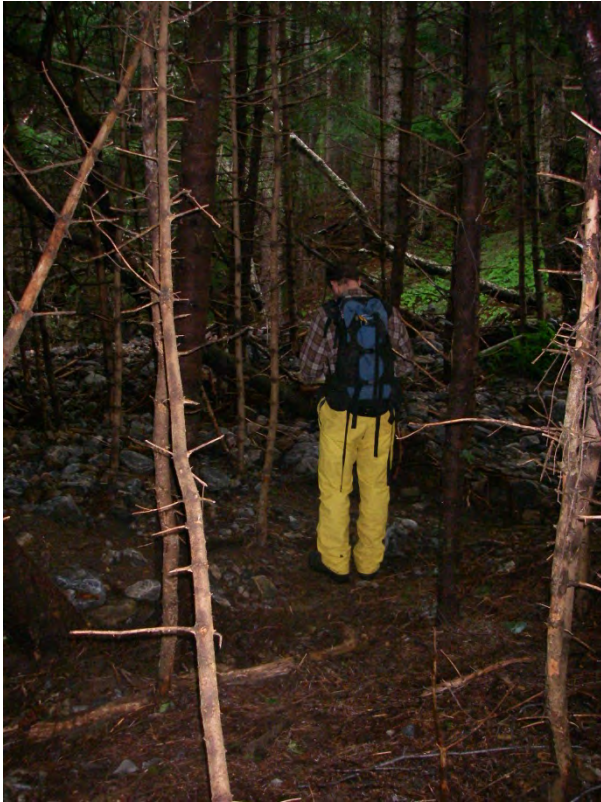
DF17. View north/up alignment at margin of old debris flow and recent debris flow.

Hazard ID #:	DF17
Hazard Type:	debris_flow
HIN:	129
Rating:	B
2012 SEIS Alignment Location:	1826
Frequency (yrs):	25+
Predictability:	low
Material Volume (CY):	10-100
Clast Size (ft):	1-2
Source Elev. (ft):	2000-3000
Centerline Slope:	fan
Alignment Location:	deposition_zone
Impact Alignment:	yes
Alignment Exposure (ft):	50-200
Vegetation:	disturbed
Deciduous Trees:	yes
2012 SEIS Alignment South Margin:	1825+60
2012 SEIS Alignment North Margin:	1827+00
Photo #:	1186, 4012, 4015, 5159, 6232

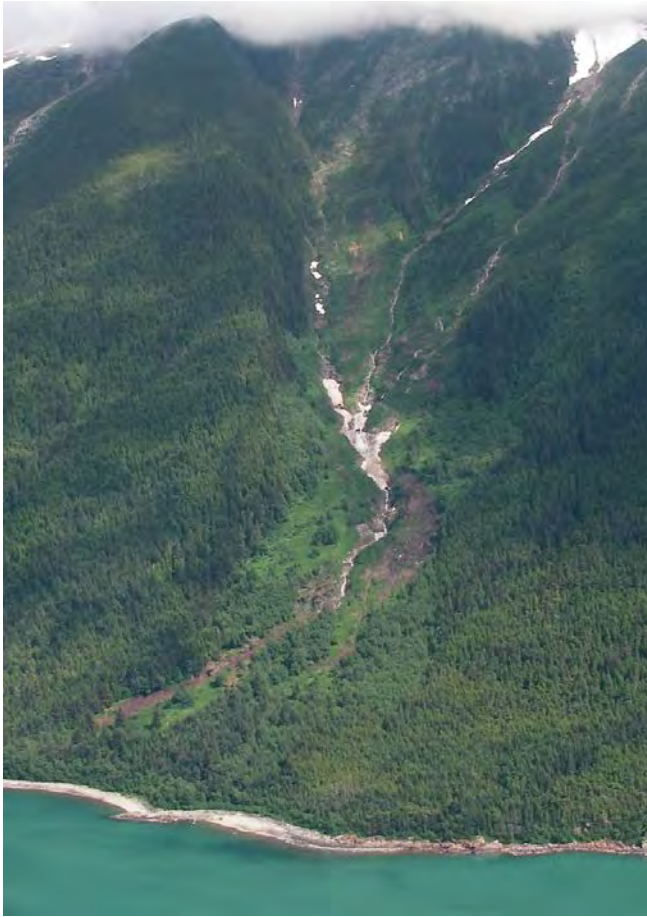
DF18. Debris flow and avalanche path.

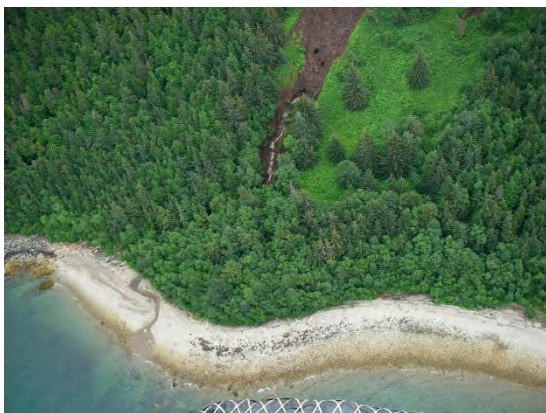
DF18. View east/upslope at debris flow.

Hazard ID #:	DF18
Hazard Type:	debris_flow
HIN:	129
Rating:	A
2012 SEIS Alignment Location:	1828
Frequency (yrs):	1-5
Predictability:	high
Material Volume (CY):	10-100
Clast Size (ft):	0-1
Source Elev. (ft):	2000-3000
Centerline Slope:	fan
Alignment Location:	deposition_zone
Impact Alignment:	yes
Alignment Exposure (ft):	50-200
Vegetation:	disturbed
Deciduous Trees:	yes
2012 SEIS Alignment South Margin:	1827+00
2012 SEIS Alignment North Margin:	1829+00
Photo #:	1186, 4012, 4015, 5159, 6232

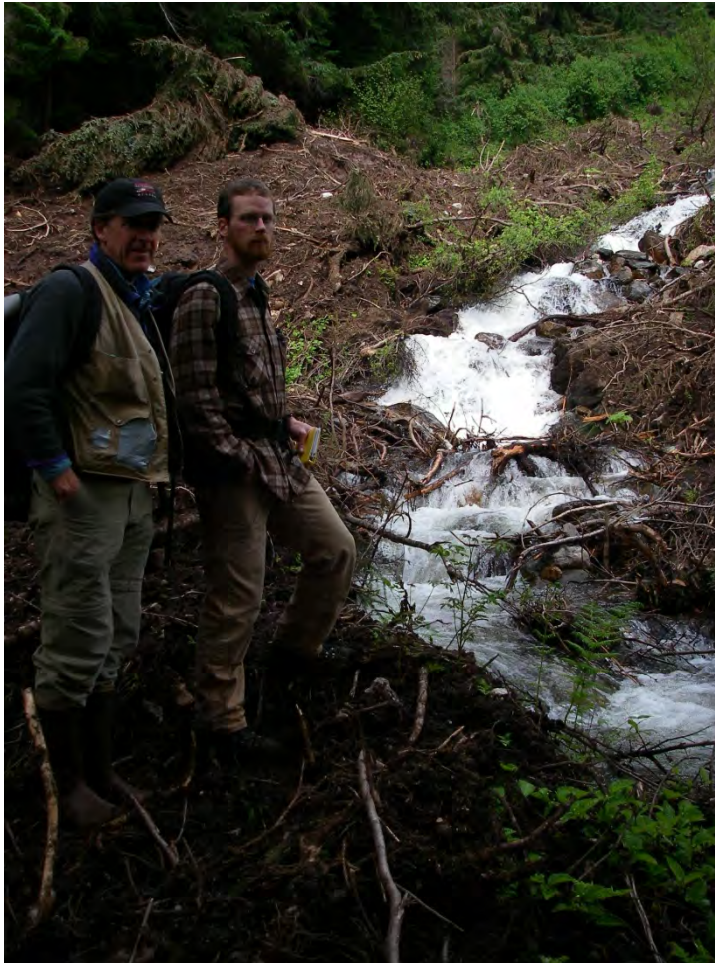
DF20. View east/upslope at debris channel. Stream is poorly channelized as a result of a high sediment/debris supply.

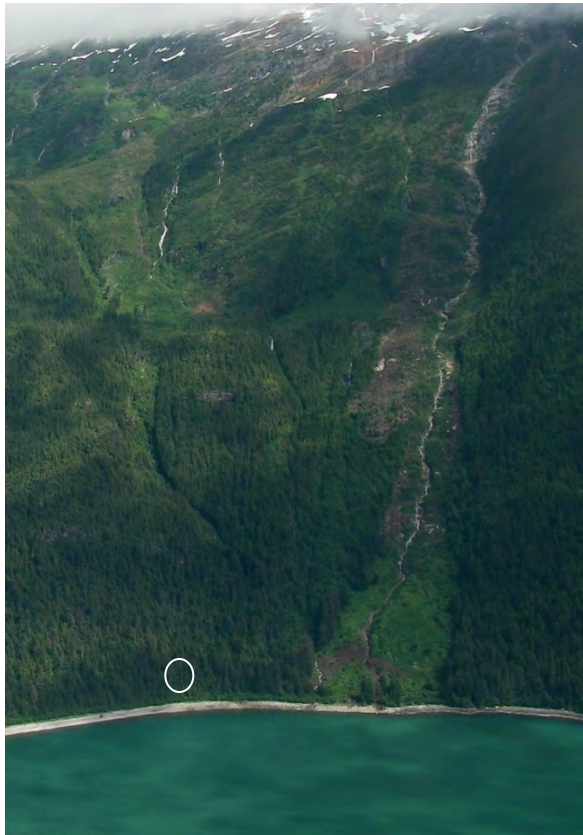
RF10. View east/upslope at rockfall.

Hazard ID #:	RF10
Hazard Type:	rockfall
HIN:	111
Rating:	C
2012 SEIS Alignment Location:	1857
Frequency (yrs):	unknown (5-25?)
Predictability:	unpredictable
Material Volume (CY):	<10
Clast Size (ft):	2-3
Source Elev. (ft):	100-500
Centerline Slope:	other
Alignment Location:	below_deposition zone
Impact Alignment:	no
Alignment Exposure (ft):	50-200
Vegetation:	disturbed
Deciduous Trees:	yes
2012 SEIS Alignment South Margin:	1856+00
2012 SEIS Alignment North Margin:	1857+00
Photo #:	4816

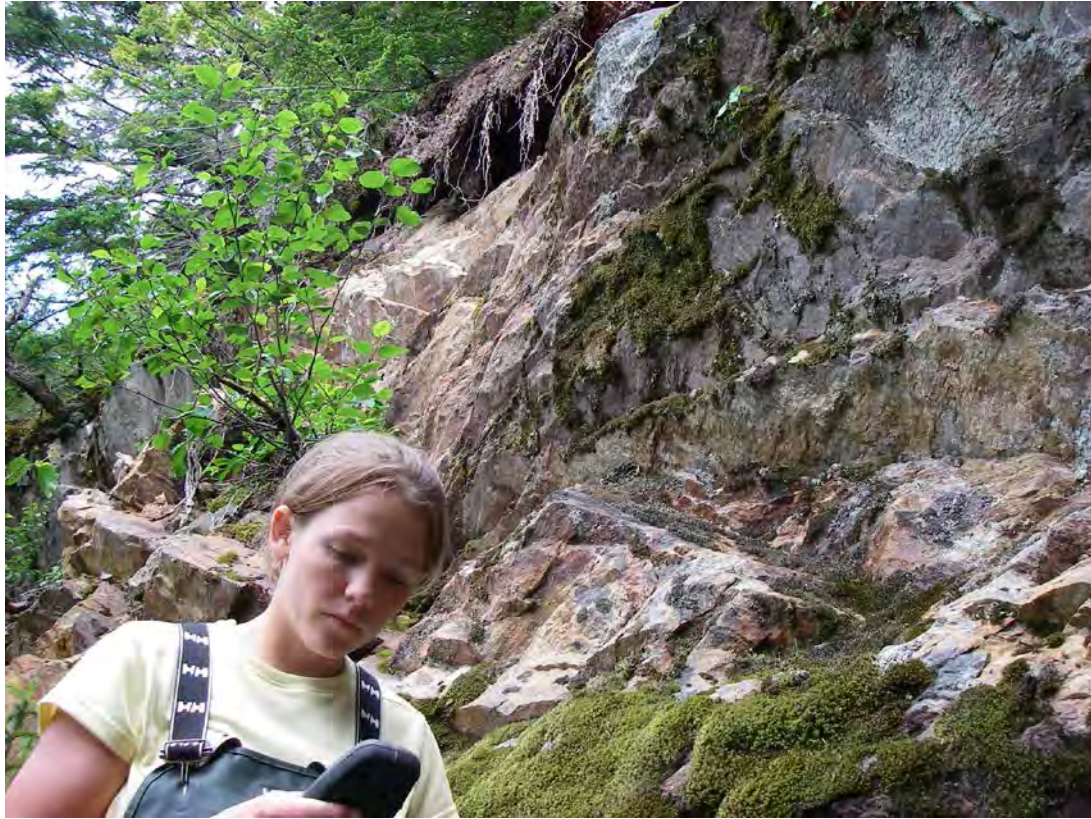
RF10. View at basalt cliffs that create the rockfall zone.

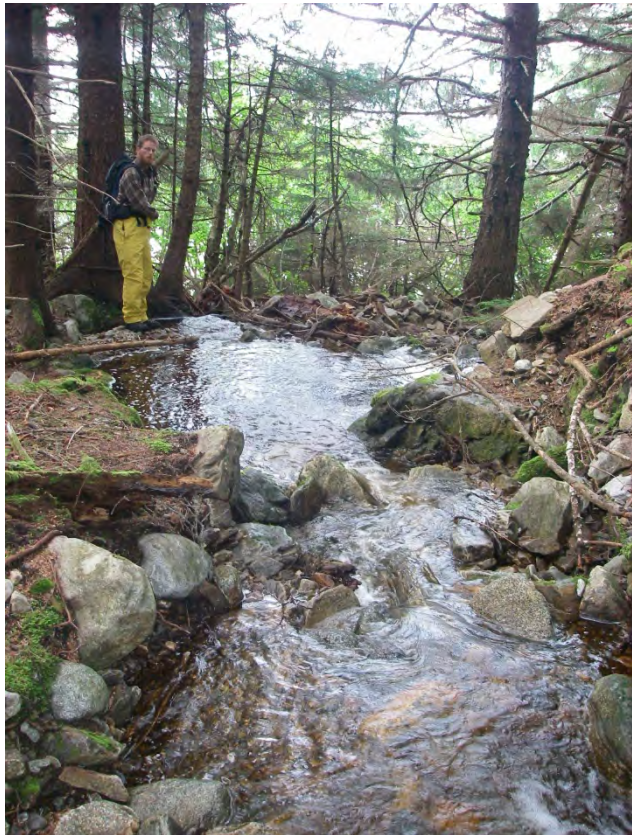
DF21. View west/downslope at debris flow deposition zone.

Hazard ID #:	DF21
Hazard Type:	debris_flow
HIN:	123
Rating:	B
2012 SEIS Alignment Location:	1895
Frequency (yrs):	1-5
Predictability:	high
Material Volume (CY):	<10
Clast Size (ft):	0-1
Source Elev. (ft):	2000-3000
Centerline Slope:	single_channel
Alignment Location:	path
Impact Alignment:	yes
Alignment Exposure (ft):	50-200
Vegetation:	disturbed
Deciduous Trees:	yes
2012 SEIS Alignment South Margin:	1894+40
2012 SEIS Alignment North Margin:	1895+60
Photo #:	5161, 6238

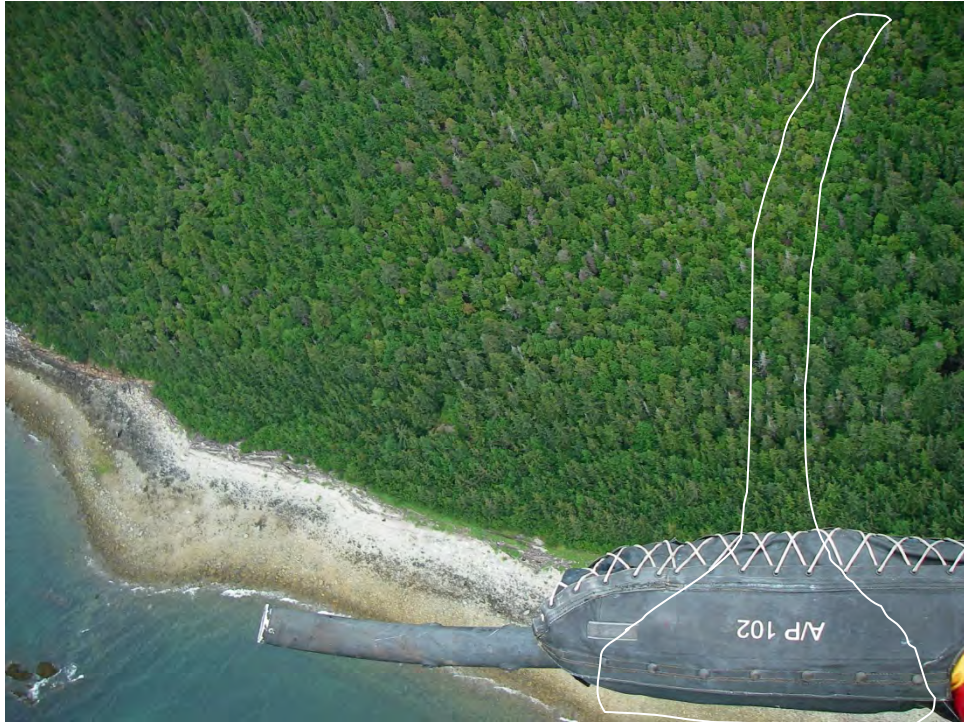
DF21. View east/upslope at moderate slope old growth covering the debris flow channel.

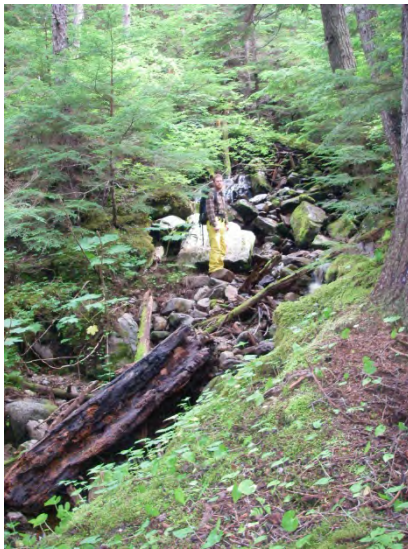
DF21. View east/upslope at debris flow channel.

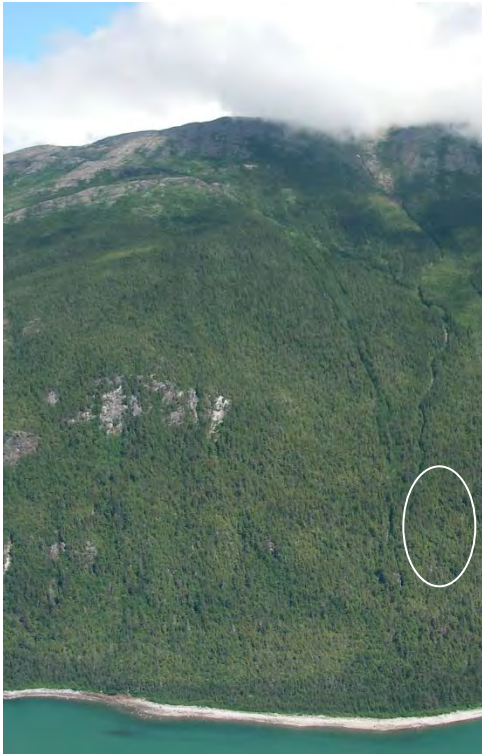
RF12. View east/upslope at rockfall area.

Hazard ID #:	RF12
Hazard Type:	rockfall
HIN:	105
Rating:	C
2012 SEIS Alignment Location:	1917
Frequency (yrs):	unknown (>25?)
Predictability:	unpredictable
Material Volume (CY):	<10
Clast Size (ft):	4+
Source Elev. (ft):	100-500
Centerline Slope:	-
Alignment Location:	below_deposition_zone
Impact Alignment:	no
Alignment Exposure (ft):	50-200
Vegetation:	disturbed
Deciduous Trees:	yes
2012 SEIS Alignment South Margin:	1916+10
2012 SEIS Alignment North Margin:	1917+30
Photo #:	5162

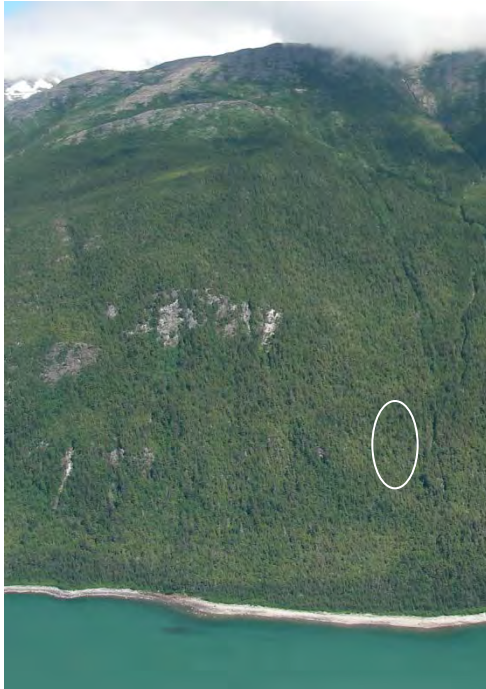
RF13. View east/upslope at rockfall area.

Hazard ID #:	RF13
Hazard Type:	rockfall
HIN:	111
Rating:	C
2012 SEIS Alignment Location:	1932
Frequency (yrs):	0-1
Predictability:	moderate
Material Volume (CY):	<10
Clast Size (ft):	1-2
Source Elev. (ft):	100-500
Centerline Slope:	-
Alignment Location:	below_deposition_zone
Impact Alignment:	no
Alignment Exposure (ft):	50-200
Vegetation:	disturbed
Deciduous Trees:	yes
2012 SEIS Alignment South Margin:	1931+00
2012 SEIS Alignment North Margin:	1932+00
Photo #:	5162

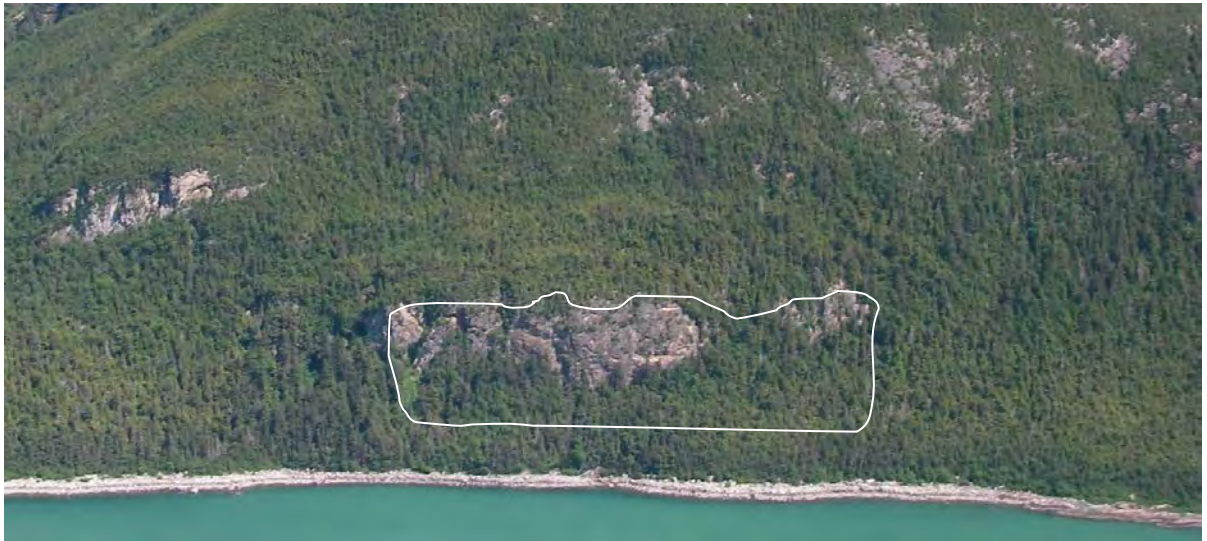
Hazard ID #:	RF14
Hazard Type:	rockfall
HIN:	183
Rating:	A
2012 SEIS Alignment Location:	1943
Frequency (yrs):	unknown (5-25?)
Predictability:	unpredictable
Material Volume (CY):	<10
Clast Size (ft):	2-3
Source Elev. (ft):	100-500
Centerline Slope:	-
Alignment Location:	below_deposition_zone
Impact Alignment:	yes
Alignment Exposure (ft):	>1000
Vegetation:	disturbed
Deciduous Trees:	no
2012 SEIS Alignment South Margin:	1933+30
2012 SEIS Alignment North Margin:	1953+00
Photo #:	5163, 5909, 5910, 5911

RF14. View east/upslope at moderate rockfall hazard below massive gneiss cliffs.

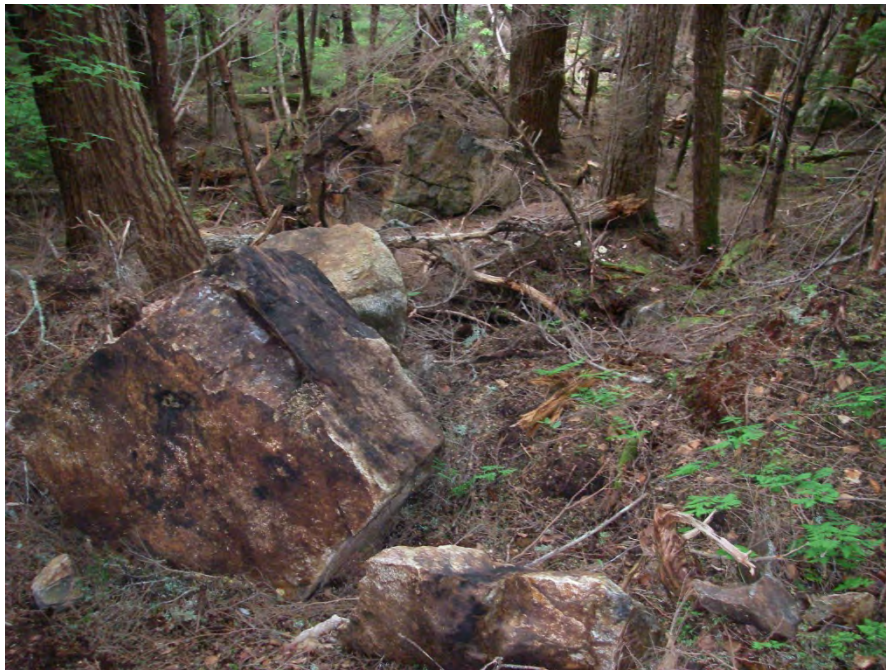
RF14. View west/downslope at fresh rockfall with 3-4 ft diameter boulders.

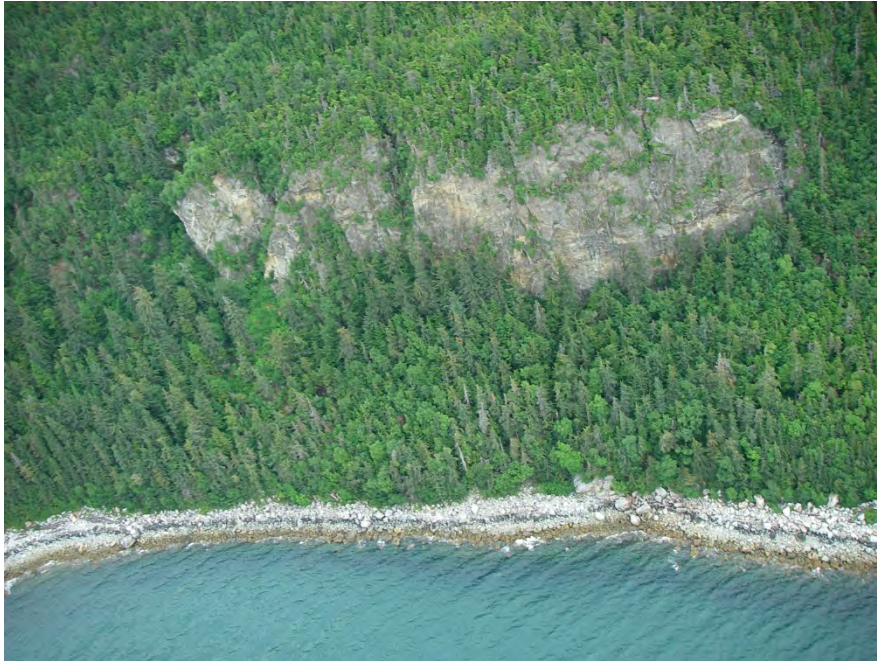
Hazard ID #:	RF15
Hazard Type:	rockfall
HIN:	129
Rating:	A
2012 SEIS Alignment Location:	1947
Frequency (yrs):	5-25
Predictability:	unpredictable
Material Volume (CY):	<10
Clast Size (ft):	4+
Source Elev. (ft):	100-500
Centerline Slope:	other
Alignment Location:	deposition_zone
Impact Alignment:	yes
Alignment Exposure (ft):	200-500
Vegetation:	disturbed
Deciduous Trees:	yes
2012 SEIS Alignment South Margin:	1946+60
2012 SEIS Alignment North Margin:	1948+90
Photo #:	5163

RF15. View east/upslope at rockfall area within rockfall area RF14.

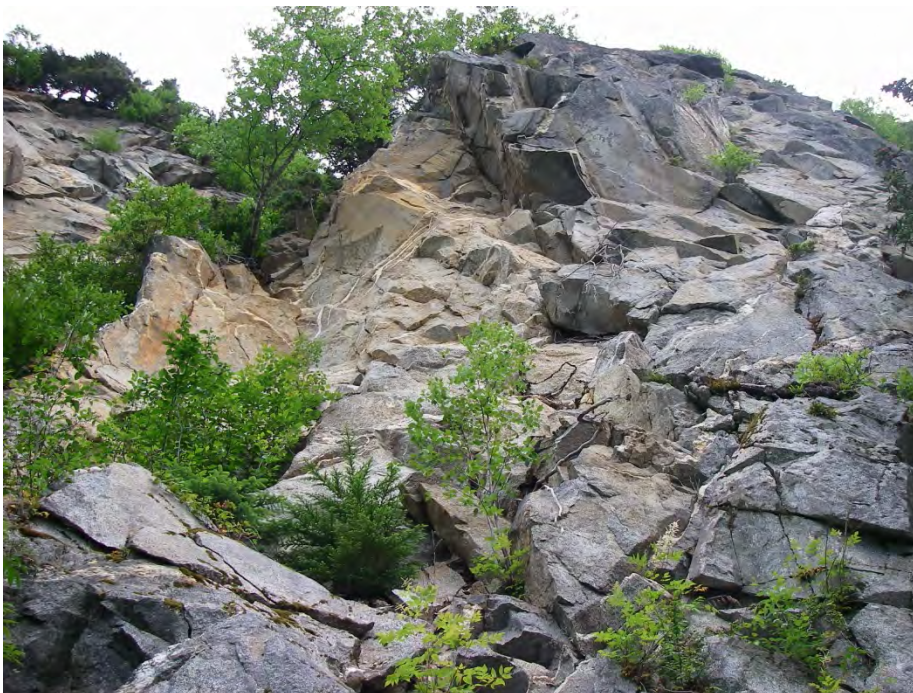
RF15. View east/upslope at large cliffs, fresh rockfall scars.

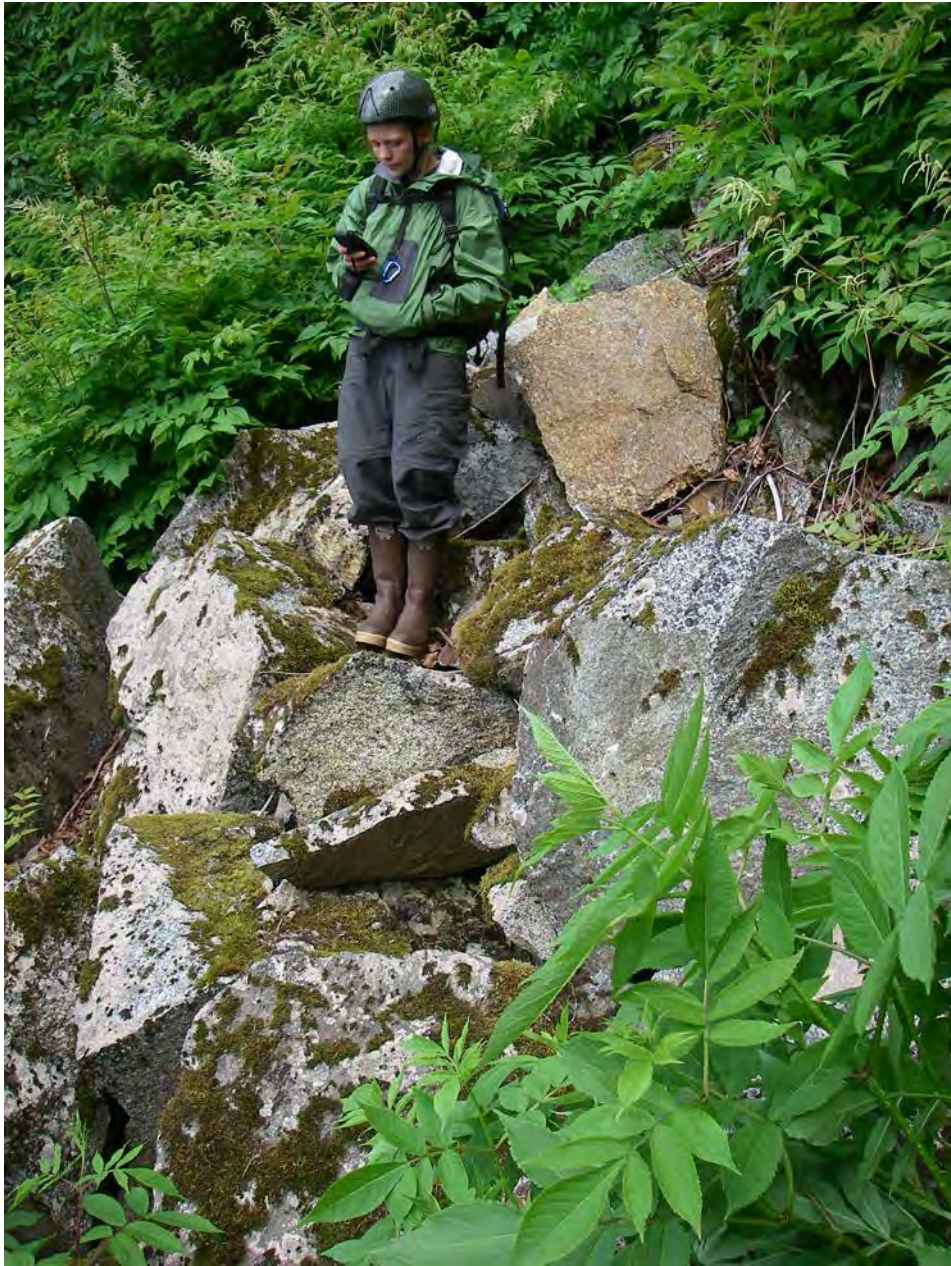
RF15. View north/up alignment across deposit of fresh 2 ft diameter rockfall.

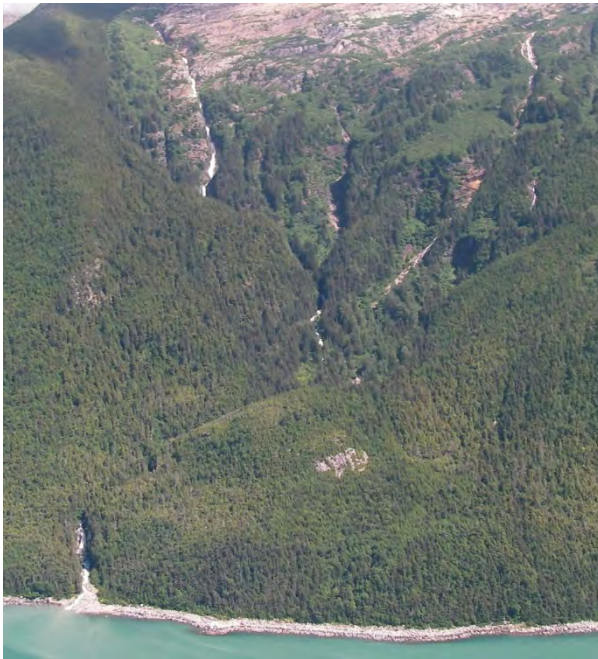
DF22. View east/upslope at debris flow channel and avalanche path.

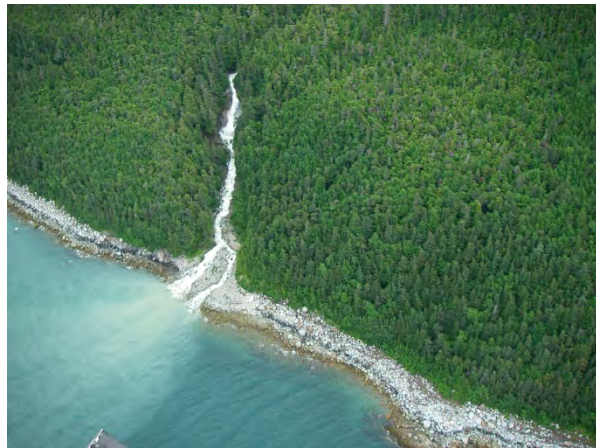
DF22. View east/upslope at debris flow channel.

Hazard ID #:	DF22
Hazard Type:	debris_flow
HIN:	129
Rating:	A
2012 SEIS Alignment Location:	1984
Frequency (yrs):	1-5
Predictability:	high
Material Volume (CY):	10-100
Clast Size (ft):	1-2
Source Elev. (ft):	2000-3000
Centerline Slope:	fan
Alignment Location:	deposition_zone
Impact Alignment:	yes
Alignment Exposure (ft):	50-200
Vegetation:	disturbed
Deciduous Trees:	no
2012 SEIS Alignment South Margin:	1983+50
2012 SEIS Alignment North Margin:	1985+00
Photo #:	5047, 5164, 5914

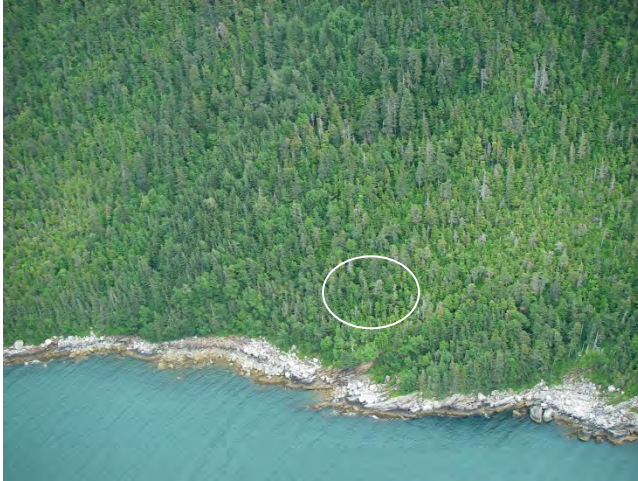
RF16. View east/upslope at rockfall hazard.

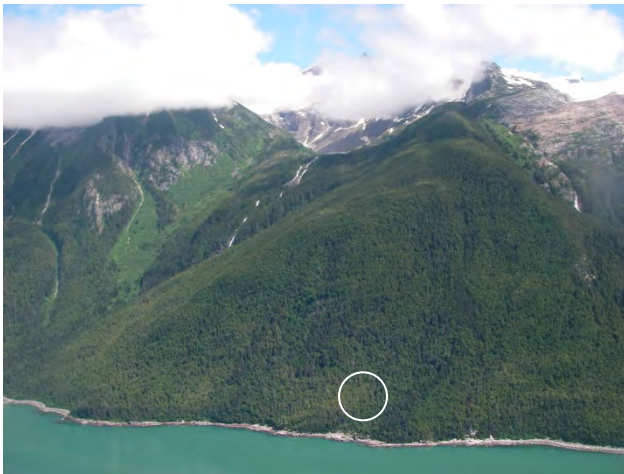
RF16. View east/upslope at rockfall area.

Hazard ID #:	RF16
Hazard Type:	rockfall
HIN:	129
Rating:	B
2012 SEIS Alignment Location:	2014
Frequency (yrs):	unknown (5-25?)
Predictability:	unpredictable
Material Volume (CY):	<10
Clast Size (ft):	3-4
Source Elev. (ft):	100-500
Centerline Slope:	deciduous_trees
Alignment Location:	below_deposition_zone
Impact Alignment:	yes
Alignment Exposure (ft):	200-500
Vegetation:	disturbed
Deciduous Trees:	yes
2012 SEIS Alignment South Margin:	2013+00
2012 SEIS Alignment North Margin:	2015+70
Photo #:	5052, 5053, 6240

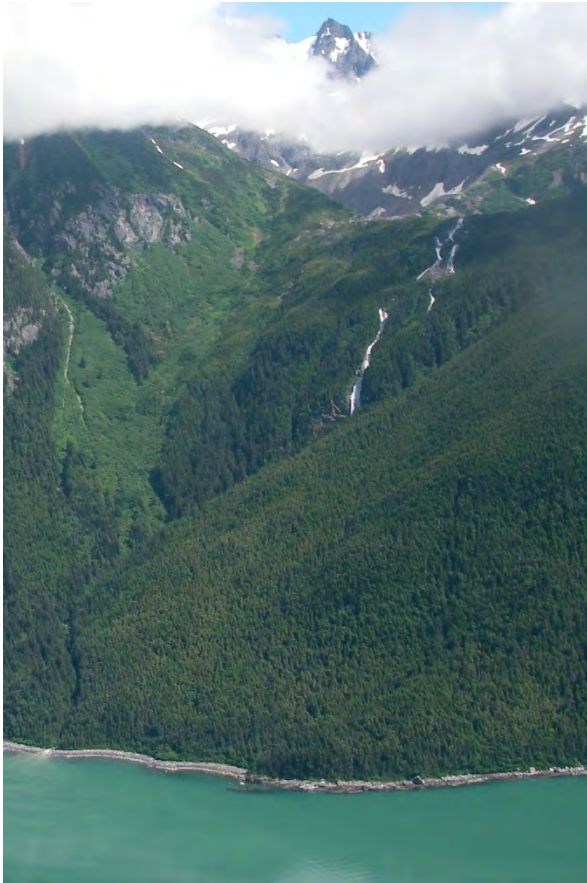
DF23. View east/upslope at debris flow channel and avalanche path.

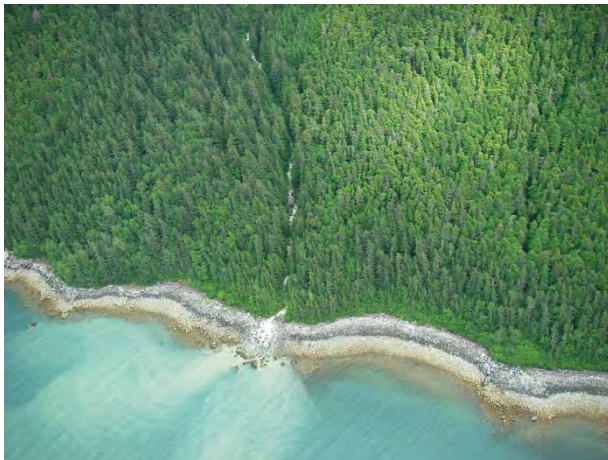
DF23. View east/upslope at debris flow channel and avalanche path.

Hazard ID #:	DF23
Hazard Type:	debris_flow
HIN:	117
Rating:	A
2012 SEIS Alignment Location:	2040
Frequency (yrs):	5-25
Predictability:	moderate
Material Volume (CY):	10-100
Clast Size (ft):	1-2
Source Elev. (ft):	3000+
Centerline Slope:	multi_channel
Alignment Location:	path
Impact Alignment:	yes
Alignment Exposure (ft):	50-200
Vegetation:	disturbed
Deciduous Trees:	yes
2012 SEIS Alignment South Margin:	2039+70
2012 SEIS Alignment North Margin:	2041+20
Photo #:	5057, 5166

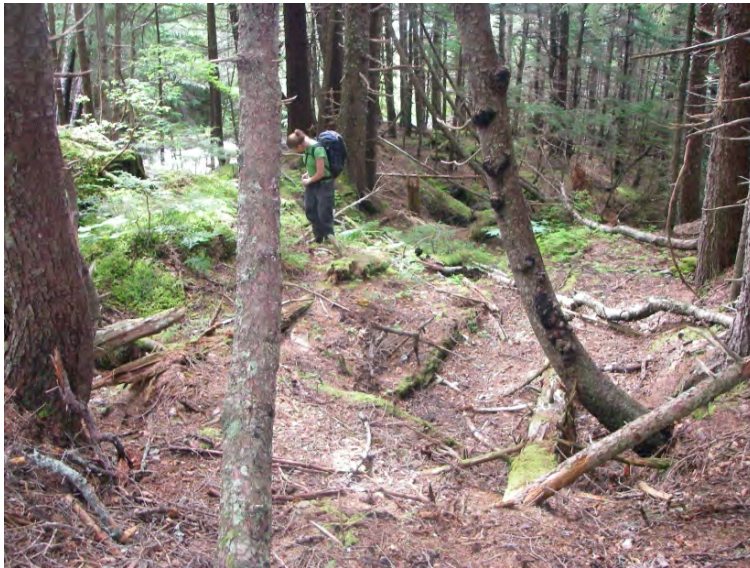
DF23. View southwest (downslope and down alignment) into multi-channel debris flow at centerline. Secondary channel is seen to right of person.

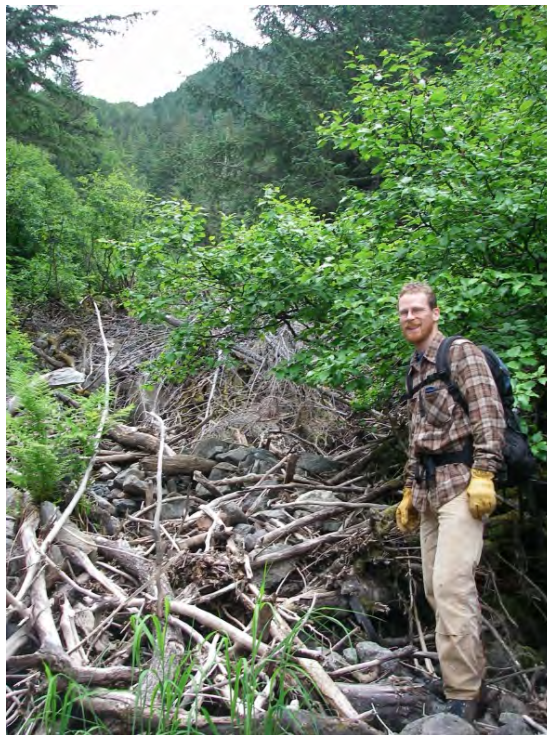
DF23. View east/upslope at debris flow channel and avalanche path.

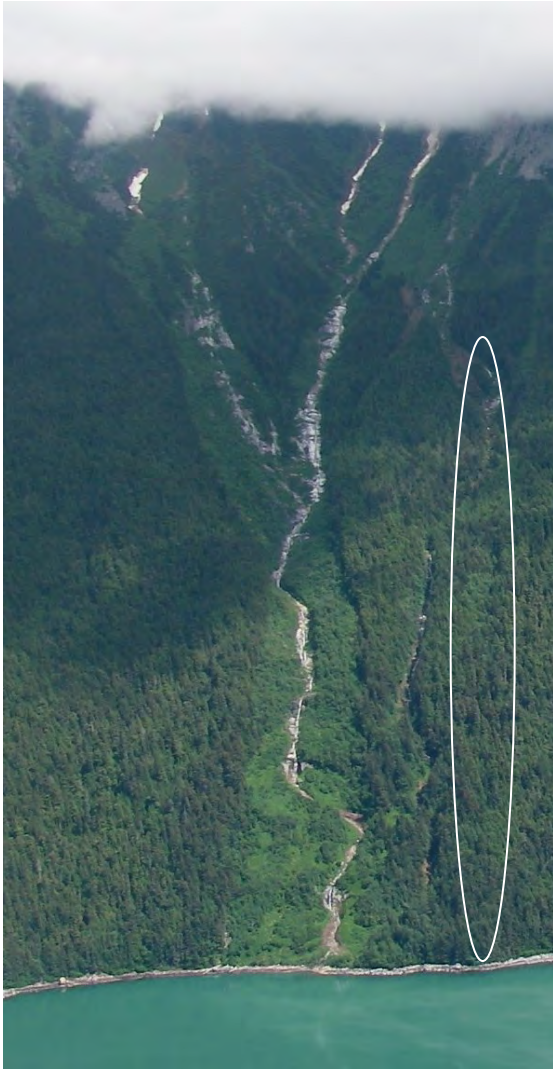
DF24. View east/upslope at debris flow channel and avalanche path (circled, right) and avalanche path (with major stream, center).

Hazard ID #:	DF24
Hazard Type:	debris_flow
HIN:	129
Rating:	B
2012 SEIS Alignment Location:	2054
Frequency (yrs):	1-5
Predictability:	high
Material Volume (CY):	10-100
Clast Size (ft):	1-2
Source Elev. (ft):	3000+
Centerline Slope:	multi_channel
Alignment Location:	deposition_zone
Impact Alignment:	yes
Alignment Exposure (ft):	50-200
Vegetation:	disturbed
Deciduous Trees:	yes
2012 SEIS Alignment South Margin:	2053+00
2012 SEIS Alignment North Margin:	2054+10
Photo #:	2054, 2239, 3462, 3463, 5093, 6195

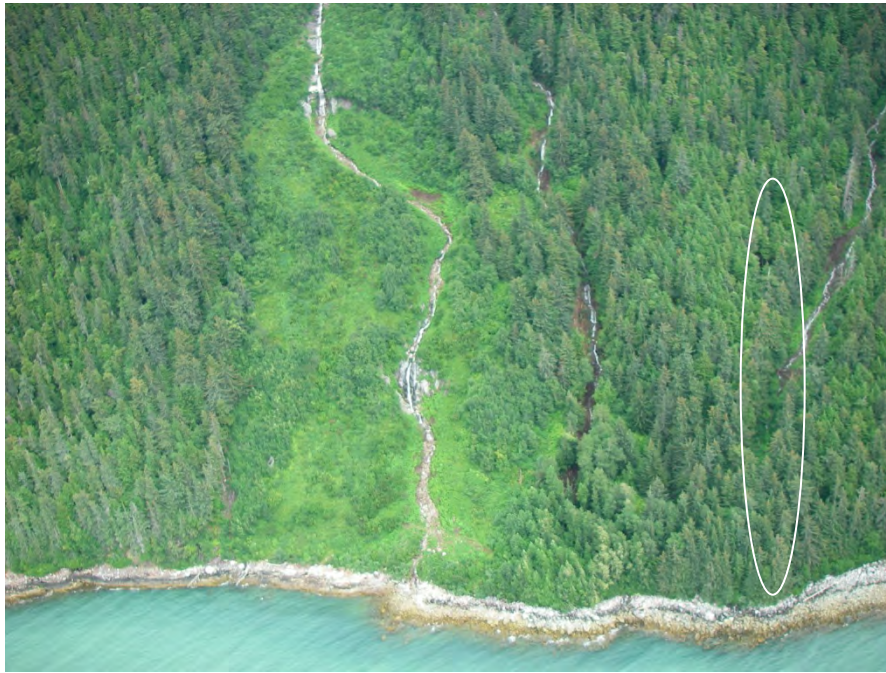
DF24. View east/upslope at debris flow channel and avalanche path (circled, right) and avalanche path (with major stream, center).

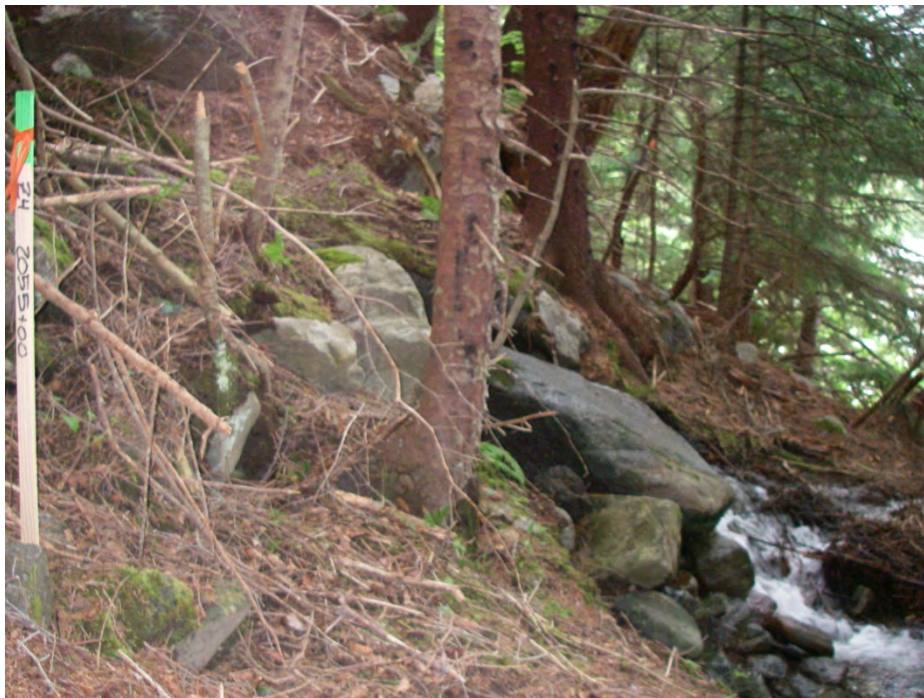
DF24. View south/ down alignment across debris flow fan. Survey lath represents previous IRP 2006 alignment.

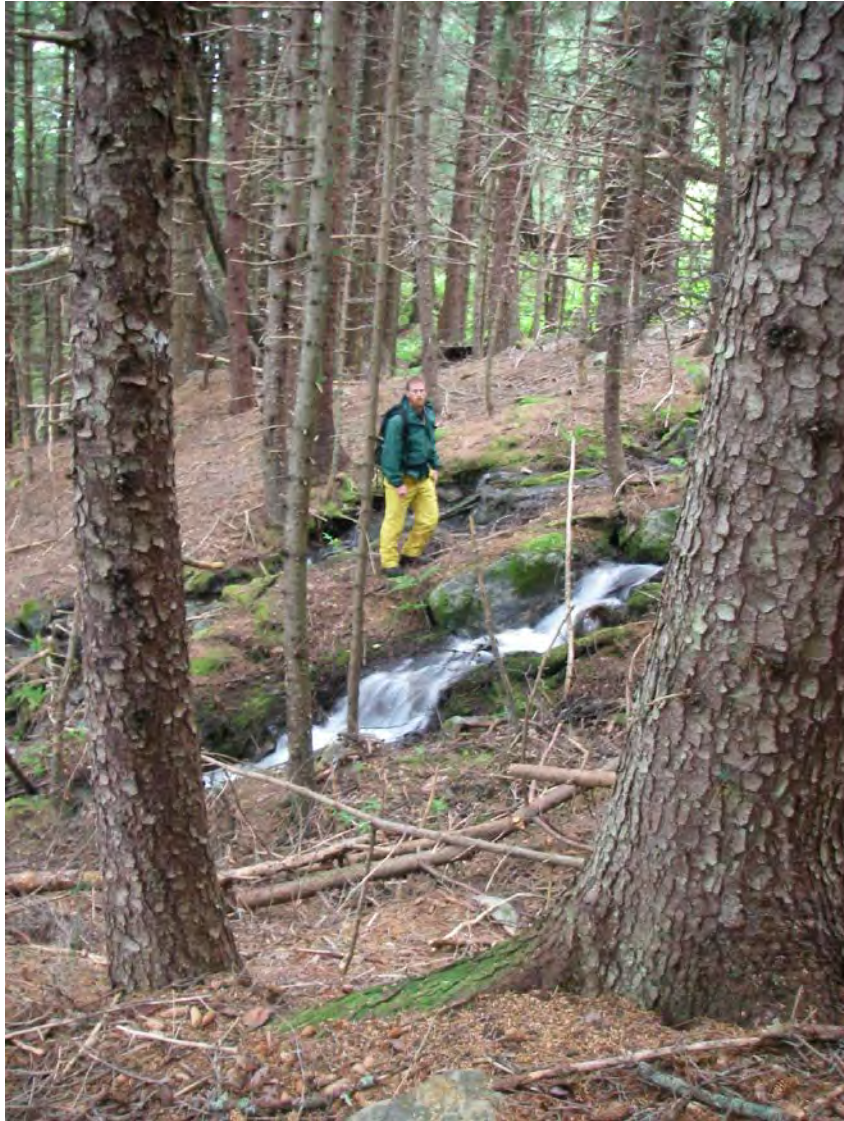
DF24. View north/up alignment across debris flow fan.

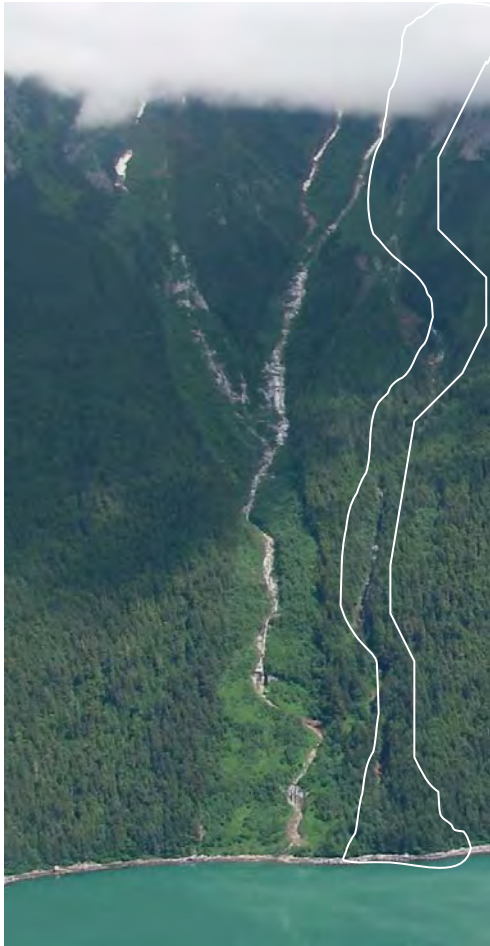
DF25. View east/upslope at debris flow channel.
