TITLE
GEOLOGIC HAZARD SUMMARY
ARRANGED BY 2012 SEIS STATIONING
 LYNN CANAL HIGHWAY PHASE 2
 2012 SEIS ALIGNMENT HAZARD REVISIONS

HDR / 2012 SEIS JUNEAU ACCESS / AK

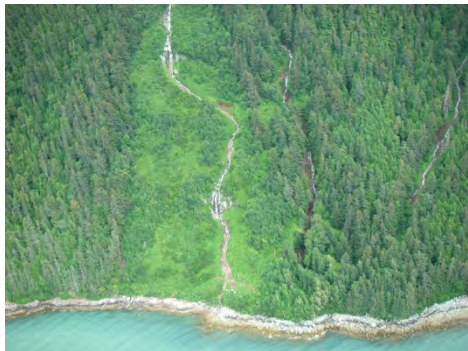
DF25. View east/upslope at debris flow channel.

Hazard ID #:	DF25
Hazard Type:	debris_flow
HIN:	111
Rating:	B
2012 SEIS Alignment Location:	2056
Frequency (yrs):	5-25
Predictability:	moderate
Material Volume (CY):	<10
Clast Size (ft):	0-1
Source Elev. (ft):	3000+
Centerline Slope:	fan
Alignment Location:	deposition_zone
Impact Alignment:	yes
Alignment Exposure (ft):	50-200
Vegetation:	disturbed
Deciduous Trees:	no
2012 SEIS Alignment South Margin:	2056+00
2012 SEIS Alignment North Margin:	2057+00
Photo #:	3462, 3463, 5093, 6195

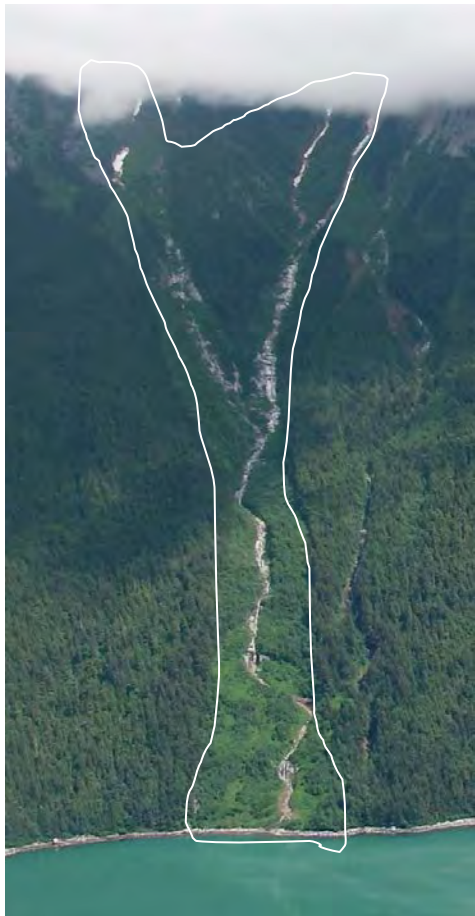
DF26. View east/upslope at debris flow channel and avalanche path.

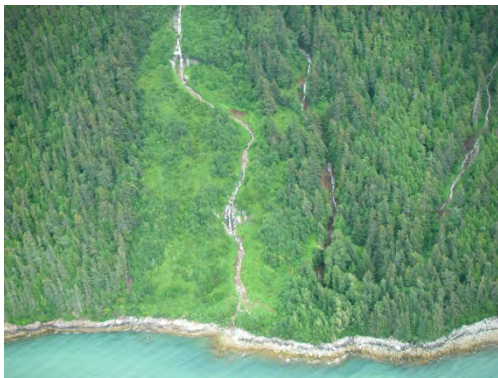
DF26. View east/upslope at debris flow channel and avalanche path (center).

Hazard ID #:	DF26
Hazard Type:	debris_flow
HIN:	129
Rating:	B
2012 SEIS Alignment Location:	2059
Frequency (yrs):	1-5
Predictability:	high
Material Volume (CY):	10-100
Clast Size (ft):	0-1
Source Elev. (ft):	3000+
Centerline Slope:	fan
Alignment Location:	deposition_zone
Impact Alignment:	yes
Alignment Exposure (ft):	50-200
Vegetation:	disturbed
Deciduous Trees:	yes
2012 SEIS Alignment South Margin:	2058+80
2012 SEIS Alignment North Margin:	2059+60
Photo #:	2241, 3470, 6195

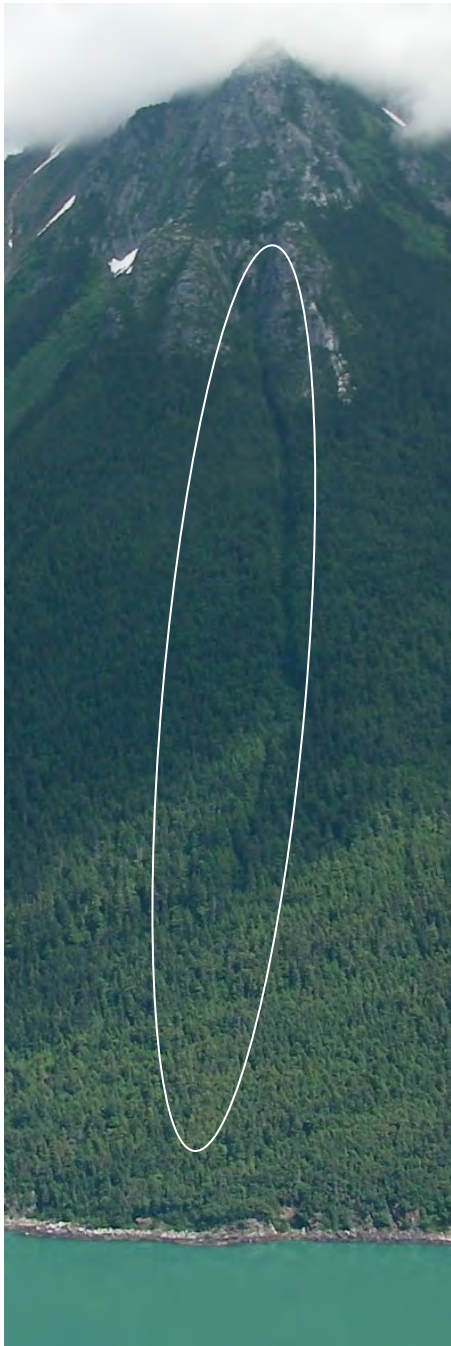
DF27. View east/upslope at debris flow channel and avalanche path.

Hazard ID #:	DF27
Hazard Type:	debris_flow
HIN:	129
Rating:	B
2012 SEIS Alignment Location:	2087
Frequency (yrs):	5-25
Predictability:	Low
Material Volume (CY):	<10
Clast Size (ft):	0-1
Source Elev. (ft):	2000-3000
Centerline Slope:	open_soil_slope
Alignment Location:	deposition_zone
Impact Alignment:	yes
Alignment Exposure (ft):	50-200
Vegetation:	disturbed
Deciduous Trees:	yes
2012 SEIS Alignment South Margin:	2087+30
2012 SEIS Alignment North Margin:	2088+00
Photo #:	3885, 5167, 5924, 6247

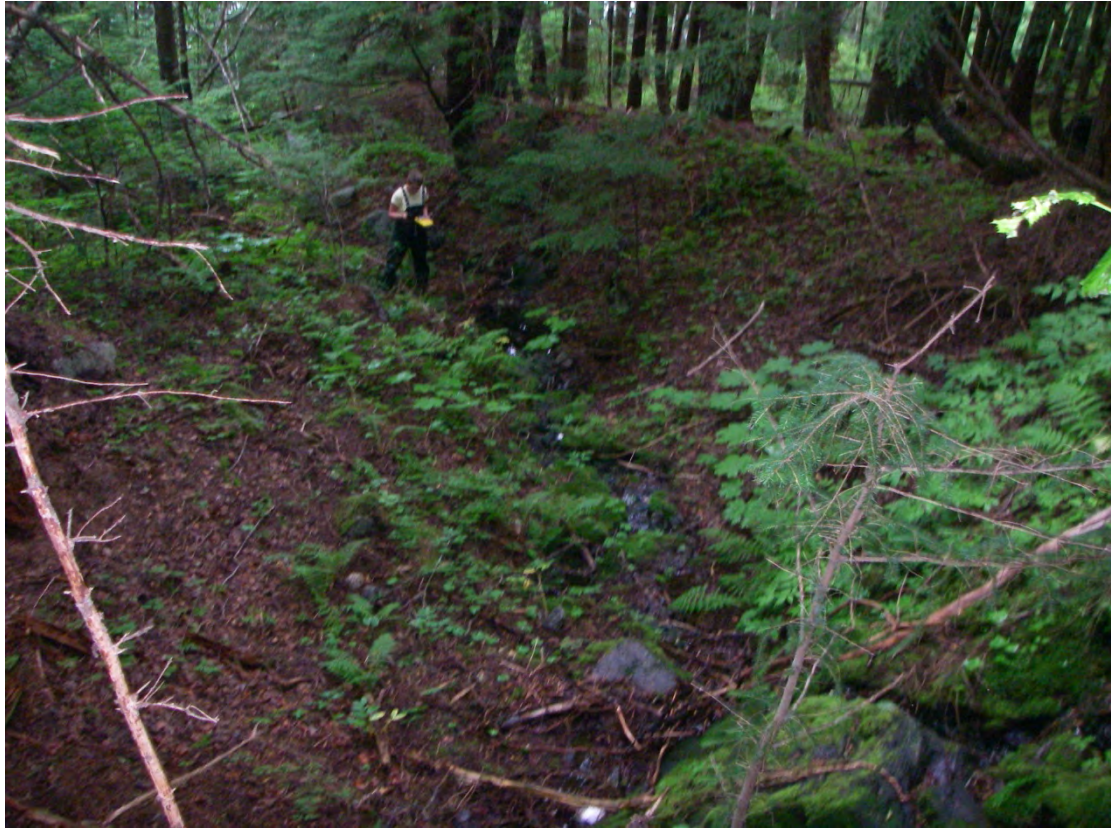
DF27. View east/upslope at debris flow channel and avalanche path.

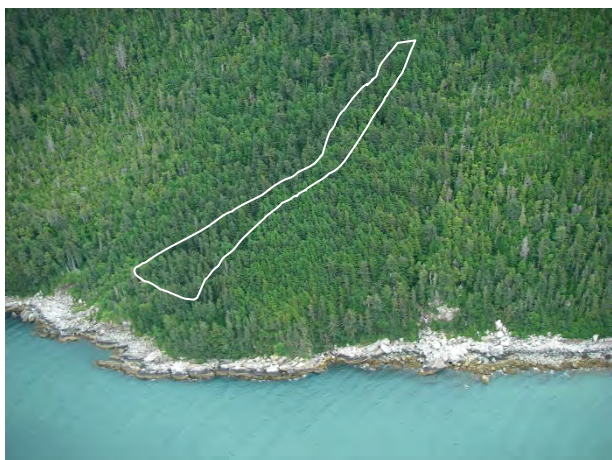
DF28. View east/upslope at debris flow channel.

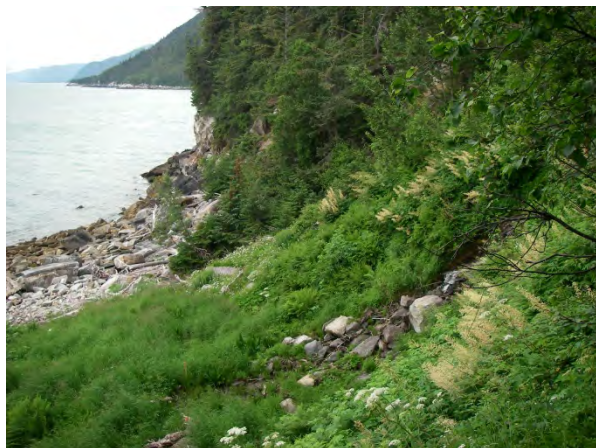
DF28. View northwest (up alignment and downslope) at deposition fan of debris flow.

Hazard ID #:	DF28
Hazard Type:	debris_flow
HIN:	183
Rating:	A
2012 SEIS Alignment Location:	2102
Frequency (yrs):	0-1
Predictability:	high
Material Volume (CY):	10-100
Clast Size (ft):	3-4
Source Elev. (ft):	3000+
Centerline Slope:	fan
Alignment Location:	deposition_zone
Impact Alignment:	yes
Alignment Exposure (ft):	50-200
Vegetation:	denuded
Deciduous Trees:	yes
2012 SEIS Alignment South Margin:	2101+40
2012 SEIS Alignment North Margin:	2102+30
Photo #:	3886, 5916
