Wetland and Waterbody Functional Assessment Report

Port Lions Airport Improvements Project (Z527960000)

Alaska Department of Transportation and Public
Facilities – Southcoast Region

Port Lions, Alaska
January 25, 2019

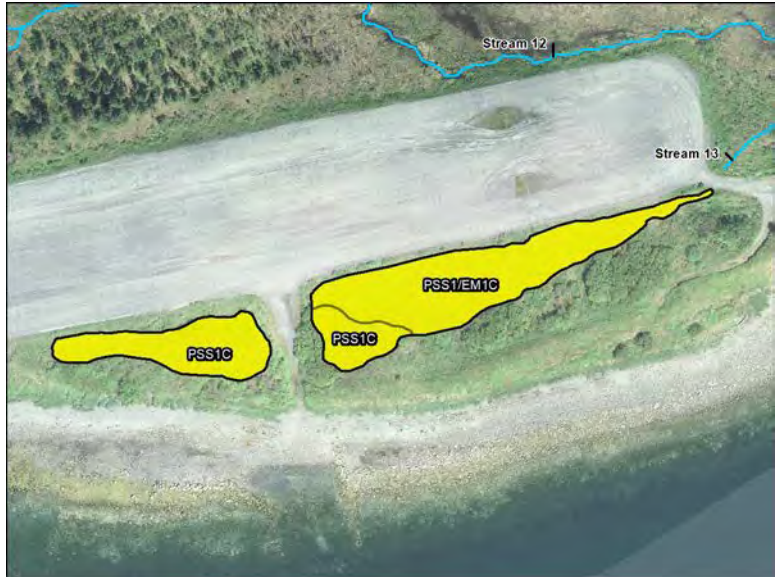
Inset 3. AA2.

AA2 consists of slope wetlands behind the upland beach berm above the shore of Settler Cove. Vegetation consists of sweetgale-sedge bog and closed alder tall shrub. Groundwater discharge at the slope break is the primary water source. AA2 is connected to AA1 via an intermittent stream that flows through a culvert under Airport Road (Stream 13).

AA2 was rated high for one function, Sediment/Nutrient/Toxicant Removal, and was rated low to moderate for most functions. The functional performance of the AA is impacted by disturbance from the airport, and AA2 was designated Category III.

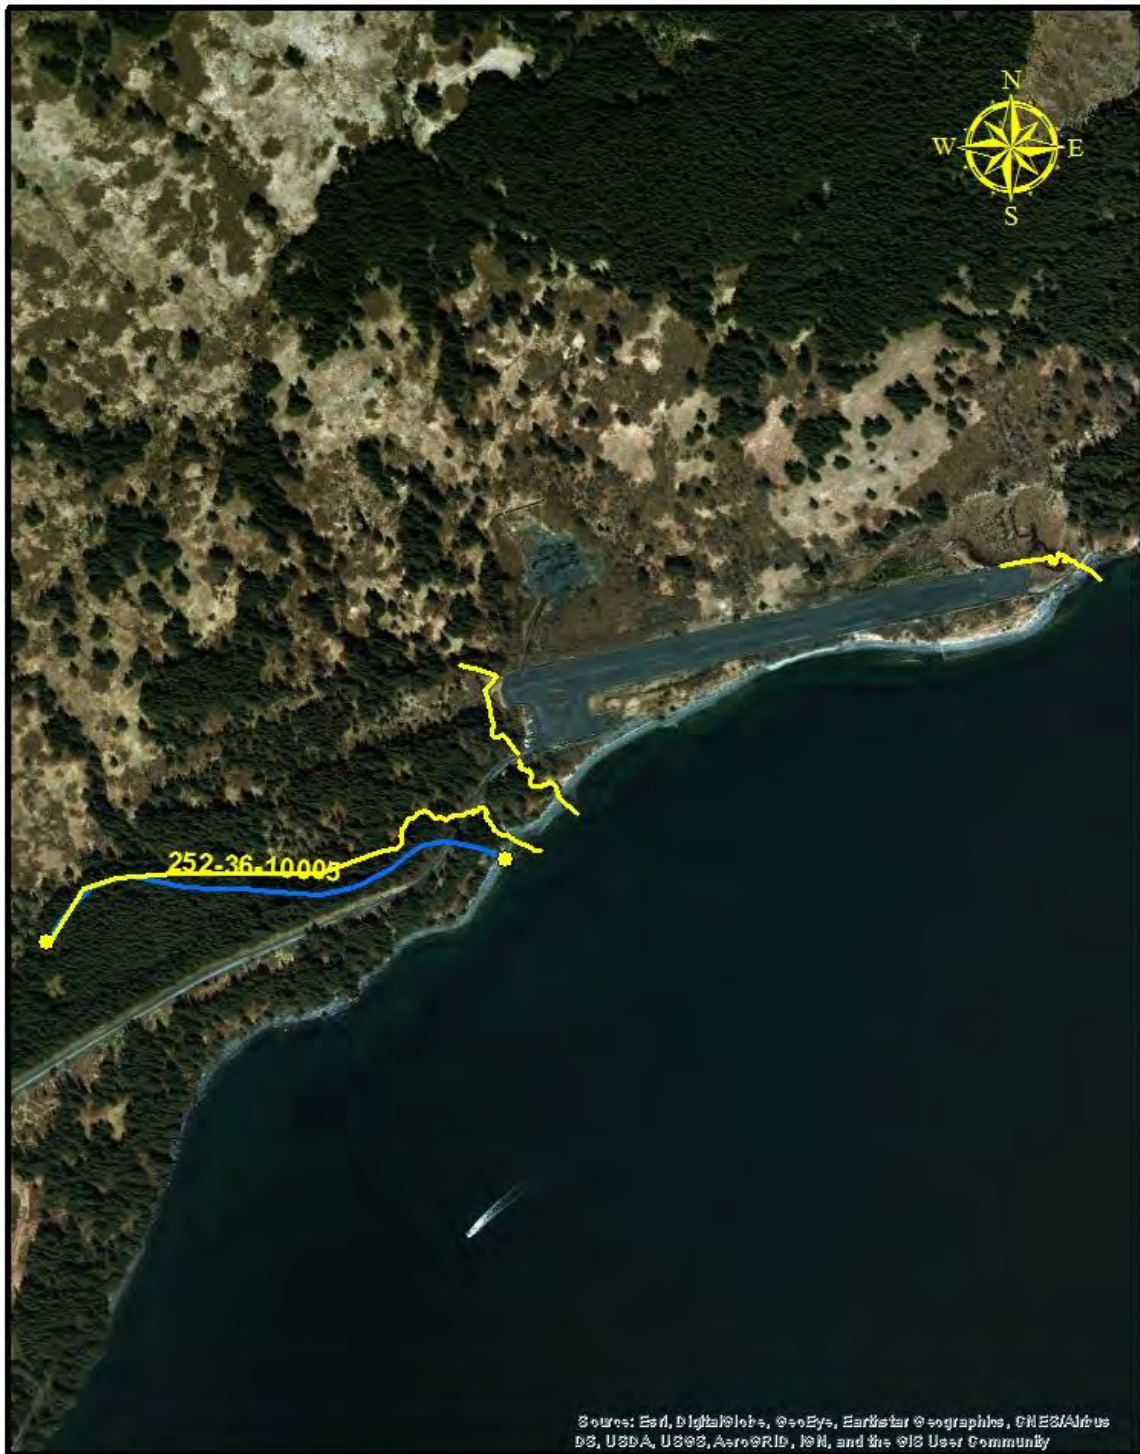
Figure 1

Streams in the project area.

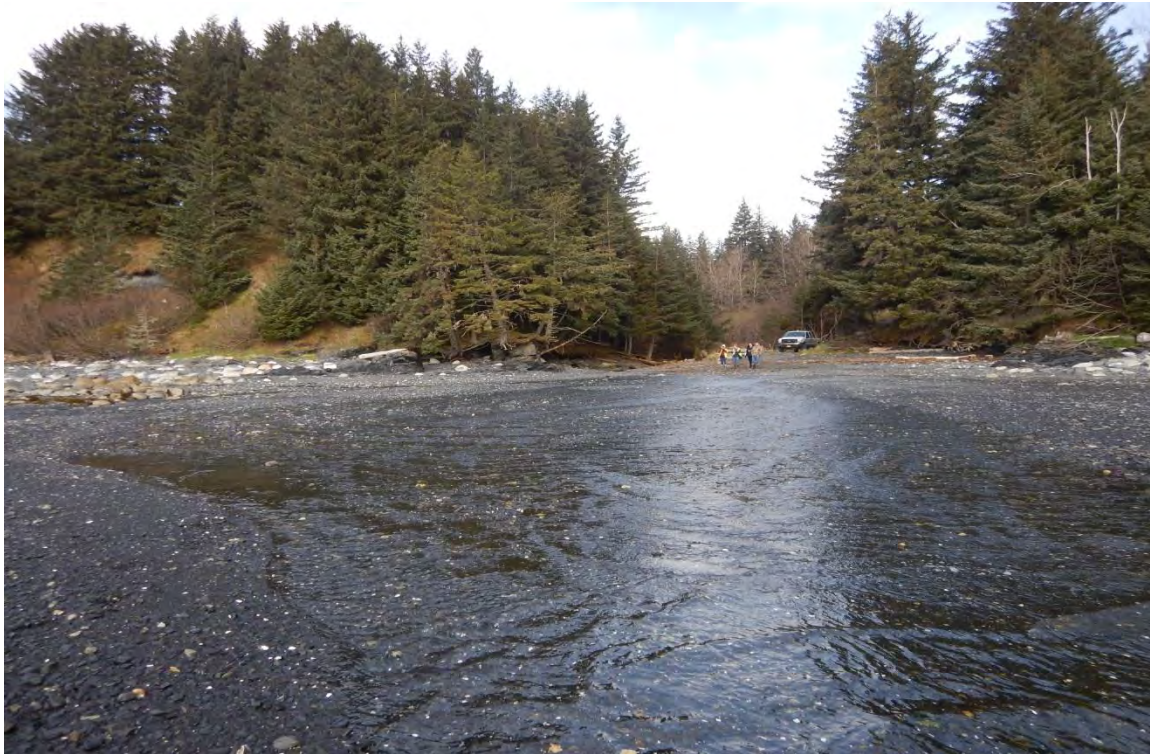
Figure 2. Bedload covering the outlet of Airport Creek at tidewater.

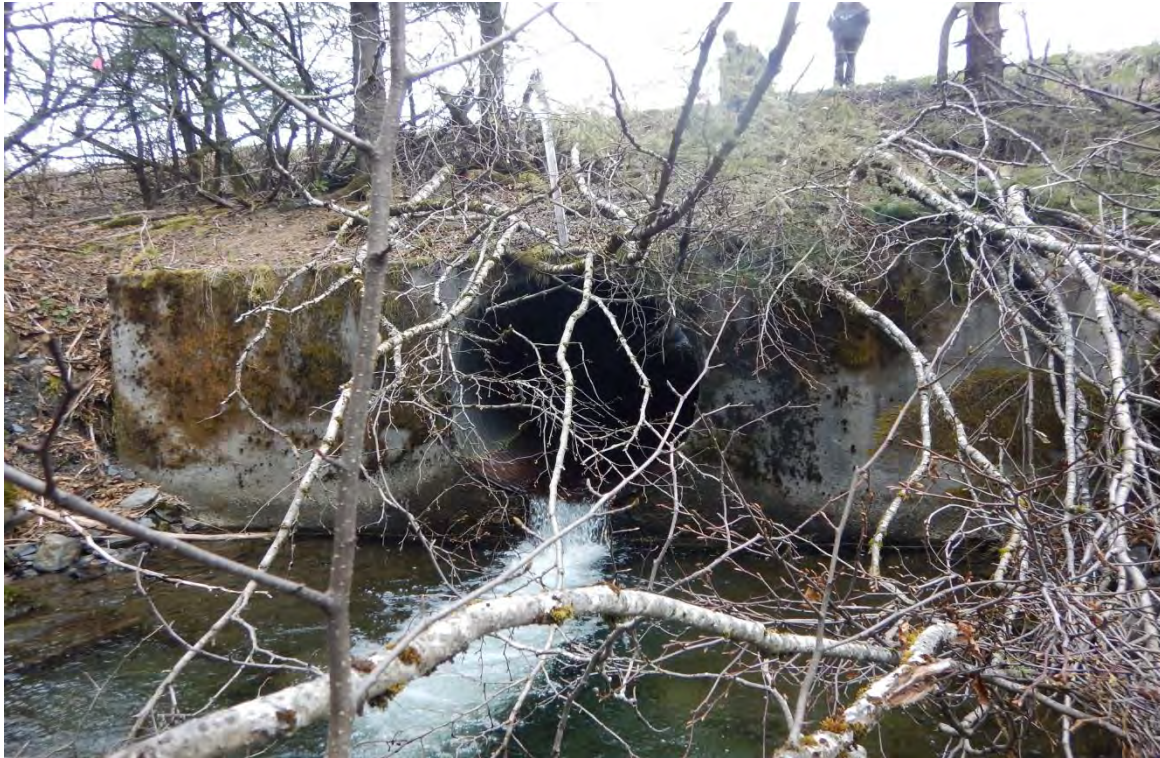
Figure 4. Perched culvert outlet located at the south end of the runway.

We walked to an unnamed stream located at 57.883 N, 152.853 W. We sampled from tidewater upstream 150 meters to a perched 60-inch diameter culvert located under the airport access road (Figure 4). We captured 5 sculpin and 5 Dolly Varden. We sampled upstream of the culvert 210 meters and captured 5 Dolly Varden. The culvert is likely a barrier to fish passage. Mr. Tripp stated if the airport access road is relocated as part of the airport improvement project the culvert would be removed.

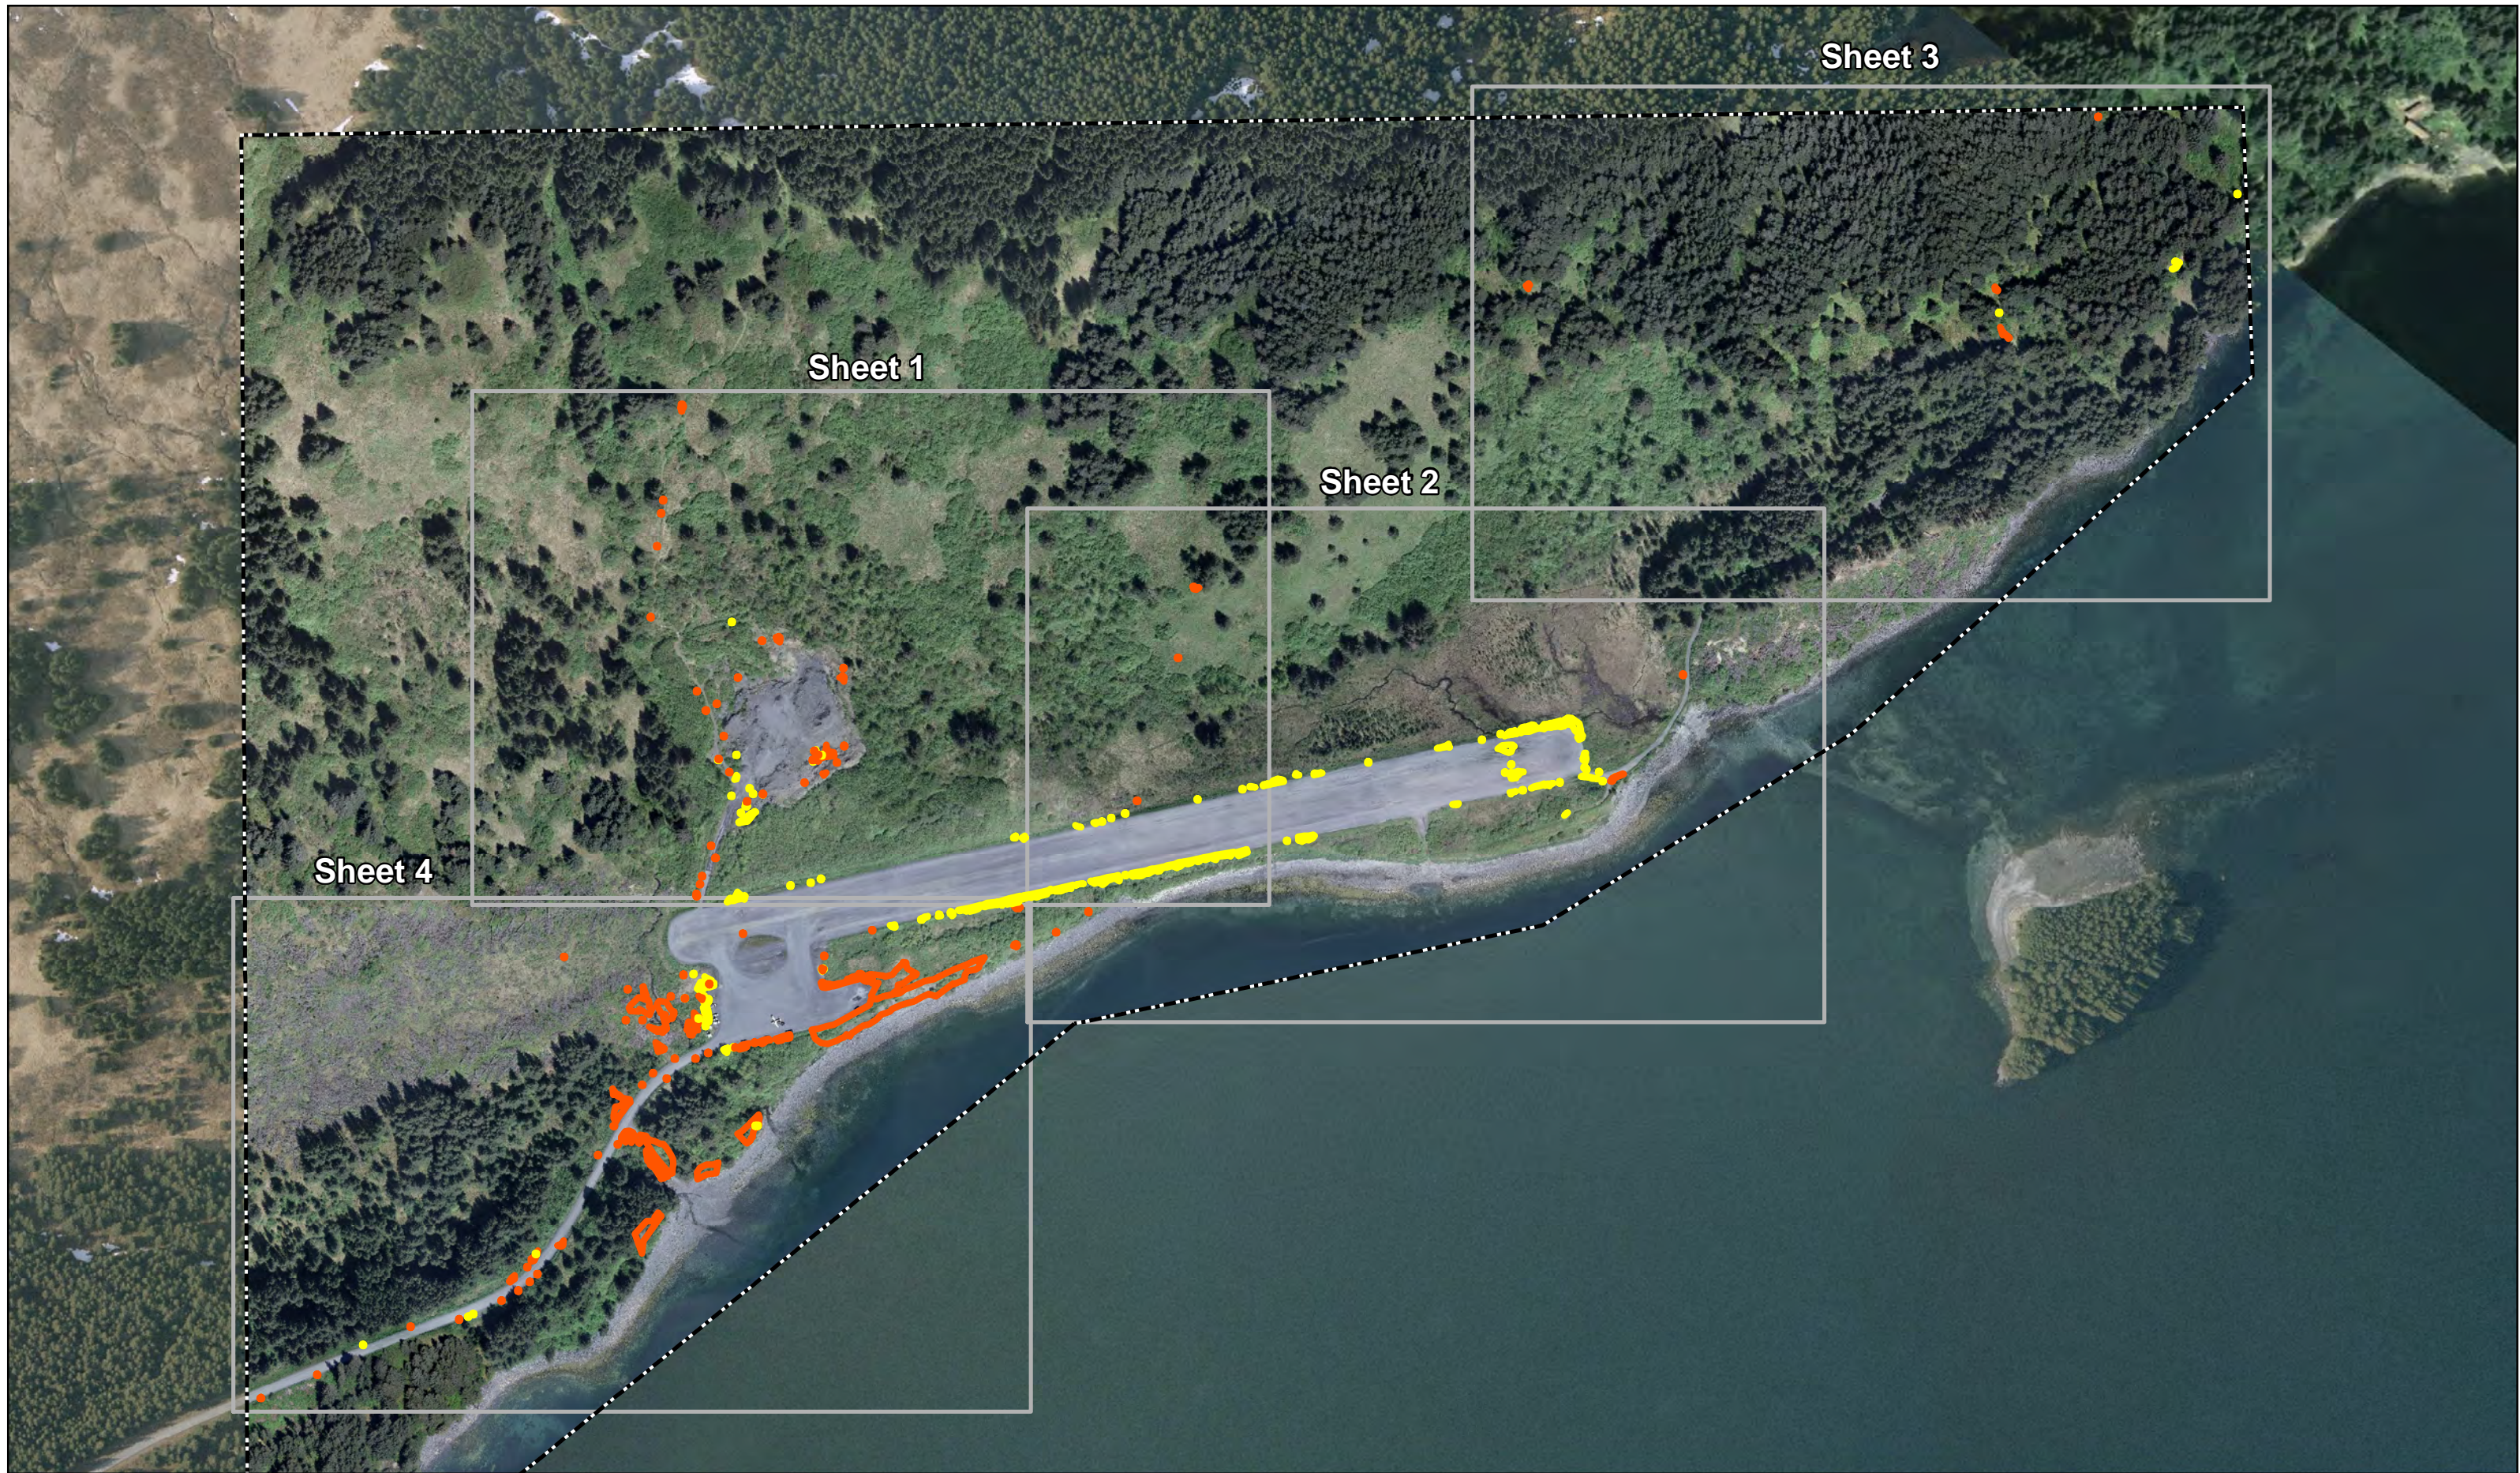
Figure 2: Survey Study Area
 Port Lions Airport Improvements
 Invasive Species Survey

Invasive Species Infestations - 2018

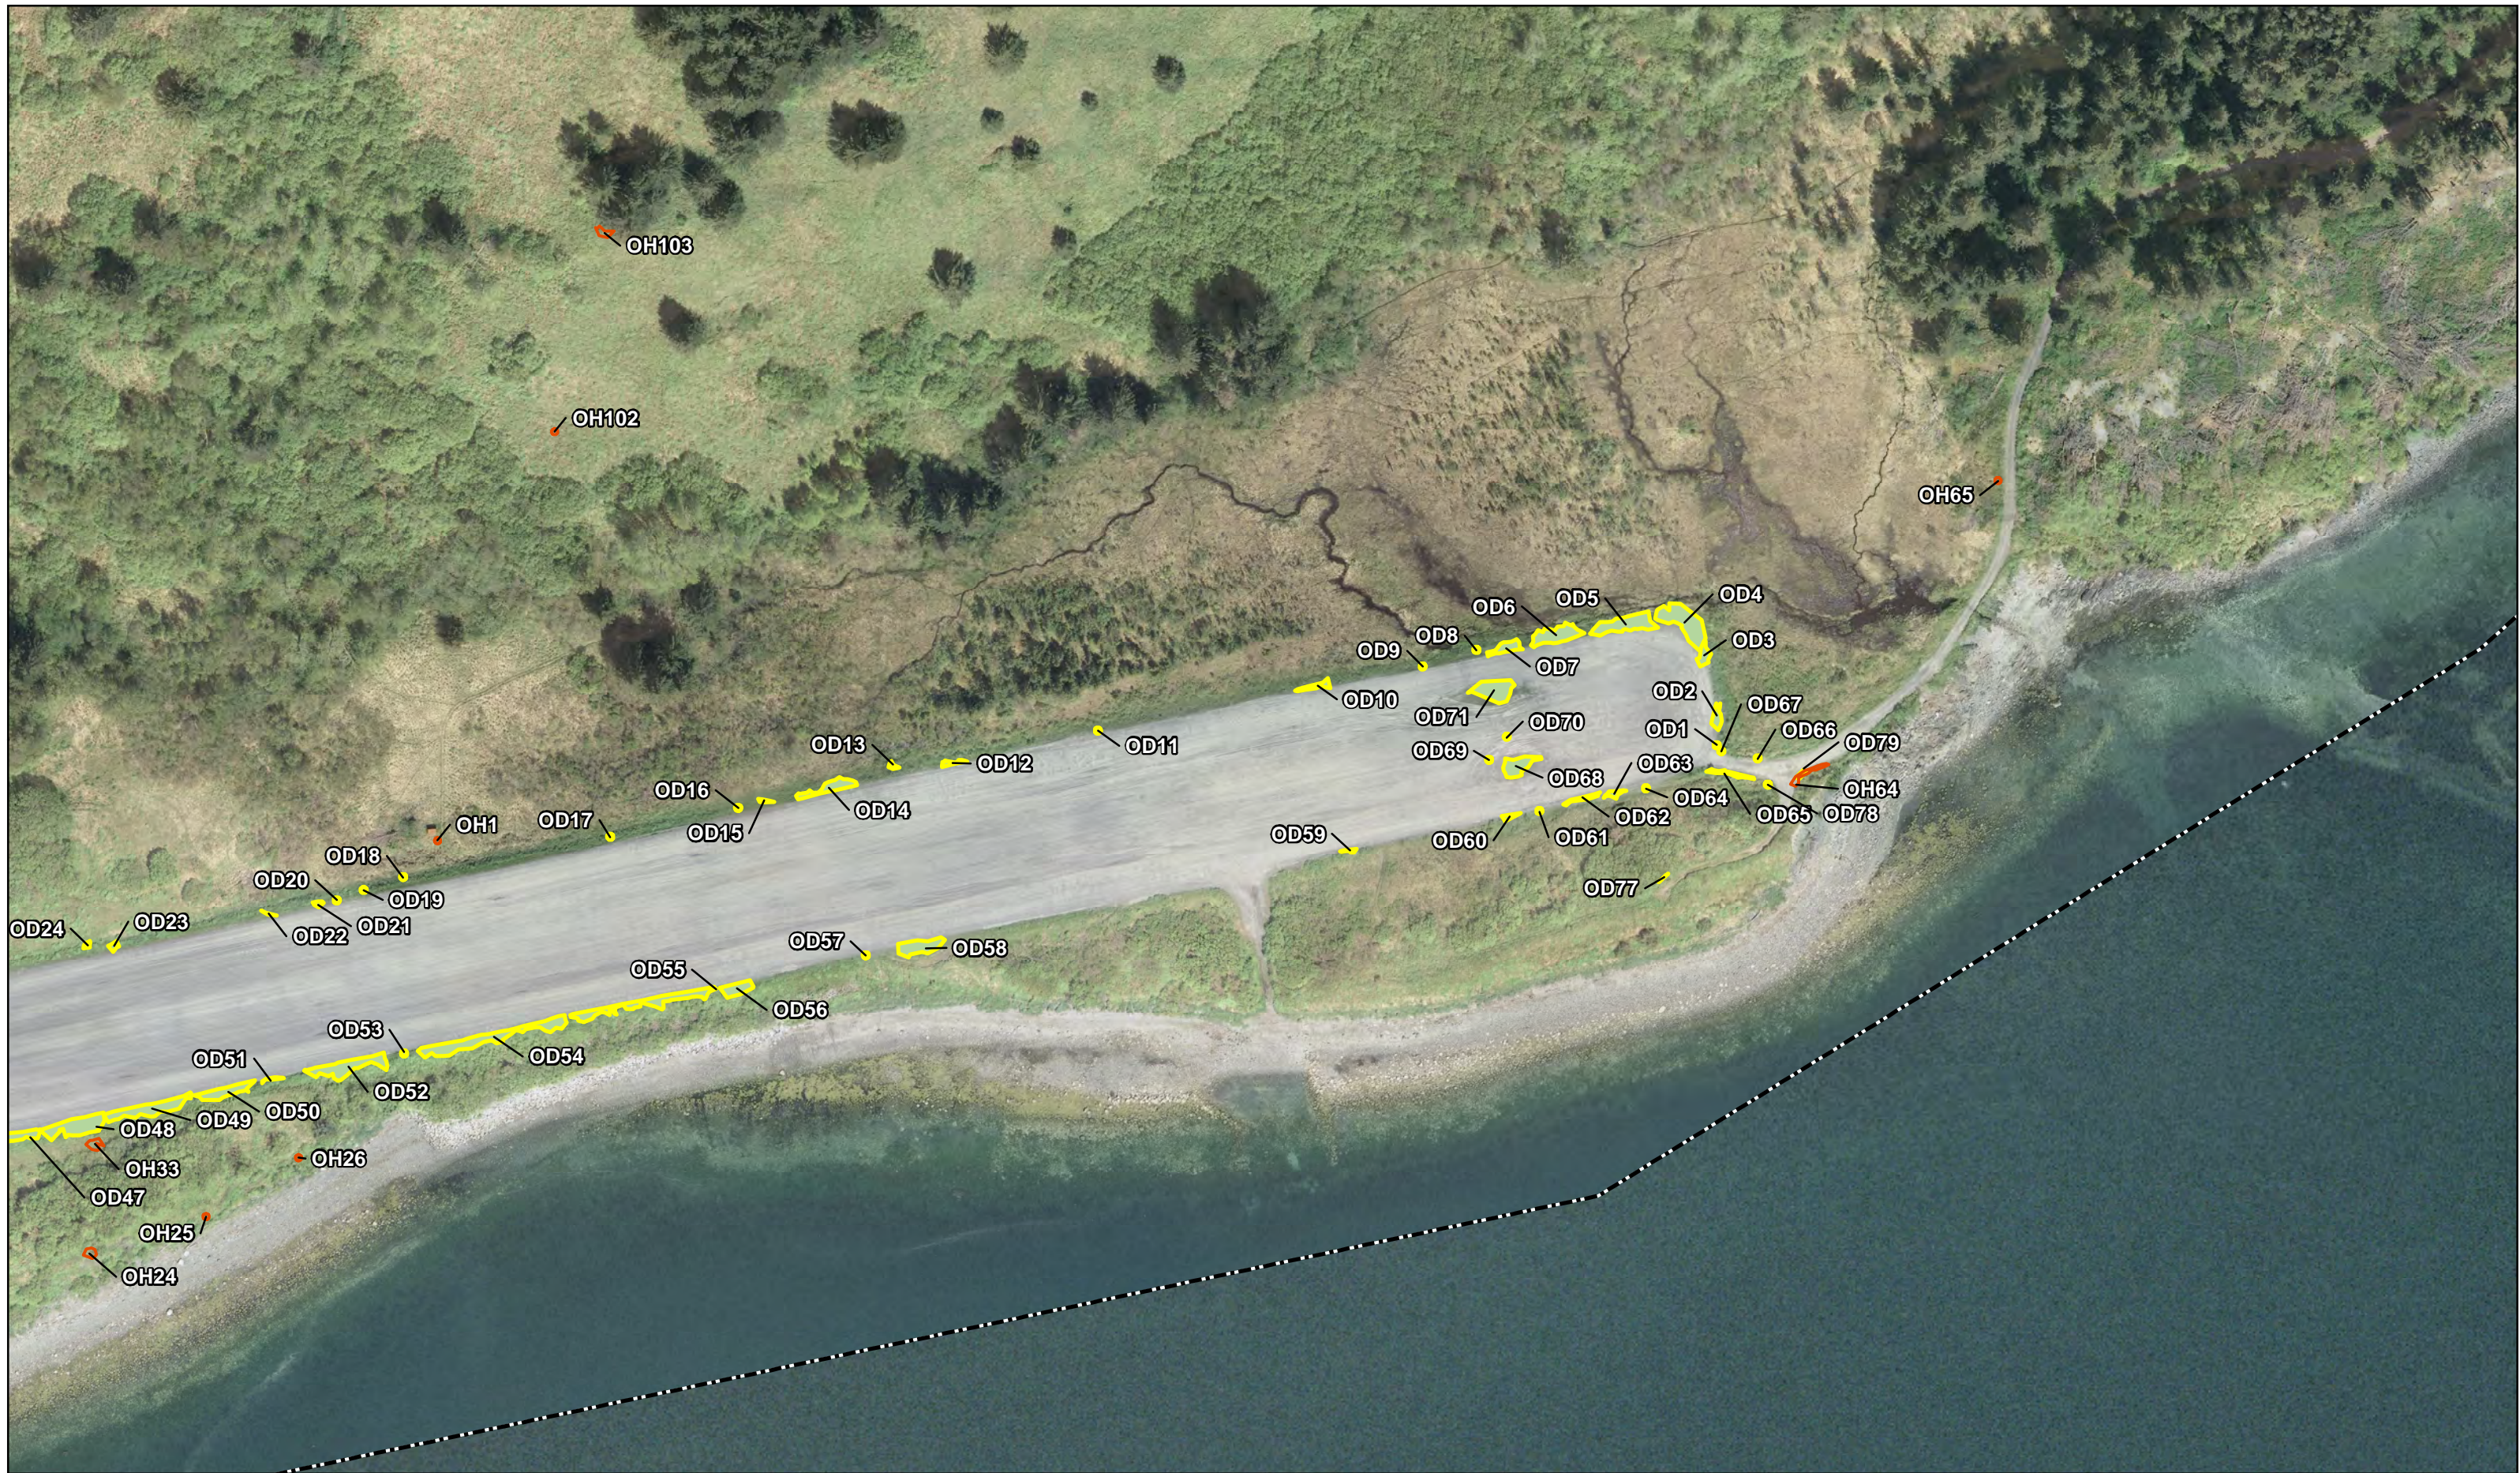
Figure 3: Sheet 2 of 4
 Port Lions Airport Improvements
 Invasive Species Survey

Invasive Species Infestations - 2018

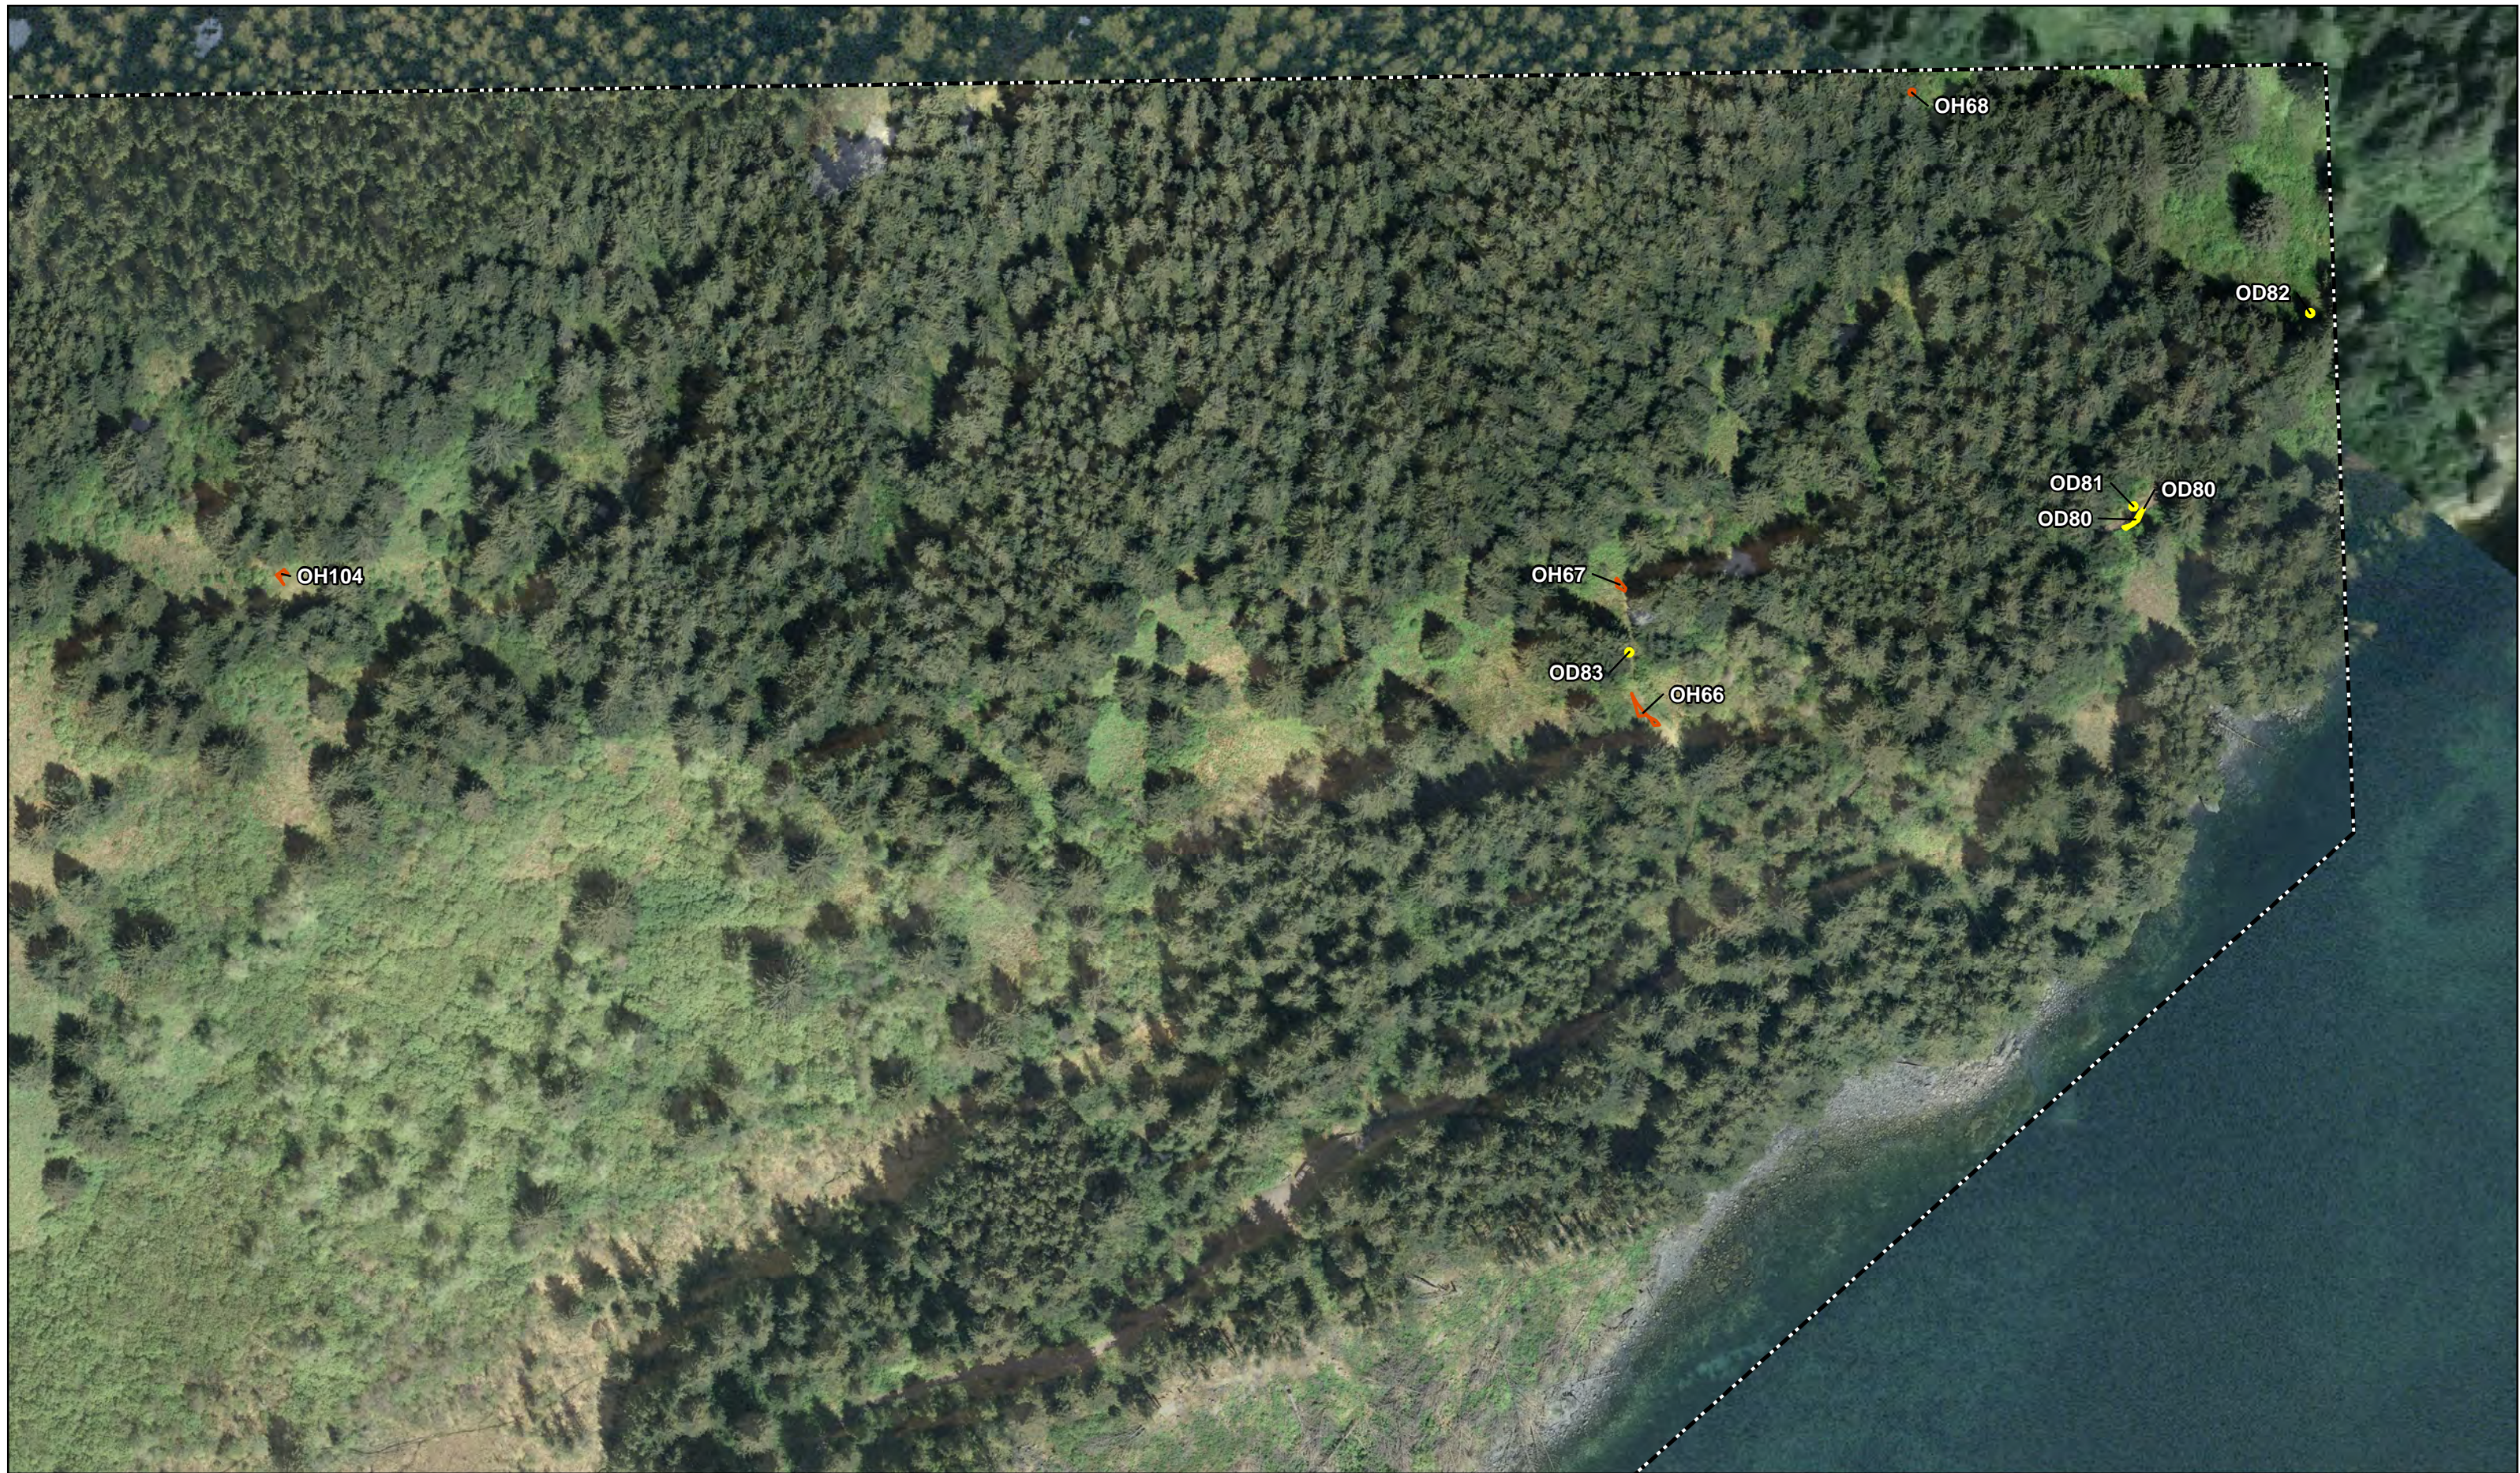
Figure 3: Sheet 3 of 4
 Port Lions Airport Improvements
 Invasive Species Survey

Invasive Species Infestations - 2018

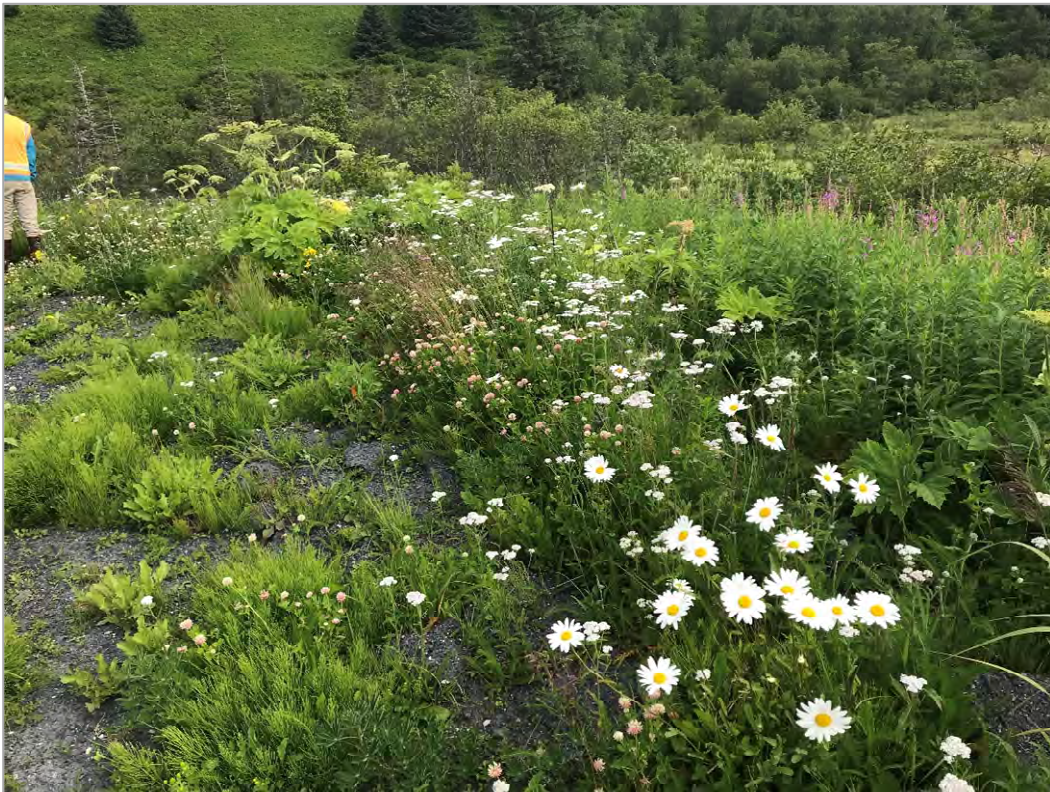
Site OD04. Oxeye daisy infestation along the graded edge of runway. Photograph taken July 20, 2018.

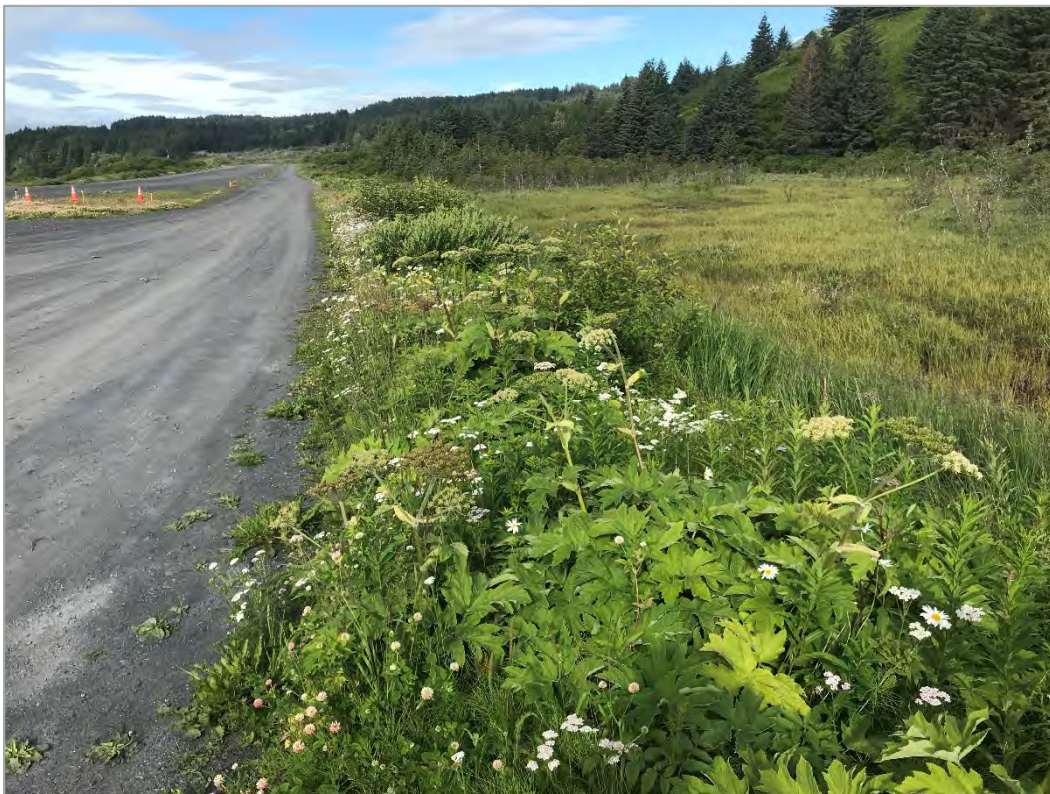
Site OD05. Oxeye daisy infestation along runway. Photograph taken July 20, 2018.
