## THE EYE IN THE SKY: AVALANCHE MAPPING FROM SPACE

**ABSTRACT:** The Seward Highway in Alaska has over one hundred avalanche paths spread out along a 150 km major transportation corridor, which traverses three different avalanche climatic regimes. This coupled with a small staff can make avalanche debris detection and mapping difficult. With the use of satellite imaging we may have a reliable means of detecting and recording avalanche deposits. During the winter of 2016 the Seward Highway recorded an unprecedented amount of glide avalanche releases. Using both optical and SAR data we can accurately detect avalanche debris, further aiding in mitigation strategies and avalanche hazard management.

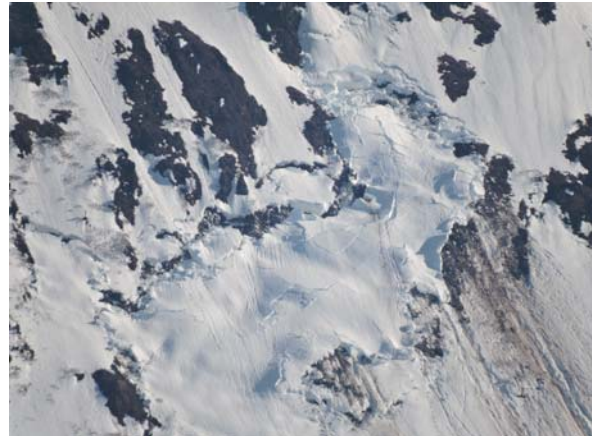
Fig. 2: "Sneaky Pete" path #975, release on 23-MAR-2016. Image source: Alaska Department of Transportation (AKDOT) image.

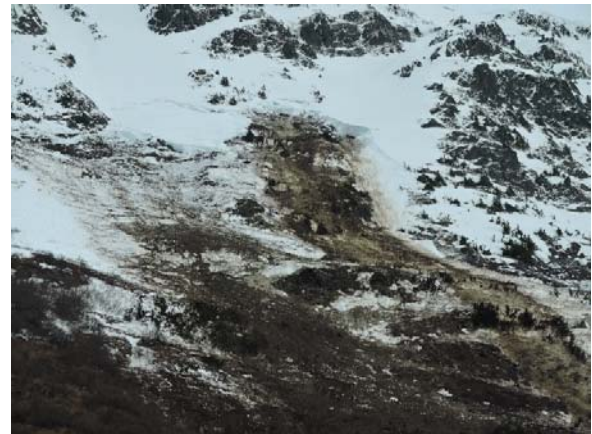
Fig. 3: "Supermans" path #945, release on 10-APR-2016. Image source: AKDOT image.
