Date: February 1, 2013
To: Bill Cole, DOT&PF (NR)
From: Mel Langdon
Project: Noatak Airport
Subject: Noatak Riverbank Erosion Assessment

W.O.#: 879301
cc: Raymond Plummer
Sara Lindberg

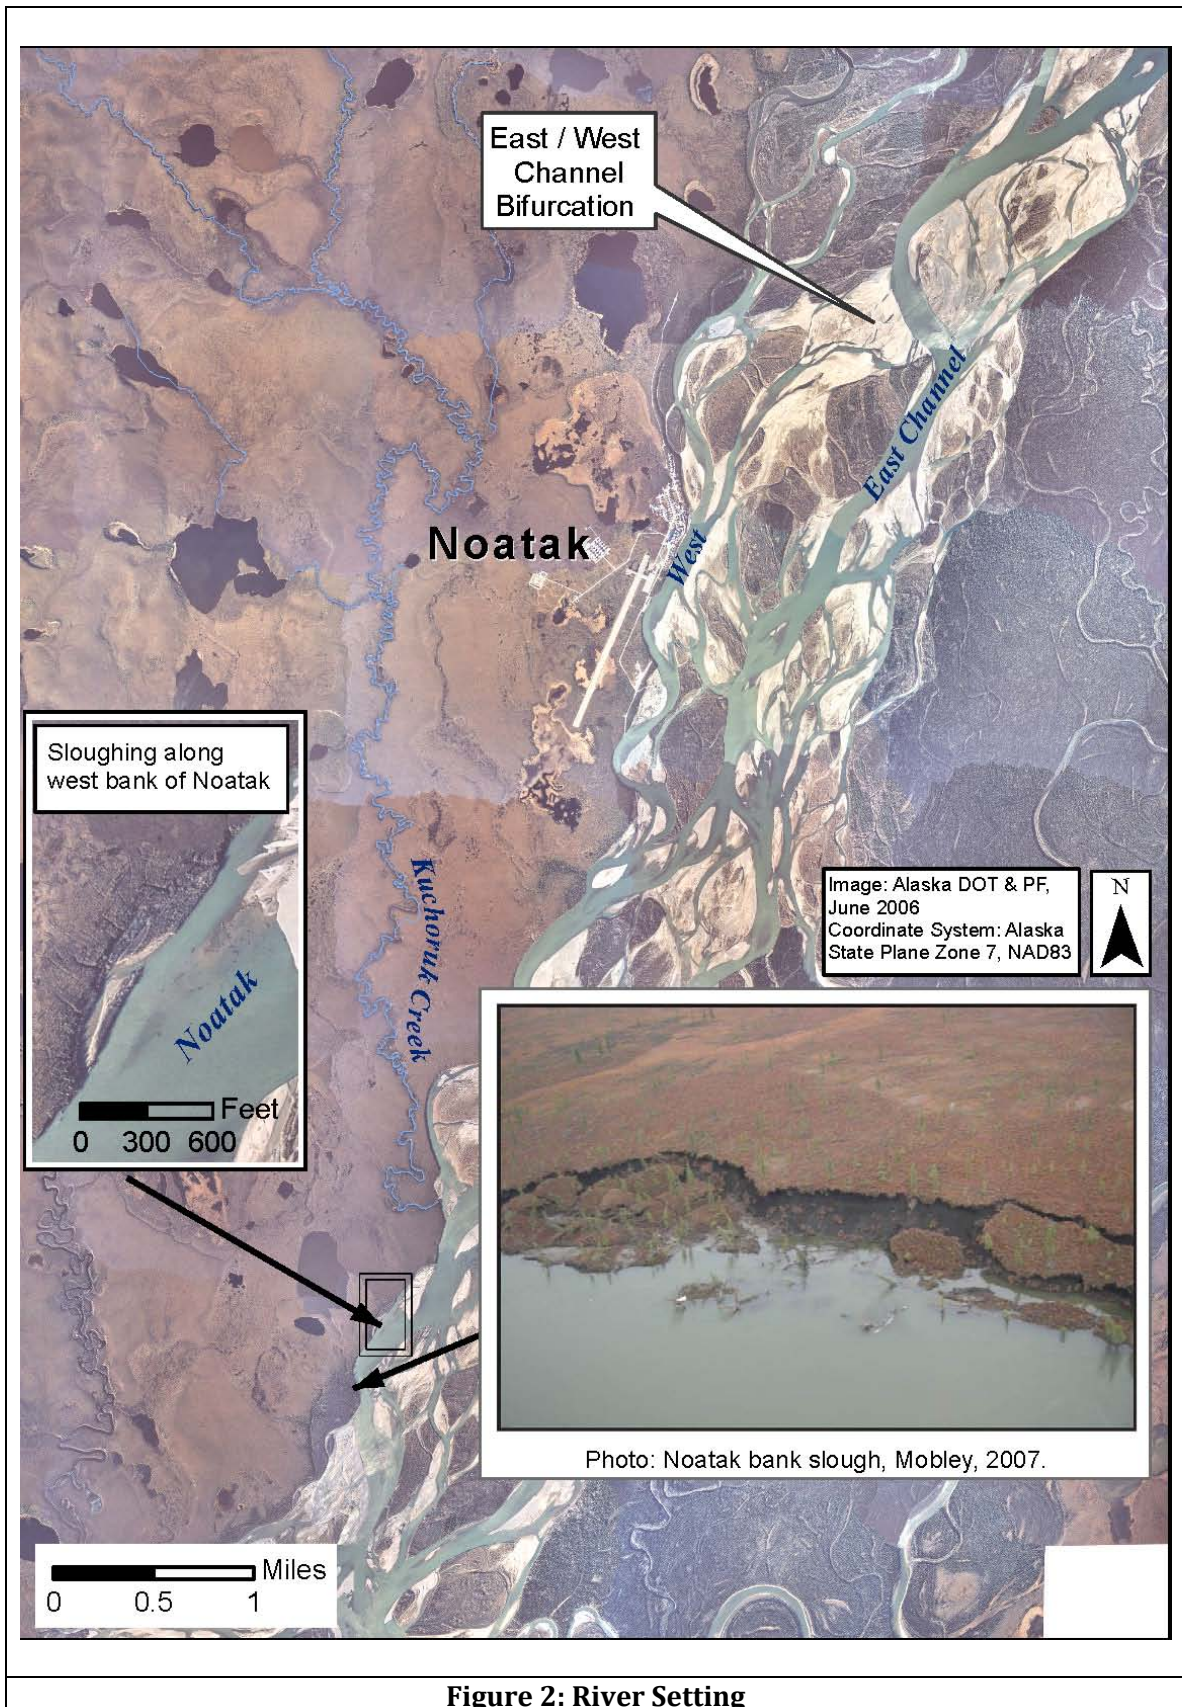
Figure 2: River Setting

In the vicinity of the Noatak Airport, the Noatak River is a split channel river, with two channels referred to as the East and West channels. The West Channel separates from the East Channel about 1 mile upstream of the airport (Figure 2). Local knowledge indicates that the main river channel migrated from the west to the east side of the river within the past three decades (Mobley, 2006). An appendix to the 1992 Environmental Assessment for runway extension and apron expansion includes a 1992 letter stating that water levels drop rapidly during the spring in the channel of the Noatak adjacent to the village, no longer allowing barge traffic. This may be reflective of the change in the dominant flow channel. The R&M study indicated that the change in the dominant flow channel, from the West Channel to the East Channel, occurred sometime between 1998 and 2002. The 2006 aerial imagery (Figure 2) indicates that the upstream bifurcation point between the East and West channels continues to exist and the East Channel is the dominant flow channel.

Channel Planform Patterns. The general pattern of planform of the Noatak River in this reach of the river is sinuous and arcuate (Figure 2) and the projected erosion extents in the R&M study reflects this. The leading edge of the erosion observed in 2004 and 2012 follows that pattern. Notable at the Noatak Airport, downriver from articulated mat, is a long stretch of linear rather than curved channel pattern. As discussed in the R&M study and apparent from observed erosion, a meander pattern is likely to develop. The upgradient bank armoring may have forestalled this channel migration and failure in that armoring may accelerate erosion.

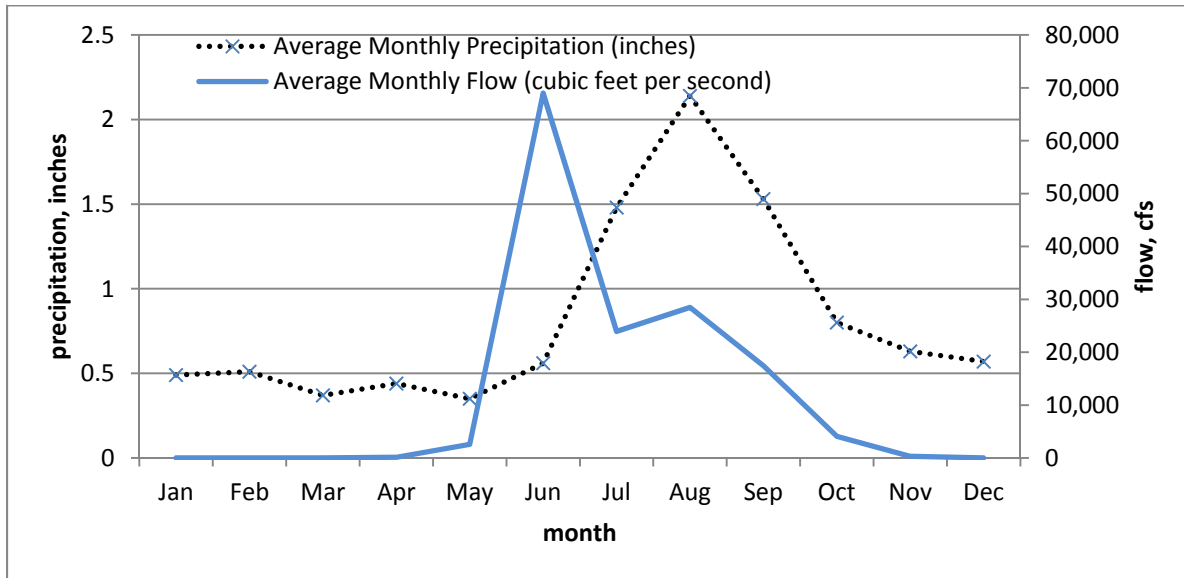
Figure 7: Average Monthly Precipitation and River Flow

Figure 7 shows average monthly precipitation at Kotzebue and total flow in the Noatak River, as gauged by the U. S. Geologic Survey downstream from the split channel section. The Kotzebue Airport is the closest climate station to the Noatak Airport with a long record. Although these precipitation values were not measured at Noatak or in the Noatak watershed, they provide a representation of the seasonal precipitation variability. Flow was only measured for seven years (1965 to 1971) so does not reflect a robust or contemporary period of record, but does show seasonal flow variation.

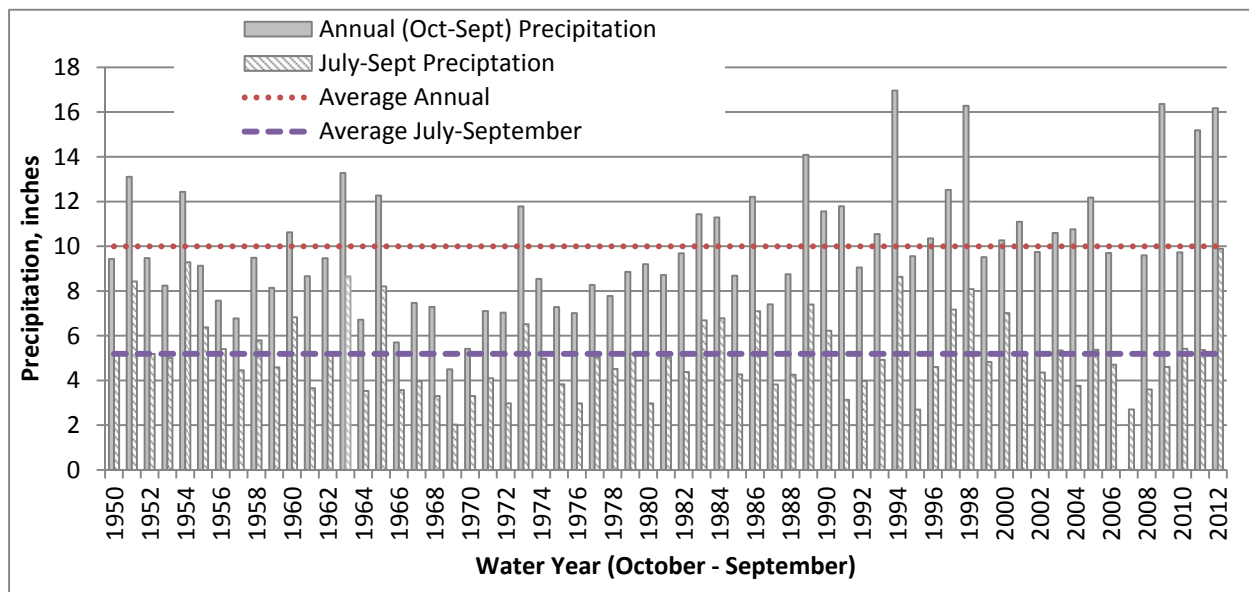
Figure 8: Historic Precipitation at Kotzebue Ralph Wein Memorial Airport Alaska Period of Record: 1950-2012

Annual and late summer precipitation depths at Kotzebue Airport are shown in Figure 8. As mentioned above, although these values were not measured at Noatak, they provide a representation of the variability of precipitation from year to year and illustrate years of higher than normal precipitation. Note in particular the high precipitation in late summer 2012, corresponding with the erosion event that occurred in August 2012 as compared to the long-term July-September average.
