APPENDIX HW
Hazardous Waste

**USACE Haines-Fairbanks Pipeline No Department of Defense Action
Indicated (NDAI) Final Determination (2014)**

Hazardous, Toxic, or Radioactive Waste
Project # F10AK1016-01
Haines-Fairbanks Pipeline
Various Locations, Alaska

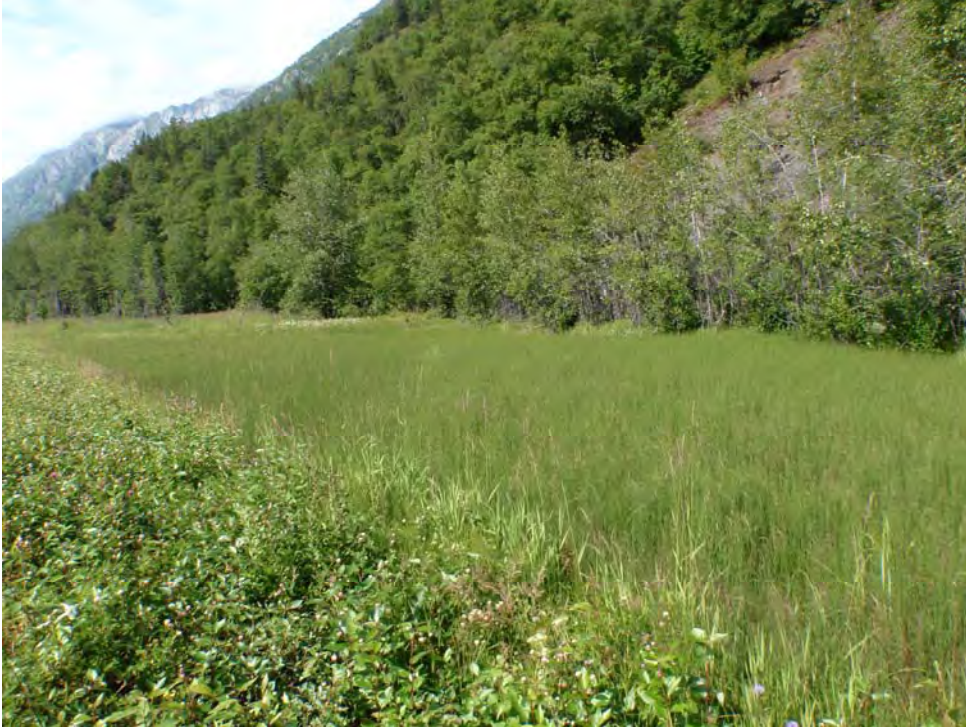
**PMP 17.7 – Wetland on East Side of Highway
(Photo taken from Haines Highway Looking North)**

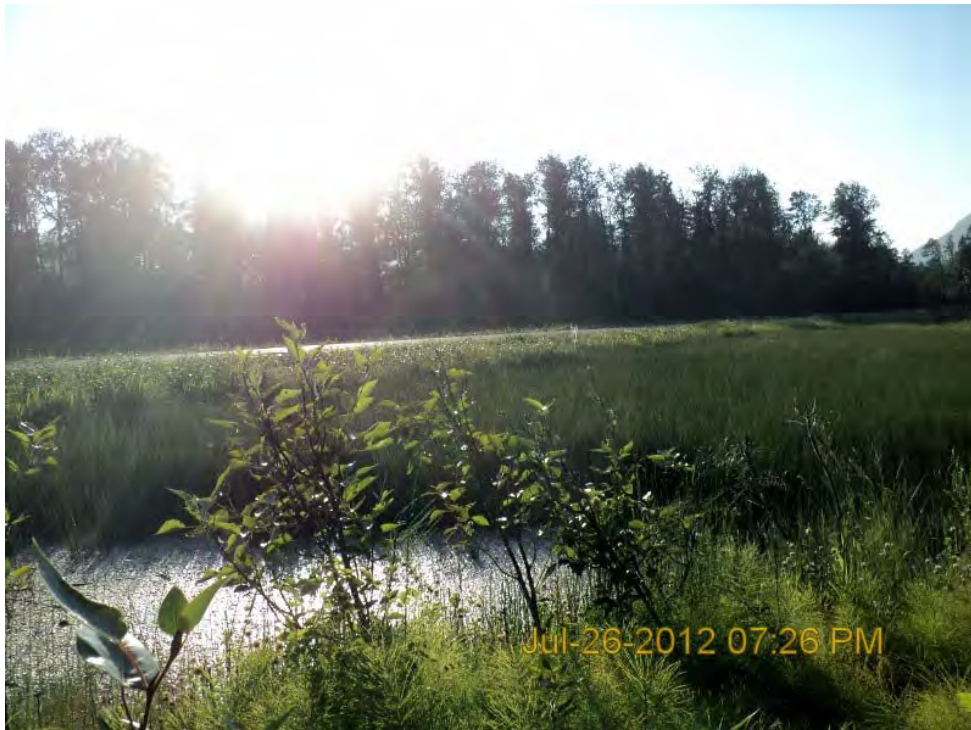
**PMP 17.7 – Wetland on East Side of Highway
(Photo taken from Pipeline Trench Mound - Looking Northwest)**

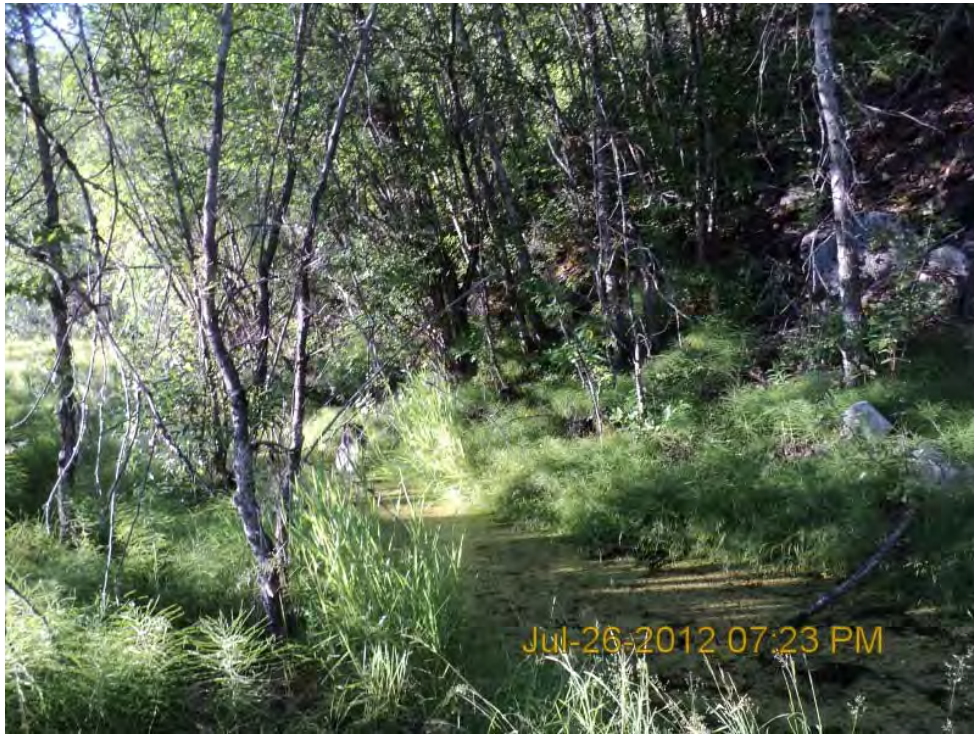
**PMP 17.7 – Pipeline Trench on East Side of Haines Highway
(Photo Taken from Pipeline Mound – Looking North)**

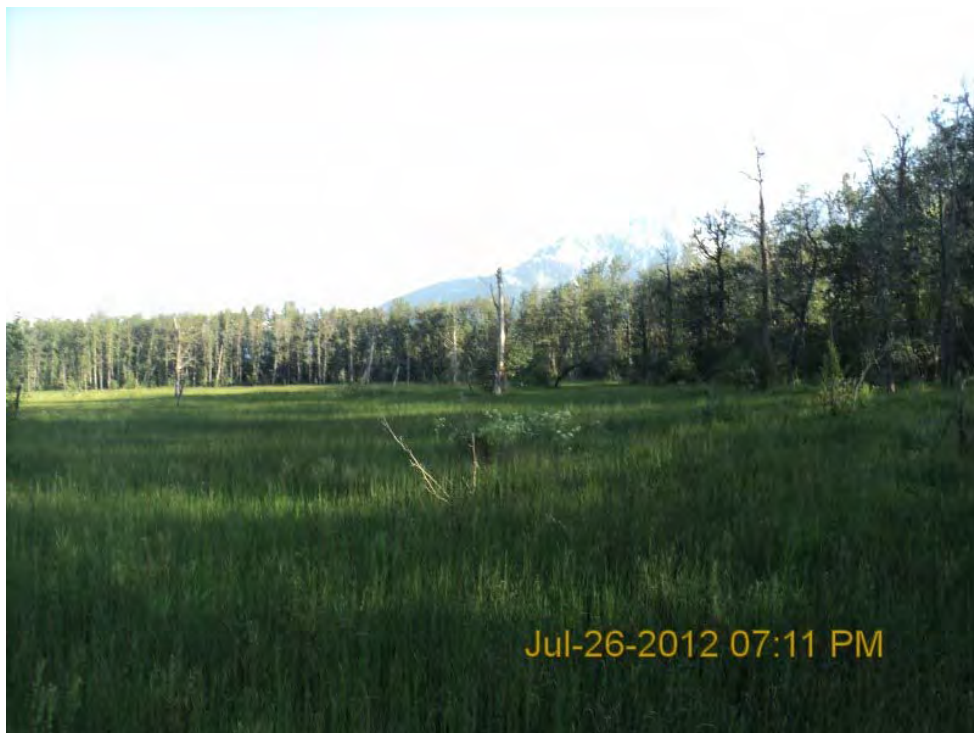
**PMP 17.7 – Wetland on West Side of Haines Highway
(Photo Taken from Haines Highway – Looking Southwest)**

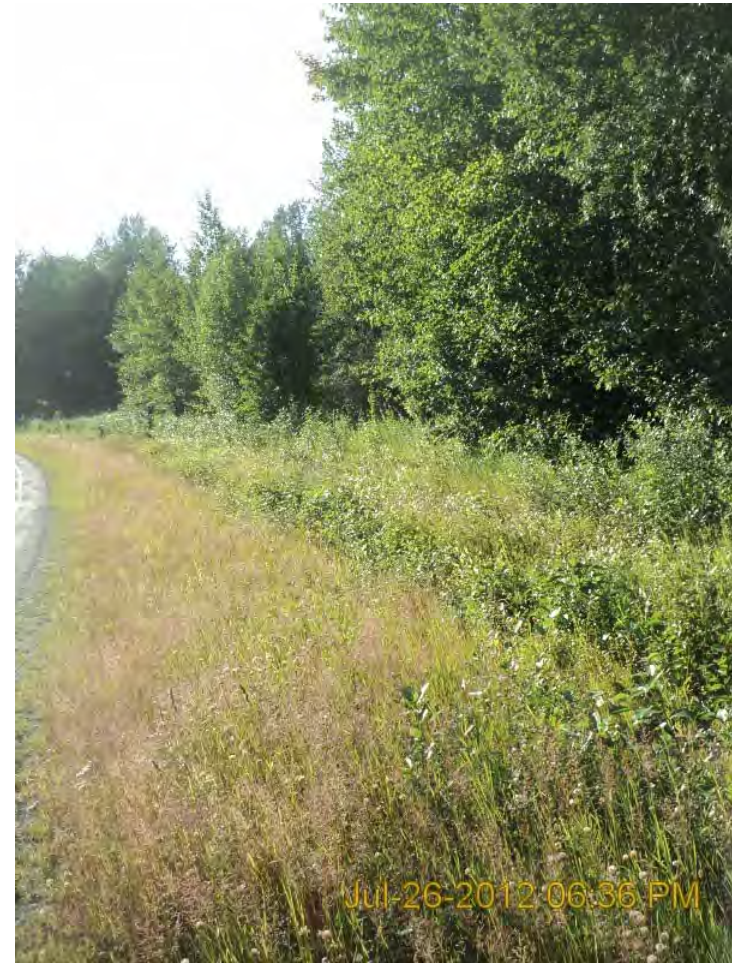
PMP 19.5 – Frontage along North Side of Haines Highway – Unnamed Stream Runs in Front of Tree Line (Photo Looking Northwest)

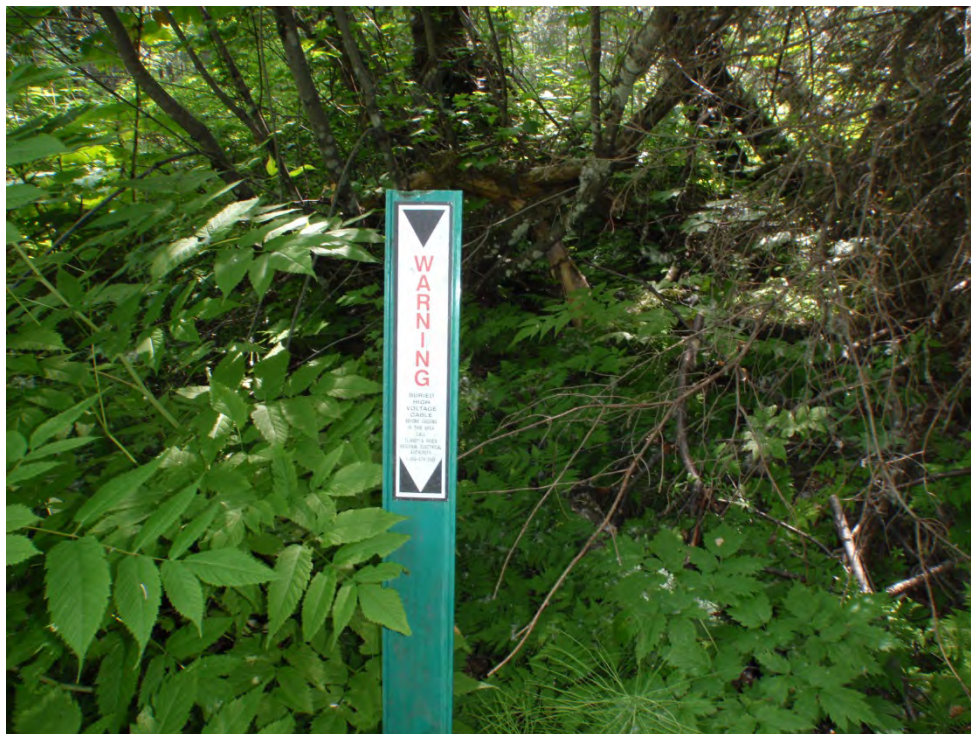
**PMP 19.5 – Marker Identifying Power/Phone Line (believed to inside the HFP)
(Photo Taken from near the Haines Highway – Looking West)**

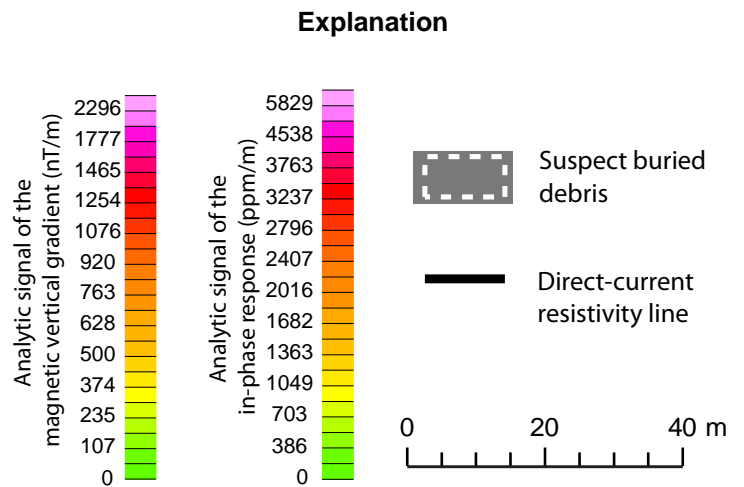
The EM and magnetic data show fairly consistent anomaly regions (fig. 1). The southernmost anomaly area identified in the magnetic data (fig. 1a) is likely the result of buried utilities running along the highway, as indicated by the strong response in the 60-Hz powerline monitoring frequency of the EM data (pink and red areas in the inset of fig. 1b). These utilities also have a strong influence on the nearby EM data; consequently, the EM data south of the DC line may not reliably detect conductive metals here. The most prominent anomaly region is present along the southern portion of the DC line and extends both east and west across the accessible areas. The anomalies extend into the heavy shrubs, where old concrete pilings and other surface debris were also noted at the surface. Few major anomalies were identified with EM or magnetic methods in the central part of the dump area (fig. 1), likely indicating a general absence of large buried metallic debris; this area was also noted to be particularly sparse of vegetative ground cover (fig. 3). A couple of small, individual anomalies were seen in the EM data (fig. 1b) that are mostly beyond the region surveyed with magnetics. These are isolated, relatively low amplitude signals, but are still distinctive from the background signals and have therefore been highlighted in fig. 1. DC resistivity data show a shallow, strongly resistive layer that partly coincides with this low-anomaly region and is also well correlated with the sparse ground cover (red area in fig. 2c). The northern anomaly region contains more dispersed anomalies, particularly focused in the eastern side of the survey area. GPS-reception was not as strong in this northern part of the site, likely the result of the limited open sky created by the close tree canopy and the steep topography. The northern anomalies are therefore not as precisely positioned as those mapped in the southern half of the survey area. However, both EM and mag results clearly indicate the presence of significant anomalies in this northern area. These anomalies coincide with the northern portion of the high-resistivity area in the DC resistivity results (red area in fig. 2c).

Figure 1. Results from surface geophysical surveys at the Haines 7-Mile Dump near Haines, Alaska. Maps show anomalies identified in the (a) magnetic vertical gradient and (b) electromagnetic in-phase response at 23 kHz with associated powerline monitoring data. Areas suspected to contain buried debris (white dashed lines) are summarized in (c).

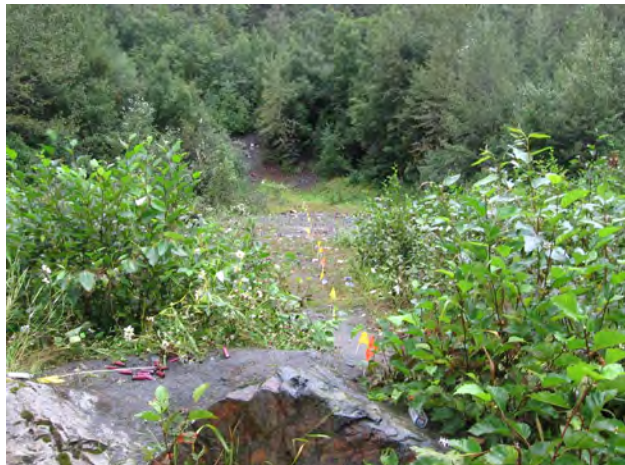
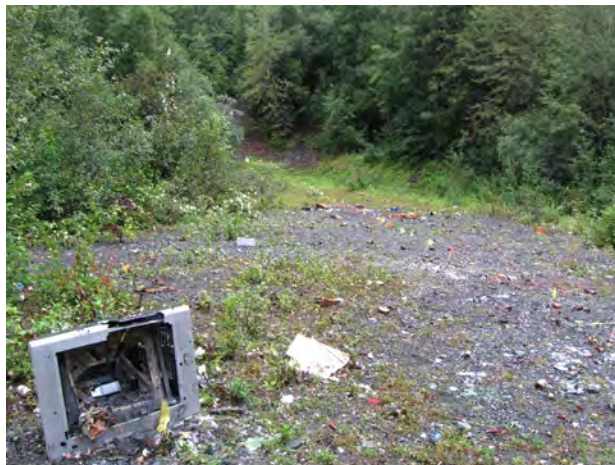
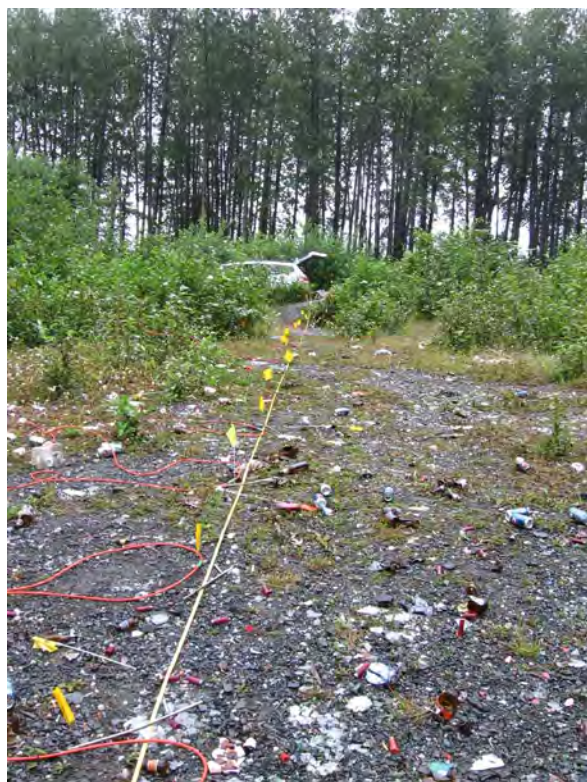
Figure 3. Photos showing the Haines 7-Mile Dump near Haines, Alaska. Photos taken looking (a) north along the direct-current resistivity line (indicated by pin flags) from the southern end of the dump area, (b) northeast from the middle of the dump area, and (c) south along the direct-current resistivity line from the middle of the dump area.

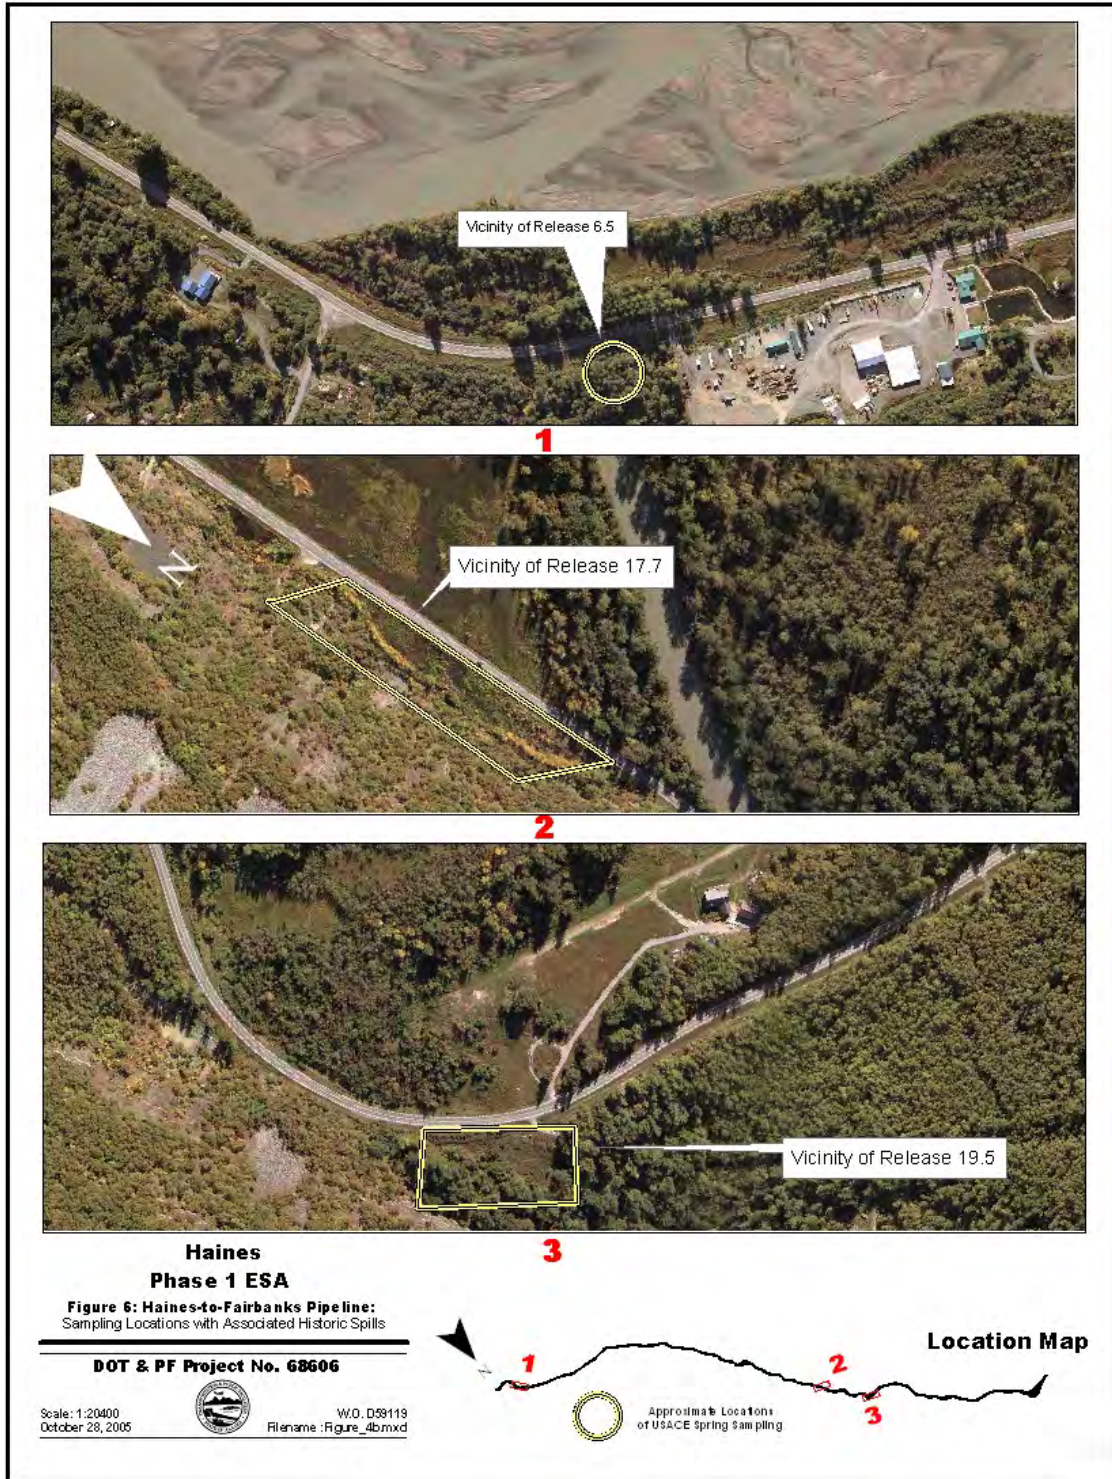
Figure 6: Haines-to-Fairbanks Pipeline: Sampling Locations with Associated Historic Spills

In spring 2006, the USACE will sample two additional locations, Release 6.5 and Release 17.7, that have associated historic spills (see Figure 6). The USACE will also revisit Release 19.5 to determine if additional product is present, as this site also has a historic spill associated with it.

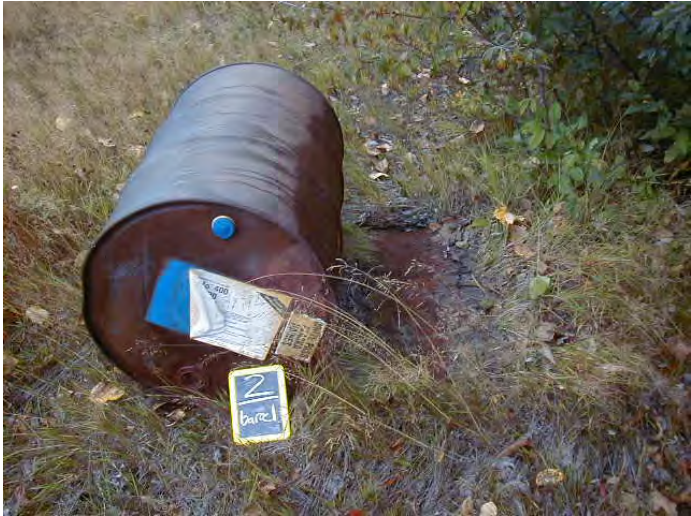
<p>Photograph No. 5</p> <p>Location: N/A</p> <p>Direction: Facing southeast</p> <p>Comments: Photo of pond on property</p>

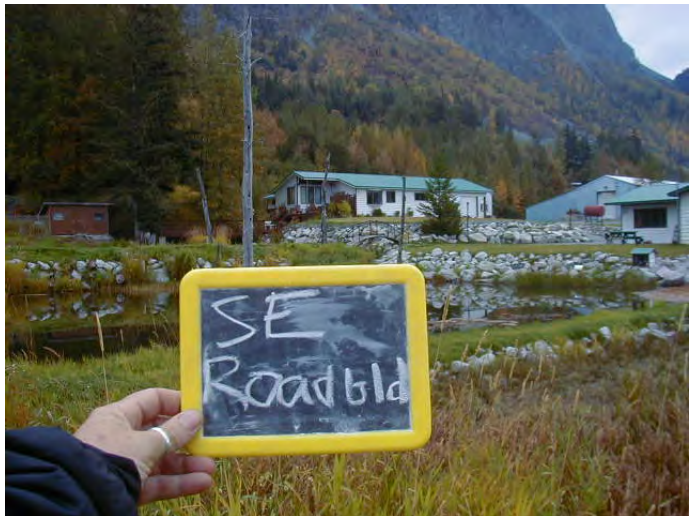
<p>Photograph No. 6</p> <p>Location: N/A</p> <p>Direction: Facing east</p> <p>Comments: Photo of pond on property</p>
